## Profile/Photo Observation Report

Street:	<b>W 61ST AVE</b>	Flow Control:	<b>Not Controlled</b>
City:	<b>Hobart, IN</b>	Year Renewed:	
Location:	<b>Yard</b>	Tape/Media #:	
Purpose:	<b>Routine Assessment</b>	Dia/Height:	<b>8"</b>
Use:	<b>Sanitary</b>	Material:	<b>PVC</b>
Drain Area:	<b>NA</b>	Lining:	
Category:	<b>NA</b>		
Comment:

Location Details:		Direction of Survey:	<b>Downstream</b>
US MH:	<b>M-608-005</b>	DS MH:	<b>M-608-010</b>
		Total Length Surveyed (ft):	<b>47.7</b>

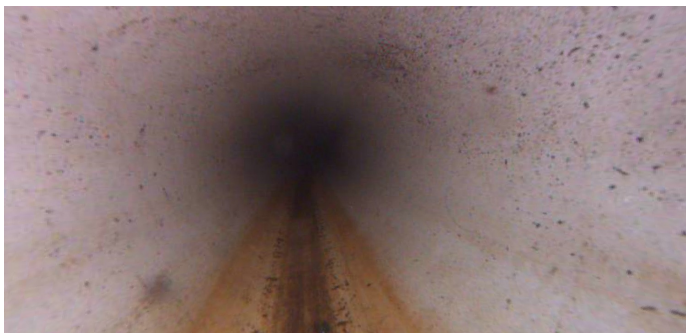
Code: **AMH**  
Description: **Manhole**

Distance (ft): **.0**  
Structural Grade: **0**  
O&M Grade: **0**  
Clock Start/From:  
Clock To:  
1st Value:  
2nd Value:  
Value Percent:  
Continuous Index:  
Within 8" of Joint: **NO**  
Remarks: **M-608-005**

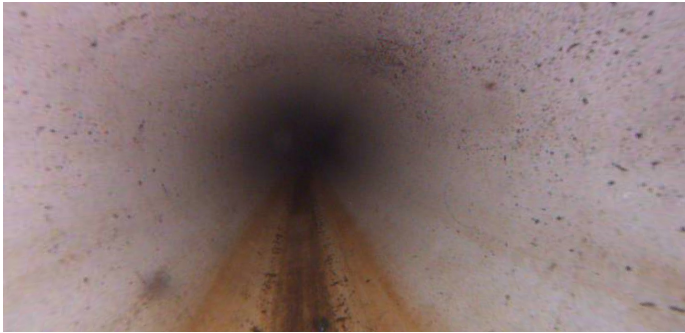
Code:	<b>MWL</b>
Description:	<b>Water Level</b>

Distance (ft):	<b>.0</b>
Structural Grade:	<b>0</b>
O&M Grade:	<b>0</b>
Clock Start/From:	
Clock To:	
1st Value:	
2nd Value:	
Value Percent:	<b>5.000</b>
Continuous Index:	
Within 8" of Joint:	<b>NO</b>
Remarks:

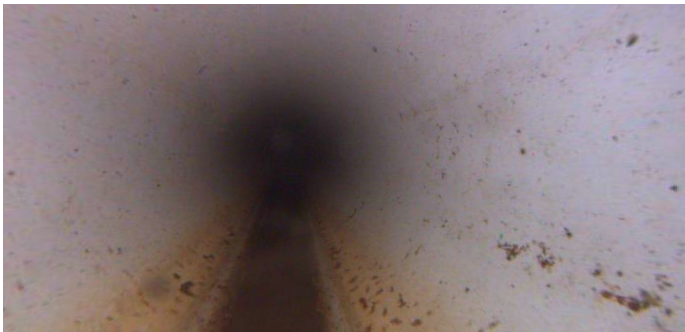
Code:	<b>MSA</b>
Description:	<b>Abandoned Survey</b>

Distance (ft):	<b>47.7</b>
Structural Grade:	<b>0</b>
O&M Grade:	<b>0</b>
Clock Start/From:	
Clock To:	
1st Value:	
2nd Value:	
Value Percent:	
Continuous Index:	
Within 8" of Joint:	<b>NO</b>
Remarks:	<b>debris</b>
