## Profile/Photo Observation Report

| Street: | <b>W 61ST AVE</b> | Flow Control: | <b>Not Controlled</b> |
| City: | <b>Hobart, IN</b> | Year Renewed: | |

| US MH: | <b>M-608-005</b> | DS MH: | <b>M-608-010</b> |

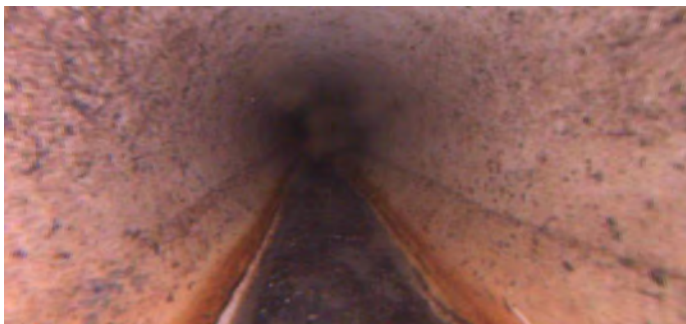
Code: **AMH**  
Description: **Manhole**

Distance (ft): **.0**  
Structural Grade: **0**  
O&M Grade: **0**  
Clock Start/From:  
Clock To:  
1st Value:  
2nd Value:  
Value Percent:  
Continuous Index:  
Within 8" of Joint: **NO**  
Remarks: **M-608-010**

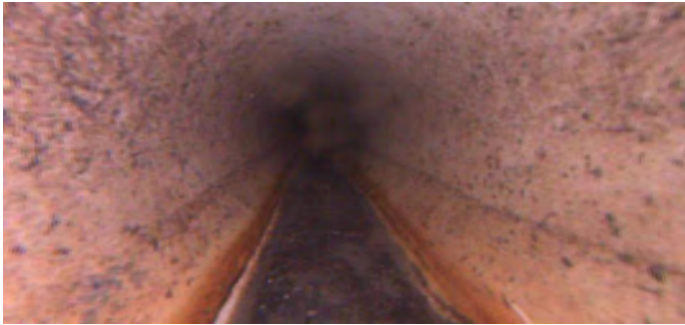
| Code: | <b>MWL</b> |
| Description: | <b>Water Level</b> |

| Value Percent: | <b>5.000</b> |

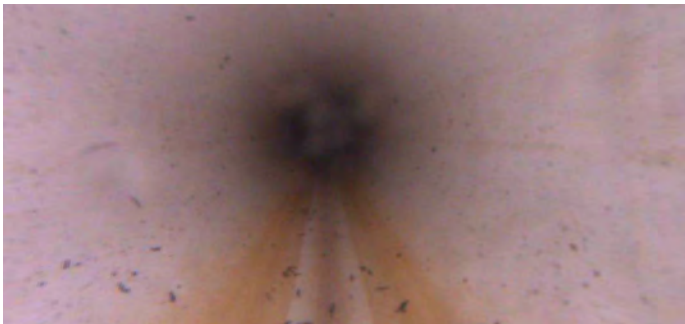
| Code: | <b>MSA</b> |
| Description: | <b>Abandoned Survey</b> |

| Distance (ft): | <b>286.1</b> |
| Remarks: | <b>camera stopped</b> |
