Profile/Photo Observation Report

Location Details:		Direction of Survey:	Downstream
US MH:	M-608-005	DS MH:	M-608-010
		Total Length Surveyed (ft):	149.4

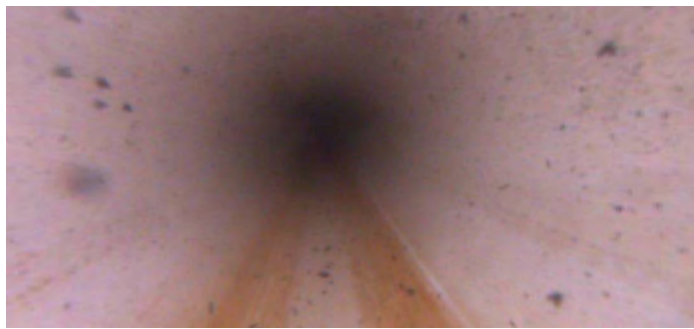
Code: **AMH**
Description: **Manhole**

Distance (ft): **.0**
Structural Grade: **0**
O&M Grade: **0**
Clock Start/From:
Clock To:
1st Value:
2nd Value:
Value Percent:
Continuous Index:
Within 8" of Joint: **NO**
Remarks: **M-608-005**

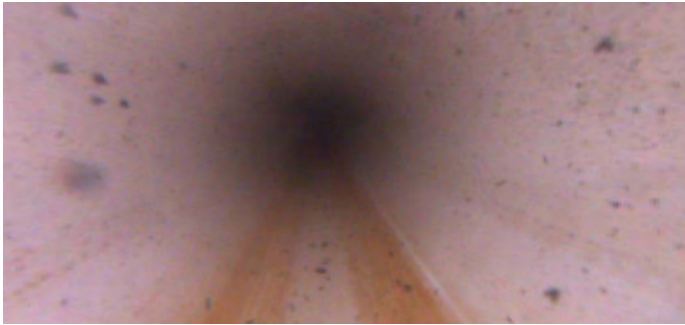
Code:	MWL
Description:	Water Level

Distance (ft):	.0
Structural Grade:	0
O&M Grade:	0
Clock Start/From:	
Clock To:	
1st Value:	
2nd Value:	
Value Percent:	5.000
Continuous Index:	
Within 8" of Joint:	NO
Remarks:

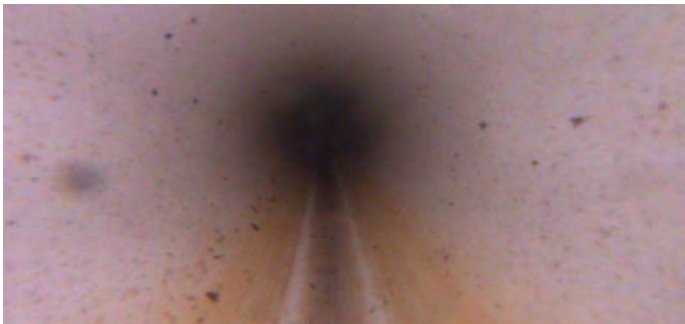
Code:	MSA
Description:	Abandoned Survey

Distance (ft):	149.4
Structural Grade:	0
O&M Grade:	0
Clock Start/From:	
Clock To:	
1st Value:	
2nd Value:	
Value Percent:	
Continuous Index:	
Within 8" of Joint:	NO
Remarks:	camera underwater
