## Profile/Photo Observation Report

Street:	<b>FOXCROFT STREET</b>	Flow Control:	<b>Not Controlled</b>
City:	<b>Hobart, IN</b>	Year Renewed:	
Location:	<b>Yard</b>	Tape/Media #:	
Purpose:	<b>Routine Assessment</b>	Dia/Height:	<b>8"</b>
Use:	<b>Sanitary</b>	Material:	<b>PVC</b>
Drain Area:	<b>NA</b>	Lining:	
Category:	<b>NA</b>		
Comment:	<b>Flow direction is marked wrong.</b>

Location Details:		Direction of Survey:	<b>Downstream</b>
US MH:	<b>M-608-008</b>	DS MH:	<b>M-608-007</b>
		Total Length Surveyed (ft):	<b>279.8</b>

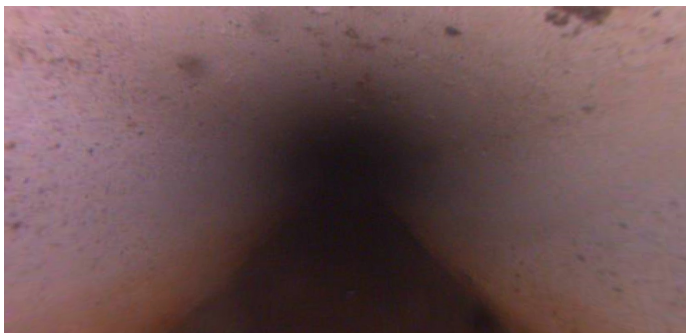
Code: **AMH**  
Description: **Manhole**

Distance (ft): **.0**  
Structural Grade: **0**  
O&M Grade: **0**  
Clock Start/From:  
Clock To:  
1st Value:  
2nd Value:  
Value Percent:  
Continuous Index:  
Within 8" of Joint: **NO**  
Remarks: **M-608-008**

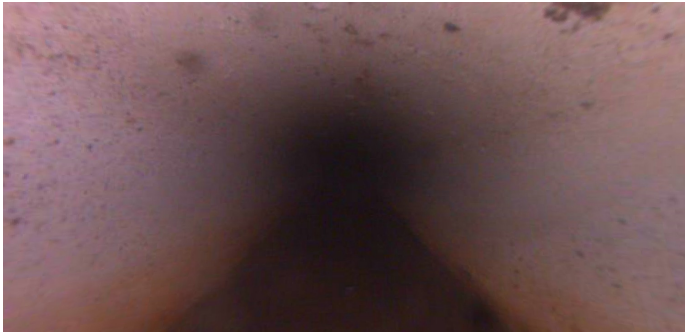
Code:	<b>MWL</b>
Description:	<b>Water Level</b>

Distance (ft):	<b>.0</b>
Structural Grade:	<b>0</b>
O&M Grade:	<b>0</b>
Clock Start/From:	
Clock To:	
1st Value:	
2nd Value:	
Value Percent:	<b>10.000</b>
Continuous Index:	
Within 8" of Joint:	<b>NO</b>
Remarks:

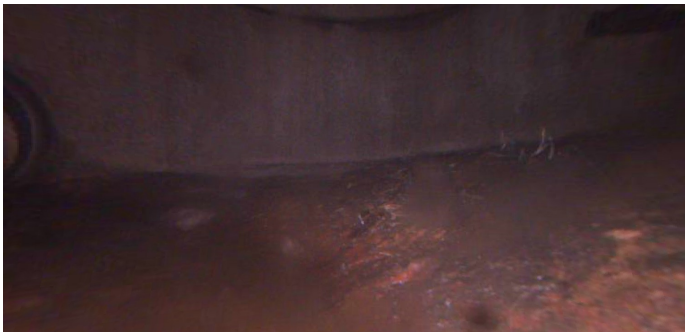
Code:	<b>AMH</b>
Description:	<b>Manhole</b>

Distance (ft):	<b>279.8</b>
Structural Grade:	<b>0</b>
O&M Grade:	<b>0</b>
Clock Start/From:	
Clock To:	
1st Value:	
2nd Value:	
Value Percent:	
Continuous Index:	
Within 8" of Joint:	<b>NO</b>
Remarks:	<b>M-608-007</b>
