## Profile/Photo Observation Report

Date:	<b>04/05/2018</b>	Weather:		Coding:	<b>PACP 6.0</b>
Pipe Length (ft):	<b>90.0</b>	Owner:	<b>NA</b>	Pre Clean:	<b>No Pre-Cleaning</b>
P.O.#:		Surveyor:	<b>Jen Costello</b>	PSR:	<b>P-608-008-009</b>
Customer:		Clean Date:	<b>01/01/1900</b>	Shape:	<b>C</b>

Street:	<b>OFF W 61ST AVE</b>	Flow Control:	<b>Not Controlled</b>
City:	<b>Hobart, IN</b>	Year Renewed:	
Location:	<b>Yard</b>	Tape/Media #:	
Purpose:	<b>Routine Assessment</b>	Dia/Height:	<b>8"</b>
Use:	<b>Sanitary</b>	Material:	<b>PVC</b>
Drain Area:	<b>NA</b>	Lining:	
Category:	<b>NA</b>		
Comment:			
Location Details:		Direction of Survey:	<b>Downstream</b>
US MH:	<b>M-608-009</b>	DS MH:	<b>M-608-008</b>
		Total Length Surveyed (ft):	<b>77.5</b>

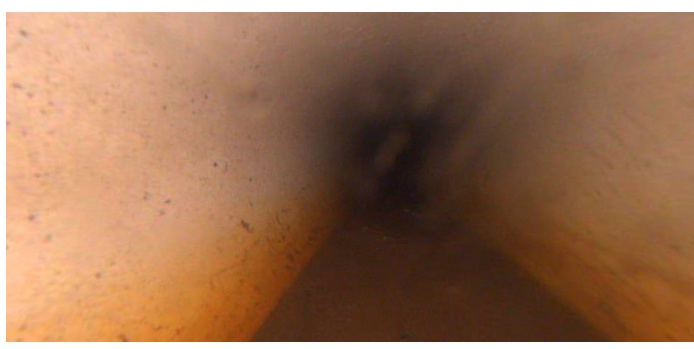
Code: **AMH**  
Description: **Manhole**

Distance (ft): **.0**  
Structural Grade: **0**  
O&M Grade: **0**  
Clock Start/From:  
Clock To:  
1st Value:  
2nd Value:  
Value Percent:  
Continuous Index:  
Within 8" of Joint: **NO**  
Remarks: **M-608-009**

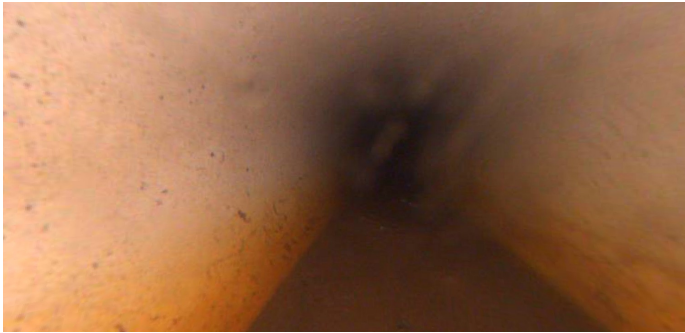
Code:	<b>MWL</b>
Description:	<b>Water Level</b>

Distance (ft):	<b>.0</b>
Structural Grade:	<b>0</b>
O&M Grade:	<b>0</b>
Clock Start/From:	
Clock To:	
1st Value:	
2nd Value:	
Value Percent:	<b>10.000</b>
Continuous Index:	
Within 8" of Joint:	<b>NO</b>
Remarks:

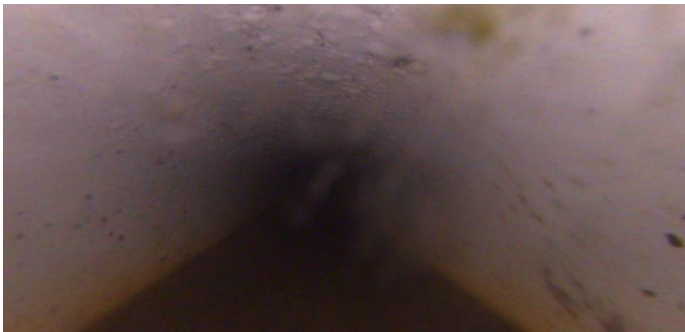
Code:	<b>MSA</b>
Description:	<b>Abandoned Survey</b>

Distance (ft):	<b>77.5</b>
Structural Grade:	<b>0</b>
O&M Grade:	<b>0</b>
Clock Start/From:	
Clock To:	
1st Value:	
2nd Value:	
Value Percent:	
Continuous Index:	
Within 8" of Joint:	<b>NO</b>
Remarks:	<b>debris under water</b>
