## Profile/Photo Observation Report

Street:	<b>FOXCROFT STREET</b>	Flow Control:	<b>Not Controlled</b>
City:	<b>Hobart, IN</b>	Year Renewed:	
Location:	<b>Yard</b>	Tape/Media #:	
Purpose:	<b>Routine Assessment</b>	Dia/Height:	<b>8"</b>
Use:	<b>Sanitary</b>	Material:	<b>PVC</b>
Drain Area:	<b>NA</b>	Lining:	
Category:	<b>NA</b>		
Comment:

Location Details:		Direction of Survey:	<b>Downstream</b>
US MH:	<b>M-608-009</b>	DS MH:	<b>M-608-008</b>
		Total Length Surveyed (ft):	<b>77.5</b>

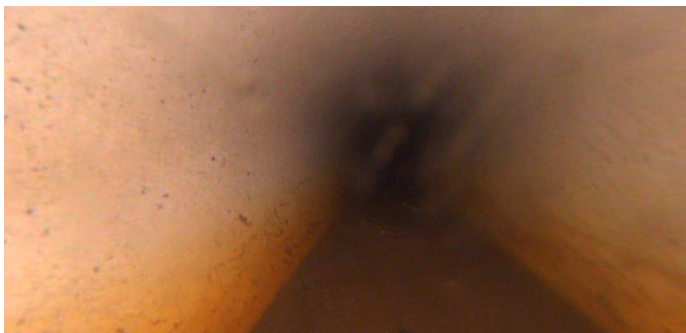
Code: **AMH**  
Description: **Manhole**

Distance (ft): **.0**  
Structural Grade: **0**  
O&M Grade: **0**  
Clock Start/From:  
Clock To:  
1st Value:  
2nd Value:  
Value Percent:  
Continuous Index:  
Within 8" of Joint: **NO**  
Remarks: **M-608-009**

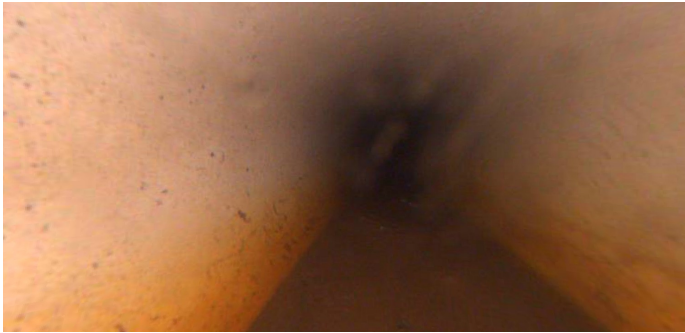
Code:	<b>MWL</b>
Description:	<b>Water Level</b>

Distance (ft):	<b>.0</b>
Structural Grade:	<b>0</b>
O&M Grade:	<b>0</b>
Clock Start/From:	
Clock To:	
1st Value:	
2nd Value:	
Value Percent:	<b>10.000</b>
Continuous Index:	
Within 8" of Joint:	<b>NO</b>
Remarks:

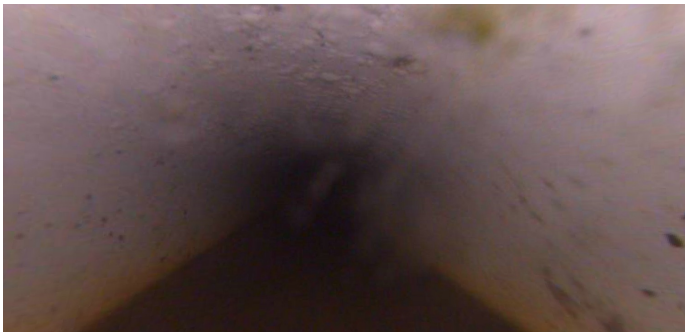
Code:	<b>MSA</b>
Description:	<b>Abandoned Survey</b>

Distance (ft):	<b>77.5</b>
Structural Grade:	<b>0</b>
O&M Grade:	<b>0</b>
Clock Start/From:	
Clock To:	
1st Value:	
2nd Value:	
Value Percent:	
Continuous Index:	
Within 8" of Joint:	<b>NO</b>
Remarks:	<b>debris under water</b>
