Profile/Photo Observation Report

Date:	04/05/2018	Weather:		Coding:	PACP 6.0
Pipe Length (ft):	90.0	Owner:	NA	Pre Clean:	No Pre-Cleaning
P.O.#:		Surveyor:	Jen Costello	PSR:	P-608-008-009
Customer:		Clean Date:	01/01/1900	Shape:	C

Street:	FOXCROFT STREET	Flow Control:	Not Controlled
City:	Hobart, IN	Year Renewed:	
Location:	Yard	Tape/Media #:	
Purpose:	Routine Assessment	Dia/Height:	8"
Use:	Sanitary	Material:	PVC
Drain Area:	NA	Lining:	
Category:	NA		
Comment:	Flow direction is marked wrong.		
Location Details:		Direction of Survey:	Upstream
US MH:	M-608-009	DS MH:	M-608-008
		Total Length Surveyed (ft):	87.6

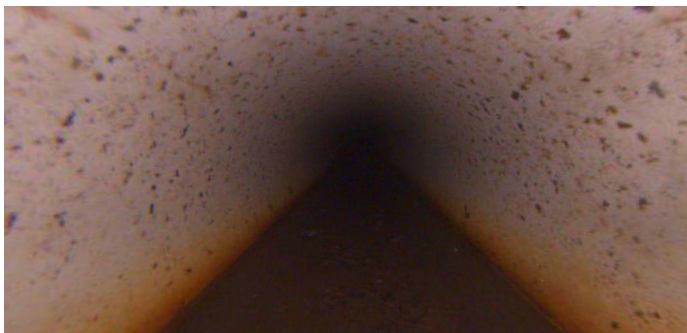
Code: **AMH**
Description: **Manhole**

Distance (ft): **.0**
Structural Grade: **0**
O&M Grade: **0**
Clock Start/From:
Clock To:
1st Value:
2nd Value:
Value Percent:
Continuous Index:
Within 8" of Joint: **NO**
Remarks: **M-608-008**

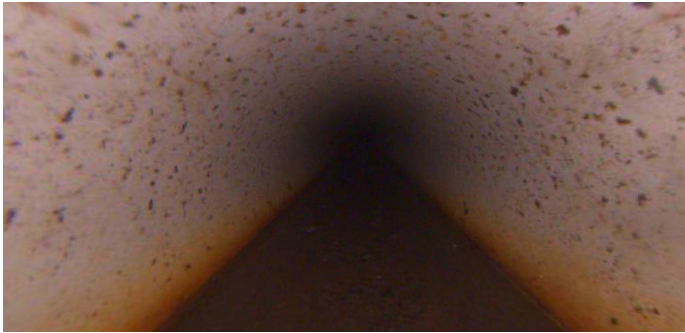
Code:	MWL
Description:	Water Level

Distance (ft):	.0
Structural Grade:	0
O&M Grade:	0
Clock Start/From:	
Clock To:	
1st Value:	
2nd Value:	
Value Percent:	10.000
Continuous Index:	
Within 8" of Joint:	NO
Remarks:

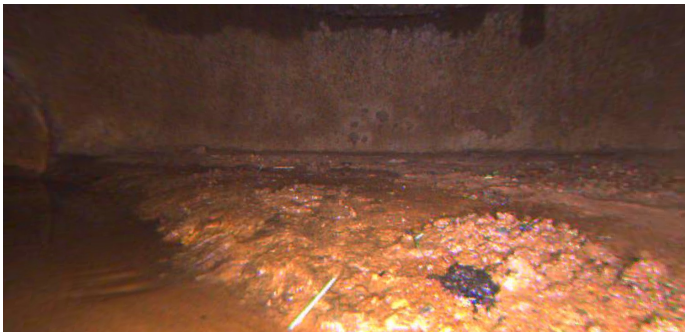
Code:	AMH
Description:	Manhole

Distance (ft):	87.6
Structural Grade:	0
O&M Grade:	0
Clock Start/From:	
Clock To:	
1st Value:	
2nd Value:	
Value Percent:	
Continuous Index:	
Within 8" of Joint:	NO
Remarks:	M-608-009
