## Profile/Photo Observation Report

Date:	<b>04/05/2018</b>	Weather:		Coding:	<b>PACP 6.0</b>
Pipe Length (ft):	<b>235.4</b>	Owner:	<b>NA</b>	Pre Clean:	<b>No Pre-Cleaning</b>
P.O.#:		Surveyor:	<b>Jen Costello</b>	PSR:	<b>P-608-009-010</b>
Customer:		Clean Date:	<b>01/01/1900</b>	Shape:	<b>C</b>

Street:	<b>W 61ST AVE</b>	Flow Control:	<b>Not Controlled</b>
City:	<b>Hobart, IN</b>	Year Renewed:	
Location:	<b>Yard</b>	Tape/Media #:	
Purpose:	<b>Routine Assessment</b>	Dia/Height:	<b>8"</b>
Use:	<b>Sanitary</b>	Material:	<b>PVC</b>
Drain Area:	<b>NA</b>	Lining:	
Category:	<b>NA</b>		
Comment:			
Location Details:		Direction of Survey:	<b>Upstream</b>
US MH:	<b>M-608-010</b>	DS MH:	<b>M-608-009</b>
		Total Length Surveyed (ft):	<b>224.2</b>

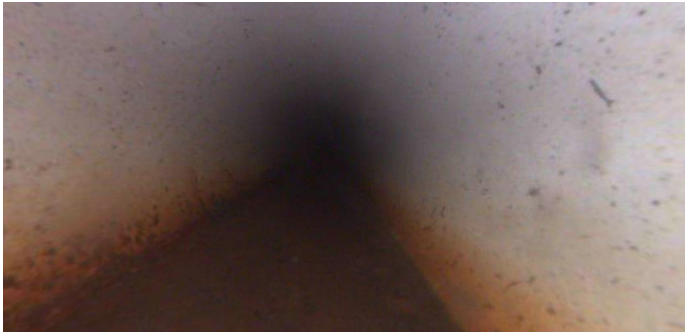
Code:	<b>MWL</b>
Description:	<b>Water Level</b>

Distance (ft):	<b>.0</b>
Structural Grade:	<b>0</b>
O&M Grade:	<b>0</b>
Clock Start/From:	
Clock To:	
1st Value:	
2nd Value:	
Value Percent:	<b>5.000</b>
Continuous Index:	
Within 8" of Joint:	<b>NO</b>
Remarks:

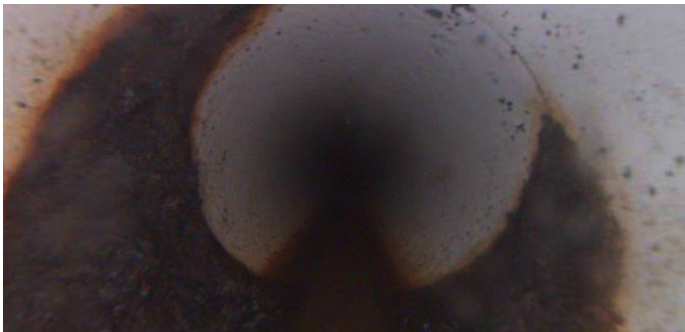
Code:	<b>DAE</b>
Description:	<b>Deposits Attached Encrustation</b>

Distance (ft):	<b>37.4</b>
Structural Grade:	<b>0</b>
O&M Grade:	<b>2</b>
Clock Start/From:	<b>7</b>
Clock To:	<b>5</b>
1st Value:	
2nd Value:	
Value Percent:	<b>10.000</b>
Continuous Index:	
Within 8" of Joint:	<b>YES</b>
Remarks:

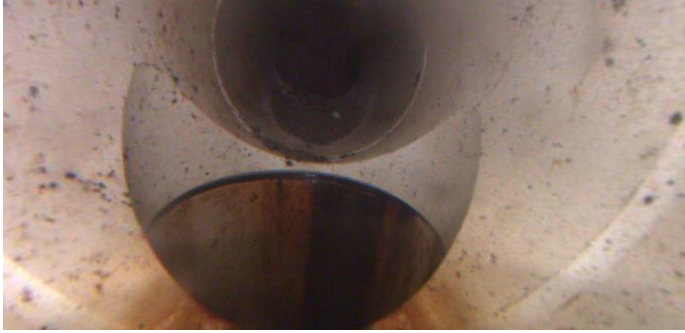
Code: **TF**  
Description: **Tap Factory**

Distance (ft): **222.9**  
Structural Grade: **0**  
O&M Grade: **0**  
Clock Start/From: **6**  
Clock To:  
1st Value: **6.000**  
2nd Value:  
Value Percent:  
Continuous Index:  
Within 8" of Joint:  
Remarks: **drop connection**

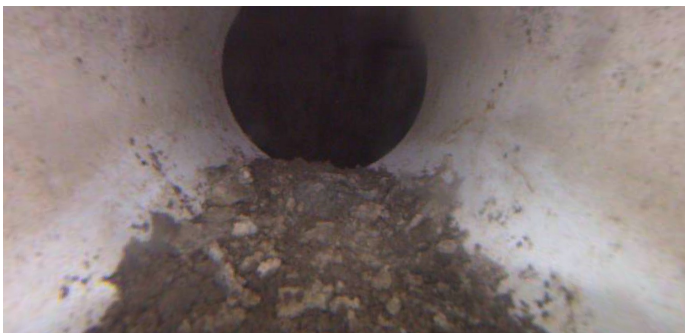
Code: **DSF**  
Description: **Deposits Settled Fine**

Distance (ft): **224.2**  
Structural Grade: **0**  
O&M Grade: **2**  
Clock Start/From: **5**  
Clock To: **7**  
1st Value:  
2nd Value:  
Value Percent: **5.000**  
Continuous Index:  
Within 8" of Joint: **NO**  
Remarks:

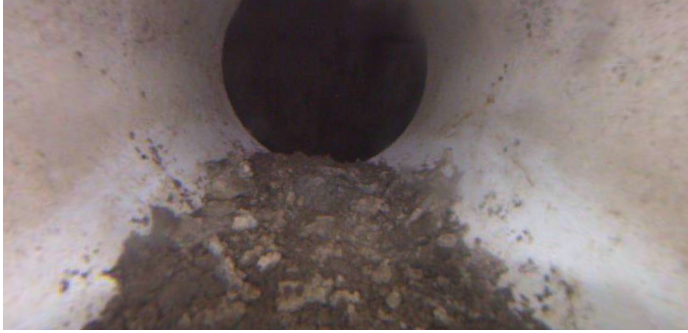
Code:	AMH
Description:	Manhole
Distance (ft):	224.2
Structural Grade:	0
O&M Grade:	0
Clock Start/From:	
Clock To:	
1st Value:	
2nd Value:	
Value Percent:	
Continuous Index:	
Within 8" of Joint:	NO
Remarks:	M-608-010 in drop
