## Profile/Photo Observation Report

| P.O.#: | <b>45-1</b> | Surveyor: | <b>M. Pielacha</b> | PSR: | <b>M-608-011-M-608-012</b> |

| Street: | <b>Off 37th Street</b> | Flow Control: | <b>Not Controlled</b> |

| US MH: | <b>M-608-011</b> | DS MH: | <b>M-608-012</b> |

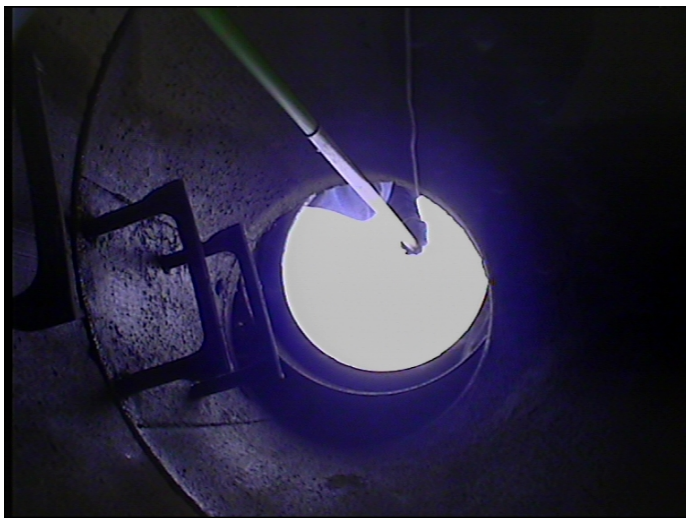
Code: **AMH**  
Description: **Manhole**

Distance (ft): **.0**  
Structural Grade: **0**  
O&M Grade: **0**  
Clock Start/From:  
Clock To:  
1st Value:  
2nd Value:  
Value Percent:  
Continuous Index:  
Within 8" of Joint: **NO**  
Remarks: **M-608-011**

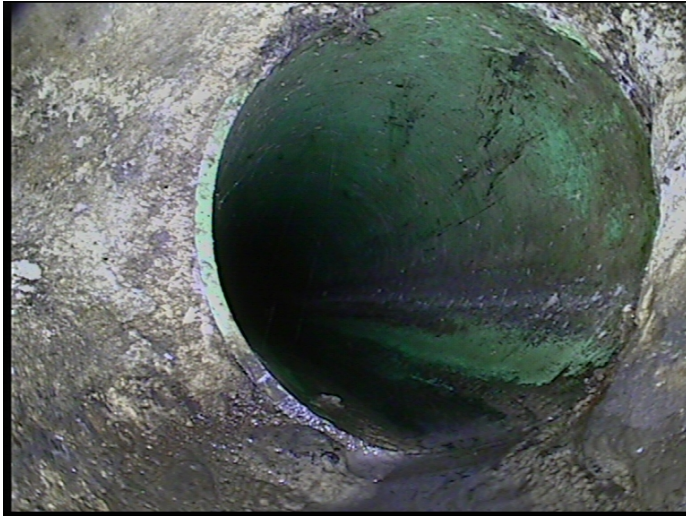
| Code: | <b>MWL</b> |
| Description: | <b>Water Level</b> |
| Distance (ft): | <b>.0</b> |
| Value Percent: | <b>5.000</b> |

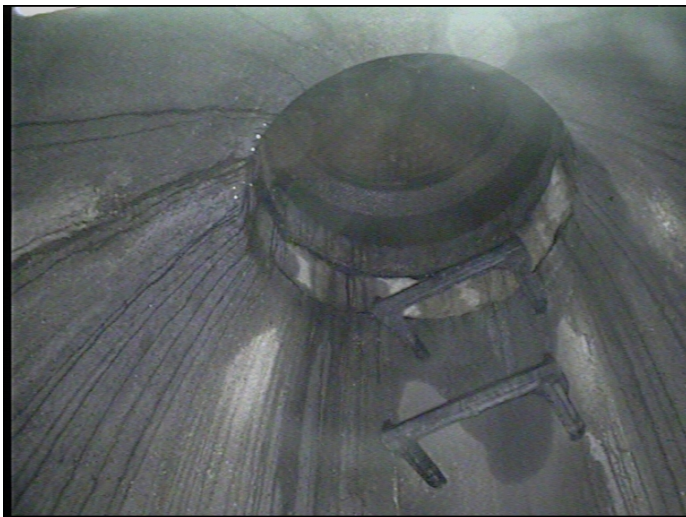
| Code: | <b>AMH</b> |
| Description: | <b>Manhole</b> |
| Distance (ft): | <b>97.1</b> |
| Remarks: | <b>M-608-012</b> |
