## **Profile/Photo Observation Report**

Profile/Photo Observation Report								
Date: Pipe Length (ft) P.O.#: Customer:	04/14/2018 : 45-1 City of Hobart	Weather: Owner: Surveyor: Clean Date:	City of Hobart M. Pielacha	i.	Coding: Pre Clean: PSR: Shape:	PACP 6.0 No Pre-Cleaning M-608-011-M-608-012 C		
Street:	Off 37th Street	Clean Date.	Flow Control:		Not Controlled			
City:	Hobart, IN		Year Renewed:		Not controlled			
Location:	Light Highway		Tape/Media #:		DEP 45			
Purpose:	Routine Assessment		Dia/Height:		6"			
Use:	Sanitary		Material:		PVC			
Drain Area:			Lining:					
Category:	NA							
Comment:								
Location Detail	s:		Direction of Sur	vey:	Downstream			
US MH:	M-608-011	DS MH:	M-608-012	Total Le	ength Surveyed (ft):	97.1		
O&M Index:	0.00	O&M Quick:	00	00	O&M Rating:	0.00		
Structural Index:	0.00	Structural Q		00	Structural Rating:	0.00		
Overall Index:	0.00	Overall Quic		00	Overall Rating:	0.00		
					_

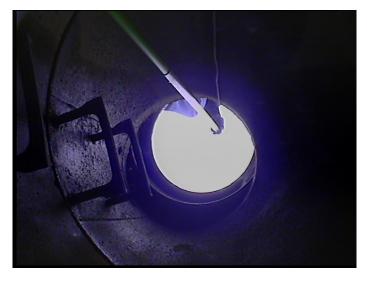
Code:

Description:	Manhole
Distance (ft):	.0
Structural Grade:	0
O&M Grade:	0
Clock Start/From:	
Clock To:	
1st Value:	
2nd Value:	
Value Percent:	
Continuous Index:	
Within 8" of Joint:	NO
Remarks:	M-608-011

AMH

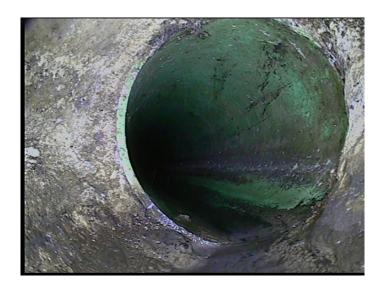
Code: MWL
Description: Water Level

Distance (ft): .0
Structural Grade: 0
O&M Grade: 0

Value Percent: 5.000

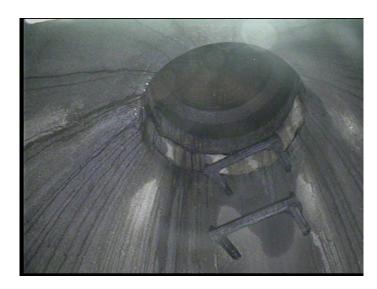
Code: AMH
Description: Manhole

Distance (ft): 97.1
Structural Grade: 0
O&M Grade: 0
Clock Start/From:

Remarks: M-608-012
