Profile/Photo Observation Report

Date:	03/30/2018	Weather:		Coding:	PACP 6.0
Pipe Length (ft):	191.6	Owner:	NA	Pre Clean:	No Pre-Cleaning
P.O.#:		Surveyor:	Jen Costello	PSR:	P-608-012-013
Customer:		Clean Date:	01/01/1900	Shape:	C

Street:	OFF S ASH ST	Flow Control:	Not Controlled
City:	Hobart, IN	Year Renewed:	
Location:	Parking Lot	Tape/Media #:	
Purpose:	Routine Assessment	Dia/Height:	10"
Use:	Sanitary	Material:	PVC
Drain Area:	NA	Lining:	
Category:	NA		
Comment:	P_C at 127 ft debris . Flow direction wrong

Location Details:		Direction of Survey:	Downstream
US MH:	M-608-013	DS MH:	M-608-012
		Total Length Surveyed (ft):	128.7

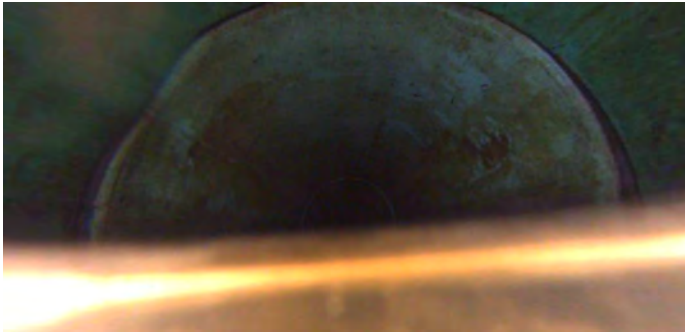
Code:	MWL
Description:	Water Level

Distance (ft):	.0
Structural Grade:	0
O&M Grade:	0
Clock Start/From:	
Clock To:	
1st Value:	
2nd Value:	
Value Percent:	40.000
Continuous Index:	
Within 8" of Joint:	NO
Remarks:

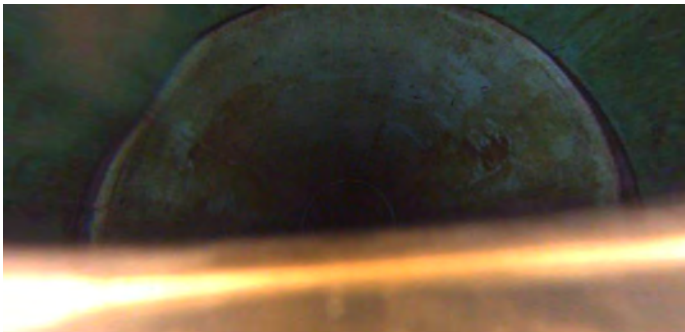
Code:	JOM
Description:	Joint Offset Medium

Distance (ft):	.0
Structural Grade:	1
O&M Grade:	0
Clock Start/From:	
Clock To:	
1st Value:	
2nd Value:	
Value Percent:	
Continuous Index:	
Within 8" of Joint:	NO
Remarks:

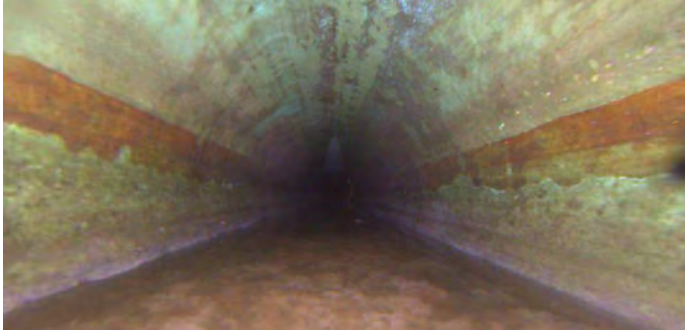
Code: **MWL**
Description: **Water Level**

Distance (ft): **34.4**
Structural Grade: **0**
O&M Grade: **0**
Clock Start/From:
Clock To:
1st Value:
2nd Value:
Value Percent: **20.000**
Continuous Index:
Within 8" of Joint: **NO**
Remarks:

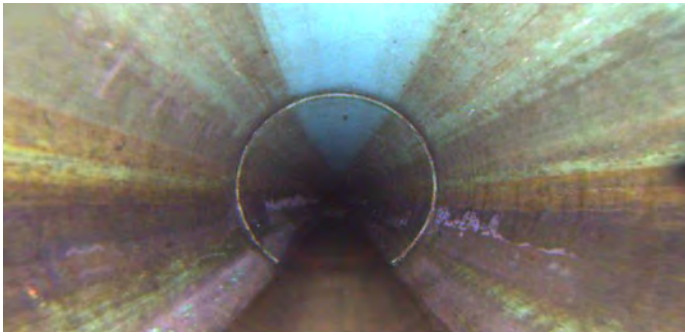
Code: **MWL**
Description: **Water Level**

Distance (ft): **101.8**
Structural Grade: **0**
O&M Grade: **0**
Clock Start/From:
Clock To:
1st Value:
2nd Value:
Value Percent: **5.000**
Continuous Index:
Within 8" of Joint: **NO**
Remarks:

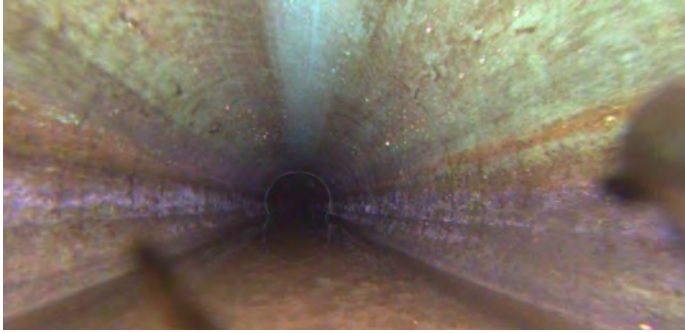
Code: **MWL**
Description: **Water Level**

Distance (ft): **111.6**
Structural Grade: **0**
O&M Grade: **0**
Clock Start/From:
Clock To:
1st Value:
2nd Value:
Value Percent: **20.000**
Continuous Index:
Within 8" of Joint: **NO**
Remarks:

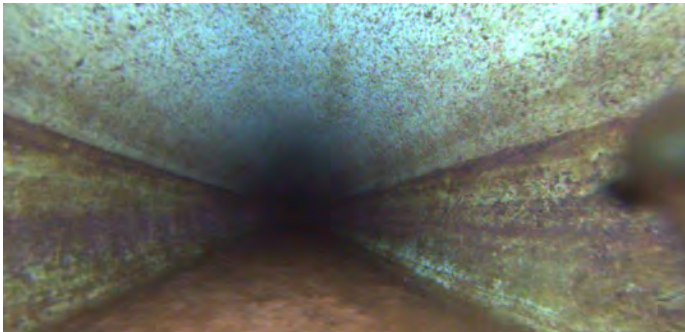
Code: **MSA**
Description: **Abandoned Survey**

Distance (ft): **128.7**
Structural Grade: **0**
O&M Grade: **0**
Clock Start/From:
Clock To:
1st Value:
2nd Value:
Value Percent:
Continuous Index:
Within 8" of Joint: **NO**
Remarks: **DEBRIS UNDER WATER**
