## Profile/Photo Observation Report

Date:	<b>03/30/2018</b>	Weather:		Coding:	<b>PACP 6.0</b>
Pipe Length (ft):	<b>191.6</b>	Owner:	<b>NA</b>	Pre Clean:	<b>No Pre-Cleaning</b>
P.O.#:		Surveyor:	<b>Jen Costello</b>	PSR:	<b>P-608-012-013</b>
Customer:		Clean Date:	<b>01/01/1900</b>	Shape:	<b>C</b>

Street:	<b>FOXCROFT STREET</b>	Flow Control:	<b>Not Controlled</b>
City:	<b>Hobart, IN</b>	Year Renewed:	
Location:	<b>Parking Lot</b>	Tape/Media #:	
Purpose:	<b>Routine Assessment</b>	Dia/Height:	<b>10"</b>
Use:	<b>Sanitary</b>	Material:	<b>PVC</b>
Drain Area:	<b>NA</b>	Lining:	
Category:	<b>NA</b>		
Comment:	<b>P_C at 127 ft debris . Flow direction wrong</b>		
Location Details:		Direction of Survey:	<b>Downstream</b>
US MH:	<b>M-608-013</b>	DS MH:	<b>M-608-012</b>
		Total Length Surveyed (ft):	<b>128.7</b>

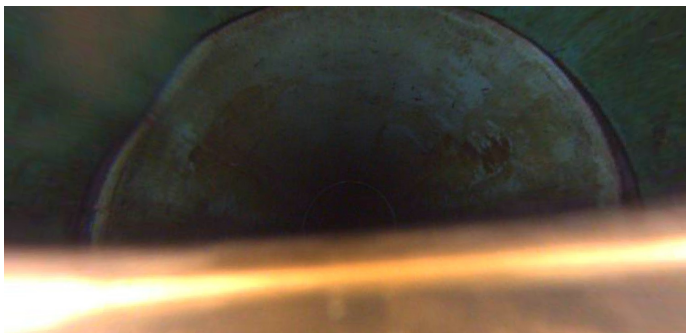
Code: **AMH**  
Description: **Manhole**

Distance (ft): **.0**  
Structural Grade: **0**  
O&M Grade: **0**  
Clock Start/From:  
Clock To:  
1st Value:  
2nd Value:  
Value Percent:  
Continuous Index:  
Within 8" of Joint: **NO**  
Remarks: **M-608-013**

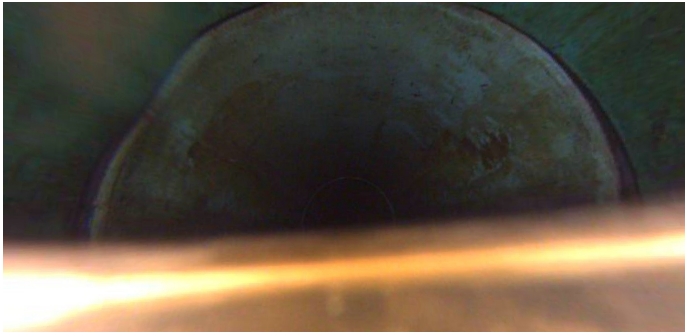
Code:	<b>MWL</b>
Description:	<b>Water Level</b>

Distance (ft):	<b>.0</b>
Structural Grade:	<b>0</b>
O&M Grade:	<b>0</b>
Clock Start/From:	
Clock To:	
1st Value:	
2nd Value:	
Value Percent:	<b>40.000</b>
Continuous Index:	
Within 8" of Joint:	<b>NO</b>
Remarks:

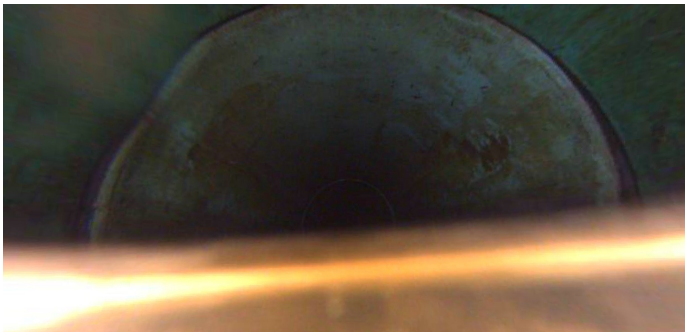
Code:	<b>JOM</b>
Description:	<b>Joint Offset Medium</b>

Distance (ft):	<b>.0</b>
Structural Grade:	<b>1</b>
O&M Grade:	<b>0</b>
Clock Start/From:	
Clock To:	
1st Value:	
2nd Value:	
Value Percent:	
Continuous Index:	
Within 8" of Joint:	<b>NO</b>
Remarks:

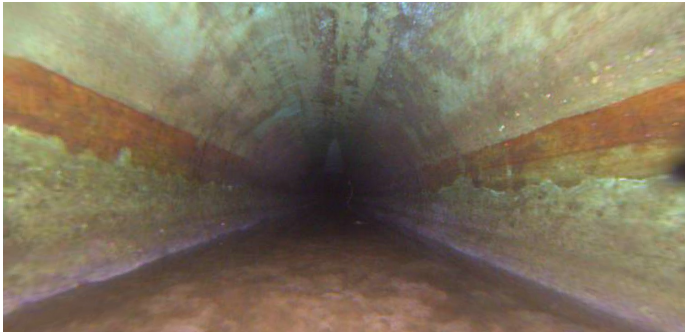
Code: **MWL**  
Description: **Water Level**

Distance (ft): **34.4**  
Structural Grade: **0**  
O&M Grade: **0**  
Clock Start/From:  
Clock To:  
1st Value:  
2nd Value:  
Value Percent: **20.000**  
Continuous Index:  
Within 8" of Joint: **NO**  
Remarks:

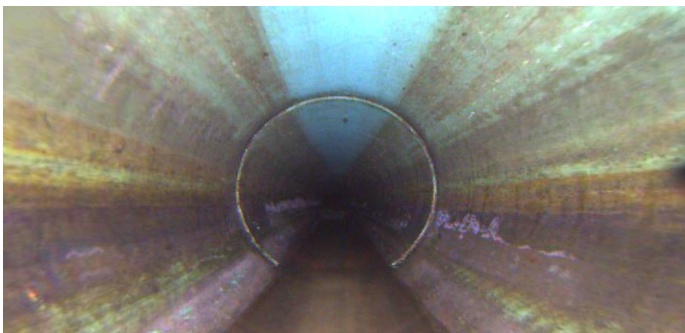
Code: **MWL**  
Description: **Water Level**

Distance (ft): **101.8**  
Structural Grade: **0**  
O&M Grade: **0**  
Clock Start/From:  
Clock To:  
1st Value:  
2nd Value:  
Value Percent: **5.000**  
Continuous Index:  
Within 8" of Joint: **NO**  
Remarks:

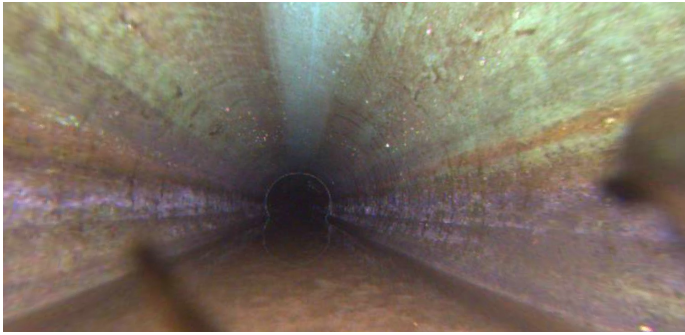
Code: **MWL**  
Description: **Water Level**

Distance (ft): **111.6**  
Structural Grade: **0**  
O&M Grade: **0**  
Clock Start/From:  
Clock To:  
1st Value:  
2nd Value:  
Value Percent: **20.000**  
Continuous Index:  
Within 8" of Joint: **NO**  
Remarks:

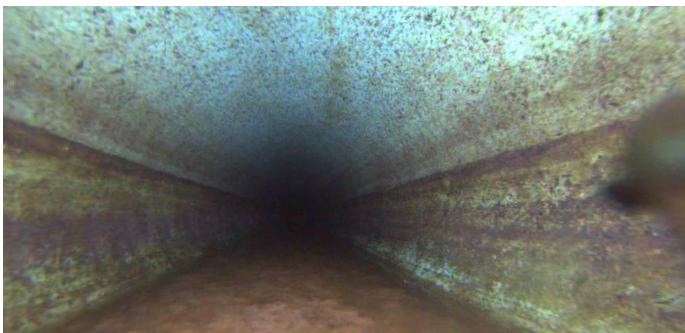
Code: **MSA**  
Description: **Abandoned Survey**

Distance (ft): **128.7**  
Structural Grade: **0**  
O&M Grade: **0**  
Clock Start/From:  
Clock To:  
1st Value:  
2nd Value:  
Value Percent:  
Continuous Index:  
Within 8" of Joint: **NO**  
Remarks: **DEBRIS UNDER WATER**
