Profile/Photo Observation Report

Date:	03/30/2018	Weather:		Coding:	PACP 6.0
Pipe Length (ft):	191.6	Owner:	NA	Pre Clean:	No Pre-Cleaning
P.O.#:		Surveyor:	Jen Costello	PSR:	P-608-012-013
Customer:		Clean Date:	01/01/1900	Shape:	C

Street:	OFF S ASH ST	Flow Control:	Not Controlled
City:	Hobart, IN	Year Renewed:	
Location:	Parking Lot	Tape/Media #:	
Purpose:	Routine Assessment	Dia/Height:	10"
Use:	Sanitary	Material:	PVC
Drain Area:	NA	Lining:	
Category:	NA		
Comment:	P_C at 14 ft debris . Flow direction wrong		
Location Details:		Direction of Survey:	Upstream
US MH:	M-608-013	DS MH:	M-608-012
		Total Length Surveyed (ft):	15.5

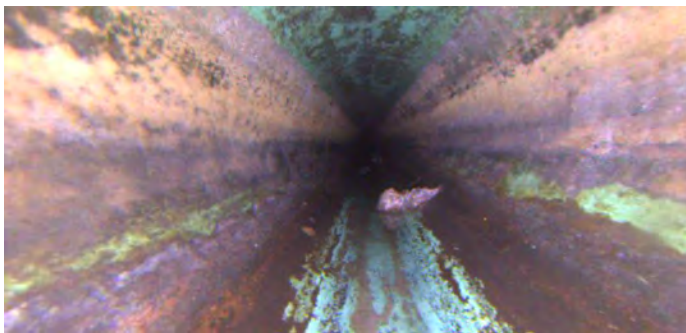
Code: **AMH**
Description: **Manhole**

Distance (ft): **.0**
Structural Grade: **0**
O&M Grade: **0**
Clock Start/From:
Clock To:
1st Value:
2nd Value:
Value Percent:
Continuous Index:
Within 8" of Joint: **NO**
Remarks: **M-608-012**

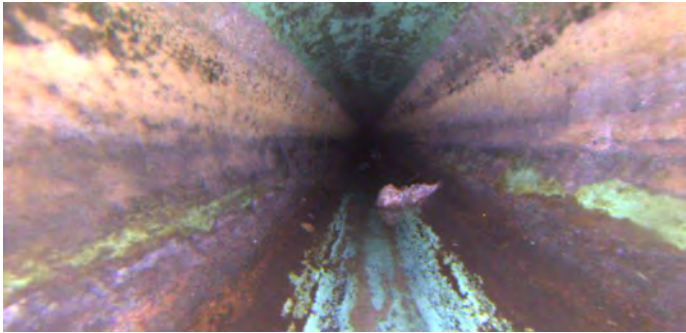
Code:	MWL
Description:	Water Level

Distance (ft):	.0
Structural Grade:	0
O&M Grade:	0
Clock Start/From:	
Clock To:	
1st Value:	
2nd Value:	
Value Percent:	5.000
Continuous Index:	
Within 8" of Joint:	NO
Remarks:

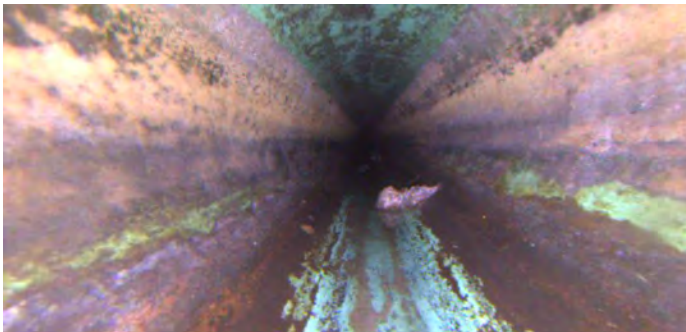
Code:	DAE
Description:	Deposits Attached Encrustation

Distance (ft):	.0
Structural Grade:	0
O&M Grade:	2
Clock Start/From:	7
Clock To:	5
1st Value:	
2nd Value:	
Value Percent:	5.000
Continuous Index:	S01
Within 8" of Joint:	NO
Remarks:

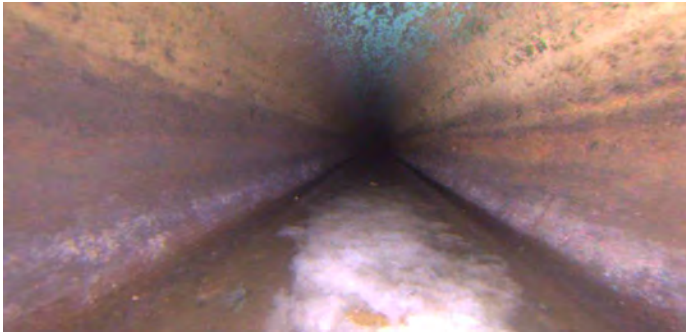
Code: **DAE**
Description: **Deposits Attached Encrustation**

Distance (ft): **15.5**
Structural Grade: **0**
O&M Grade: **2**
Clock Start/From: **7**
Clock To: **5**
1st Value:
2nd Value:
Value Percent: **5.000**
Continuous Index: **F01**
Within 8" of Joint: **NO**
Remarks:

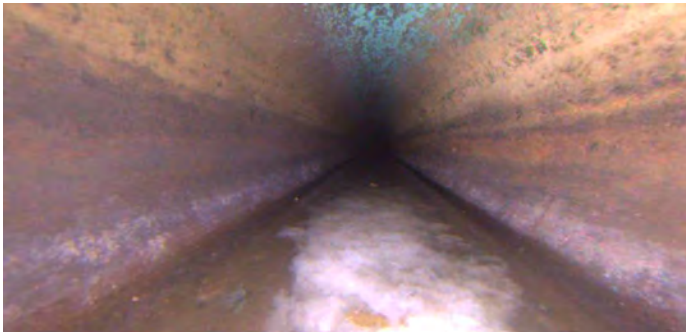
Code: **MSA**
Description: **Abandoned Survey**

Distance (ft): **15.5**
Structural Grade: **0**
O&M Grade: **0**
Clock Start/From:
Clock To:
1st Value:
2nd Value:
Value Percent:
Continuous Index:
Within 8" of Joint: **NO**
Remarks: **debris under water**
