## Profile/Photo Observation Report

Street:	<b>FOXCROFT STREET</b>	Flow Control:	<b>Not Controlled</b>
City:	<b>Hobart, IN</b>	Year Renewed:	
Location:	<b>Parking Lot</b>	Tape/Media #:	
Purpose:	<b>Routine Assessment</b>	Dia/Height:	<b>10"</b>
Use:	<b>Sanitary</b>	Material:	<b>PVC</b>
Drain Area:	<b>NA</b>	Lining:	
Category:	<b>NA</b>		
Comment:	<b>P_C at 14 ft debris . Flow direction wrong</b>		
Location Details:		Direction of Survey:	<b>Upstream</b>
US MH:	<b>M-608-013</b>	DS MH:	<b>M-608-012</b>
		Total Length Surveyed (ft):	<b>15.5</b>

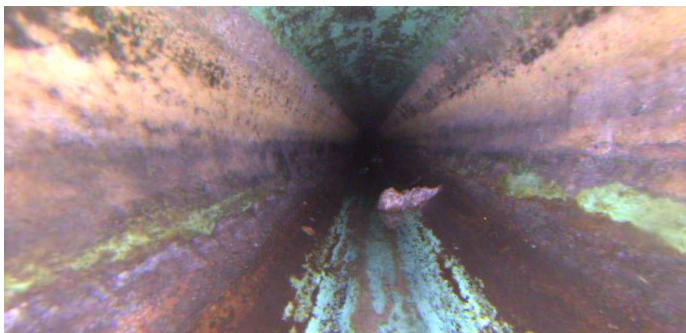
Code: **AMH**  
Description: **Manhole**

Distance (ft): **.0**  
Structural Grade: **0**  
O&M Grade: **0**  
Clock Start/From:  
Clock To:  
1st Value:  
2nd Value:  
Value Percent:  
Continuous Index:  
Within 8" of Joint: **NO**  
Remarks: **M-608-012**

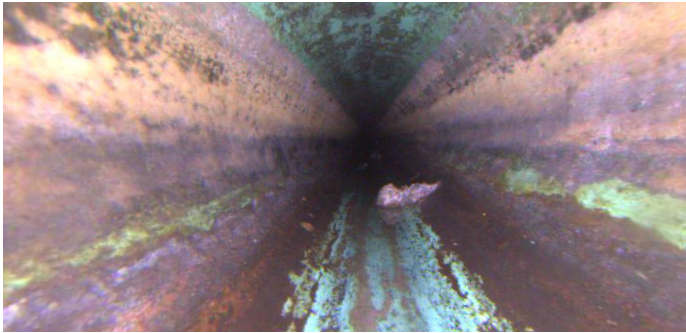
Code:	<b>MWL</b>
Description:	<b>Water Level</b>

Distance (ft):	<b>.0</b>
Structural Grade:	<b>0</b>
O&M Grade:	<b>0</b>
Clock Start/From:	
Clock To:	
1st Value:	
2nd Value:	
Value Percent:	<b>5.000</b>
Continuous Index:	
Within 8" of Joint:	<b>NO</b>
Remarks:

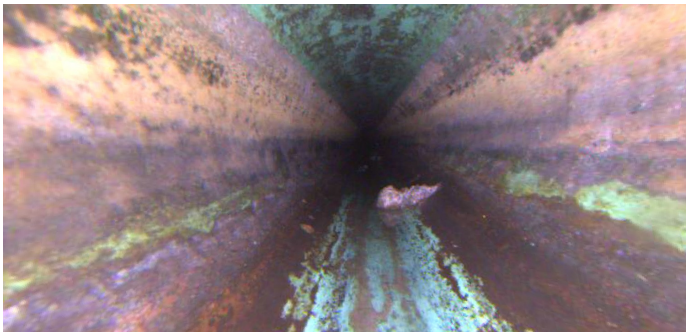
Code:	<b>DAE</b>
Description:	<b>Deposits Attached Encrustation</b>

Distance (ft):	<b>.0</b>
Structural Grade:	<b>0</b>
O&M Grade:	<b>2</b>
Clock Start/From:	<b>7</b>
Clock To:	<b>5</b>
1st Value:	
2nd Value:	
Value Percent:	<b>5.000</b>
Continuous Index:	<b>S01</b>
Within 8" of Joint:	<b>NO</b>
Remarks:

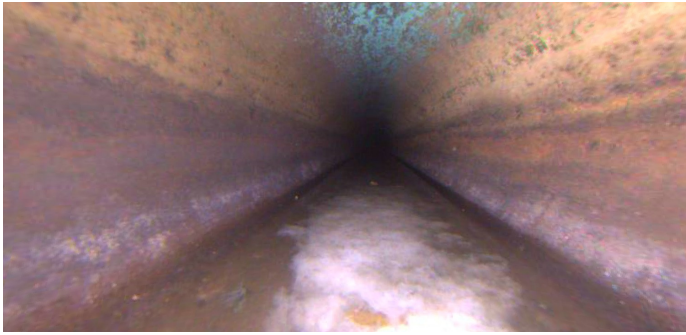
Code: **DAE**  
Description: **Deposits Attached Encrustation**

Distance (ft): **15.5**  
Structural Grade: **0**  
O&M Grade: **2**  
Clock Start/From: **7**  
Clock To: **5**  
1st Value:  
2nd Value:  
Value Percent: **5.000**  
Continuous Index: **F01**  
Within 8" of Joint: **NO**  
Remarks:

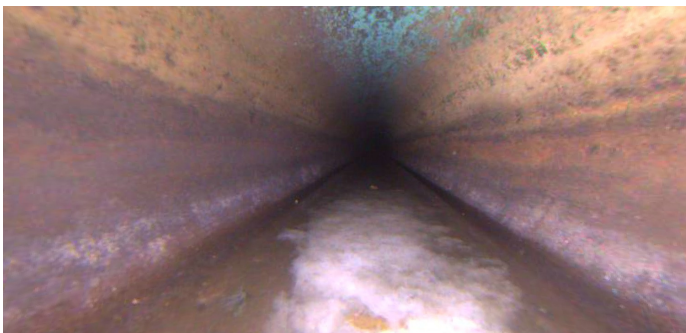
Code: **MSA**  
Description: **Abandoned Survey**

Distance (ft): **15.5**  
Structural Grade: **0**  
O&M Grade: **0**  
Clock Start/From:  
Clock To:  
1st Value:  
2nd Value:  
Value Percent:  
Continuous Index:  
Within 8" of Joint: **NO**  
Remarks: **debris under water**
