## Profile/Photo Observation Report

Street:	<b>Washington St.</b>	Flow Control:	<b>Not Controlled</b>
City:	<b>Hobart, IN</b>	Year Renewed:	
Location:	<b>Light Highway</b>	Tape/Media #:	
Purpose:	<b>Routine Assessment</b>	Dia/Height:	<b>10"</b>
Use:	<b>Sanitary</b>	Material:	<b>PVC</b>
Drain Area:	<b>NA</b>	Lining:	
Category:	<b>NA</b>		
Comment:

Location Details:		Direction of Survey:	<b>Downstream</b>
US MH:	<b>M-608-013</b>	DS MH:	<b>M-608-012</b>
		Total Length Surveyed (ft):	<b>191.6</b>

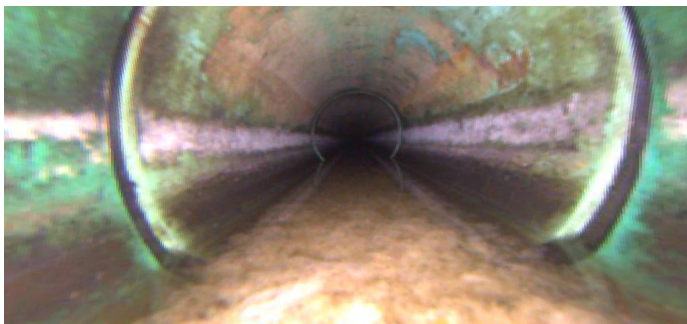
Code: **AMH**  
Description: **Manhole**

Distance (ft): **.0**  
Structural Grade: **0**  
O&M Grade: **0**  
Clock Start/From:  
Clock To:  
1st Value:  
2nd Value:  
Value Percent:  
Continuous Index:  
Within 8" of Joint: **NO**  
Remarks: **M-608-013**

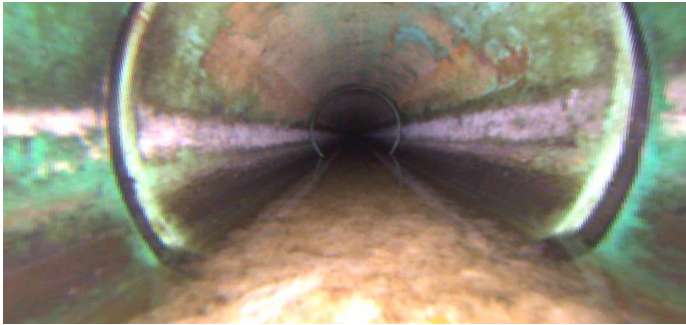
Code:	<b>MWL</b>
Description:	<b>Water Level</b>

Distance (ft):	<b>.0</b>
Structural Grade:	<b>0</b>
O&M Grade:	<b>0</b>
Clock Start/From:	
Clock To:	
1st Value:	
2nd Value:	
Value Percent:	<b>5.000</b>
Continuous Index:	
Within 8" of Joint:	<b>NO</b>
Remarks:

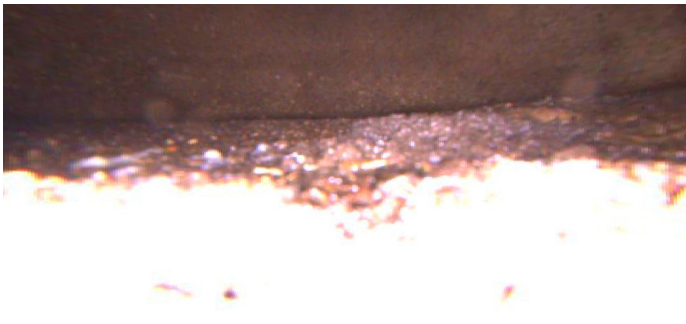
Code:	<b>AMH</b>
Description:	<b>Manhole</b>

Distance (ft):	<b>191.6</b>
Structural Grade:	<b>0</b>
O&M Grade:	<b>0</b>
Clock Start/From:	
Clock To:	
1st Value:	
2nd Value:	
Value Percent:	
Continuous Index:	
Within 8" of Joint:	<b>NO</b>
Remarks:	<b>M-608-012</b>
