Profile/Photo Observation Report

Date:	03/30/2018	Weather:		Coding:	PACP 6.0
Pipe Length (ft):	170.3	Owner:	NA	Pre Clean:	No Pre-Cleaning
P.O.#:		Surveyor:	Jen Costello	PSR:	P-608-013-014
Customer:		Clean Date:	01/01/1900	Shape:	C

Street:	OFF S ASH ST	Flow Control:	Not Controlled
City:	Hobart, IN	Year Renewed:	
Location:	Parking Lot	Tape/Media #:	
Purpose:	Routine Assessment	Dia/Height:	10"
Use:	Sanitary	Material:	PVC
Drain Area:	NA	Lining:	
Category:	NA		
Comment:	P_C at 63 ft debris .Flow direction wrong		
Location Details:		Direction of Survey:	Upstream
US MH:	M-608-014	DS MH:	M-608-013
		Total Length Surveyed (ft):	64.7

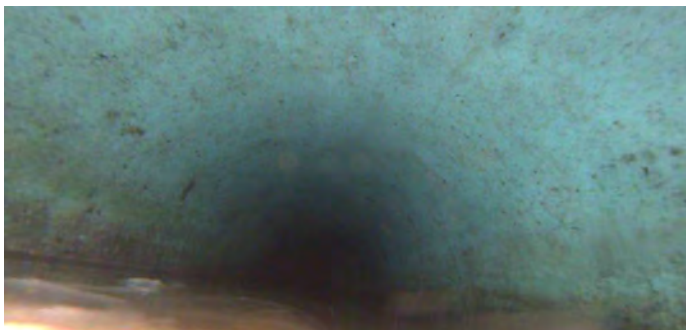
Code: **AMH**
Description: **Manhole**

Distance (ft): **.0**
Structural Grade: **0**
O&M Grade: **0**
Clock Start/From:
Clock To:
1st Value:
2nd Value:
Value Percent:
Continuous Index:
Within 8" of Joint: **NO**
Remarks: **M-608-013**

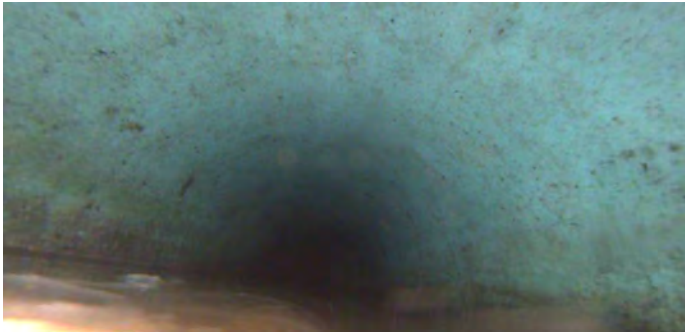
Code:	MWL
Description:	Water Level

Distance (ft):	.0
Structural Grade:	0
O&M Grade:	0
Clock Start/From:	
Clock To:	
1st Value:	
2nd Value:	
Value Percent:	30.000
Continuous Index:	
Within 8" of Joint:	NO
Remarks:

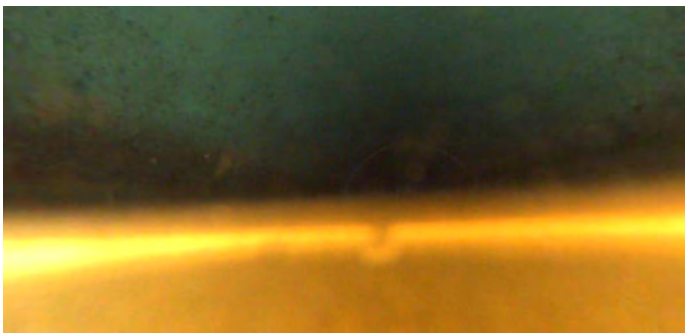
Code: **MGO**
Description: **General Observation**

Distance (ft): **30.7**
Structural Grade: **0**
O&M Grade: **0**
Clock Start/From:
Clock To:
1st Value:
2nd Value:
Value Percent:
Continuous Index:
Within 8" of Joint: **NO**
Remarks: **REAR CAMERA**

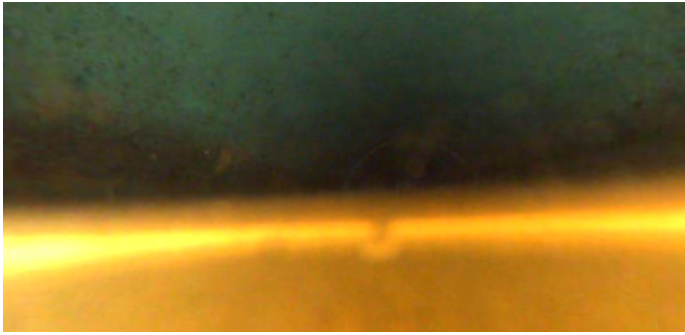
Code: **MCU**
Description: **Camera Underwater**

Distance (ft): **30.7**
Structural Grade: **0**
O&M Grade: **4**
Clock Start/From:
Clock To:
1st Value:
2nd Value:
Value Percent:
Continuous Index: **F01**
Within 8" of Joint: **NO**
Remarks:
