Profile/Photo Observation Report

Street:	FOXCROFT STREET	Flow Control:	Not Controlled
City:	Hobart, IN	Year Renewed:	
Location:	Parking Lot	Tape/Media #:	
Purpose:	Routine Assessment	Dia/Height:	10"
Use:	Sanitary	Material:	PVC
Drain Area:	NA	Lining:	
Category:	NA		
Comment:	P_C at 63 ft debris .Flow direction wrong		
Location Details:		Direction of Survey:	Upstream
US MH:	M-608-014	DS MH:	M-608-013
		Total Length Surveyed (ft):	64.7

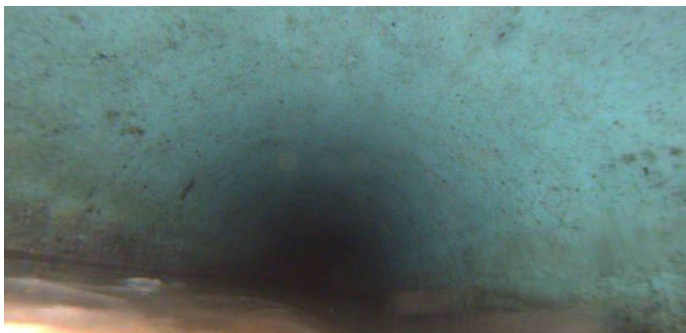
Code: **AMH**
Description: **Manhole**

Distance (ft): **.0**
Structural Grade: **0**
O&M Grade: **0**
Clock Start/From:
Clock To:
1st Value:
2nd Value:
Value Percent:
Continuous Index:
Within 8" of Joint: **NO**
Remarks: **M-608-013**

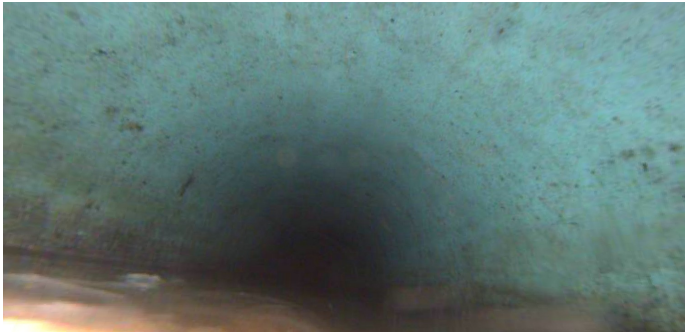
Code:	MWL
Description:	Water Level

Distance (ft):	.0
Structural Grade:	0
O&M Grade:	0
Clock Start/From:	
Clock To:	
1st Value:	
2nd Value:	
Value Percent:	30.000
Continuous Index:	
Within 8" of Joint:	NO
Remarks:

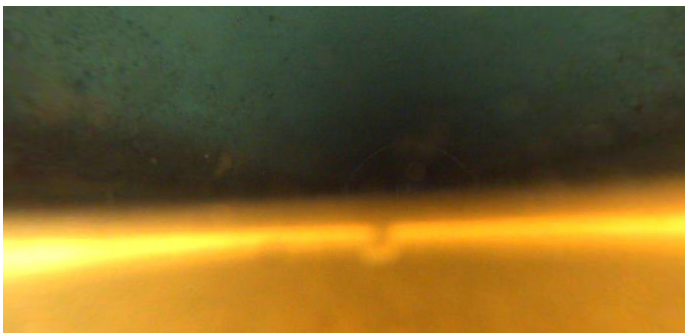
Code: **MGO**
Description: **General Observation**

Distance (ft): **30.7**
Structural Grade: **0**
O&M Grade: **0**
Clock Start/From:
Clock To:
1st Value:
2nd Value:
Value Percent:
Continuous Index:
Within 8" of Joint: **NO**
Remarks: **REAR CAMERA**

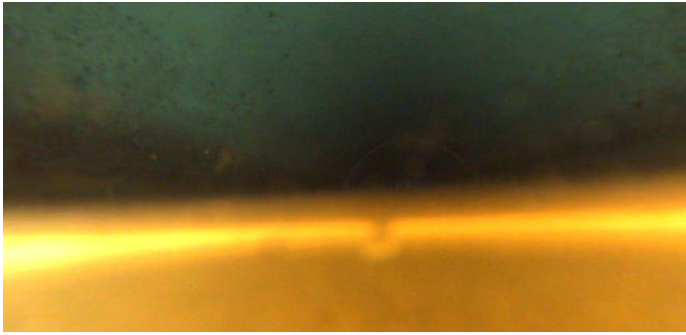
Code: **MCU**
Description: **Camera Underwater**

Distance (ft): **30.7**
Structural Grade: **0**
O&M Grade: **4**
Clock Start/From:
Clock To:
1st Value:
2nd Value:
Value Percent:
Continuous Index: **F01**
Within 8" of Joint: **NO**
Remarks:
