Profile/Photo Observation Report

Date:	03/30/2018	Weather:		Coding:	PACP 6.0
Pipe Length (ft):	170.3	Owner:	NA	Pre Clean:	No Pre-Cleaning
P.O.#:		Surveyor:	Jen Costello	PSR:	P-608-013-014
Customer:		Clean Date:	01/01/1900	Shape:	C

Street:	OFF S ASH ST	Flow Control:	Not Controlled
City:	Hobart, IN	Year Renewed:	
Location:	Parking Lot	Tape/Media #:	
Purpose:	Routine Assessment	Dia/Height:	10"
Use:	Sanitary	Material:	PVC
Drain Area:	NA	Lining:	
Category:	NA		
Comment:	F_S_P_C at 8 ft debris . Flow direction wrong		
Location Details:		Direction of Survey:	Downstream
US MH:	M-608-014	DS MH:	M-608-013
		Total Length Surveyed (ft):	9.8

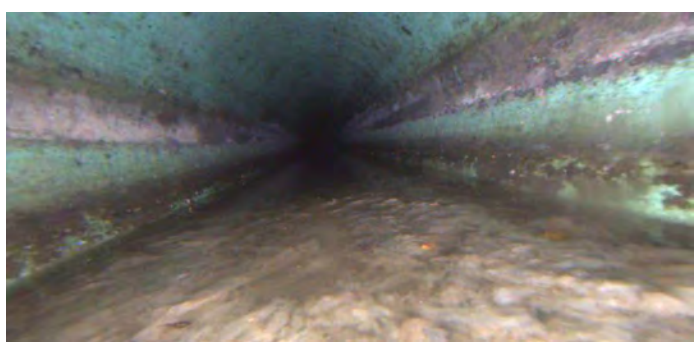
Code: **AMH**
Description: **Manhole**

Distance (ft): **.0**
Structural Grade: **0**
O&M Grade: **0**
Clock Start/From:
Clock To:
1st Value:
2nd Value:
Value Percent:
Continuous Index:
Within 8" of Joint: **NO**
Remarks: **M-608-014**

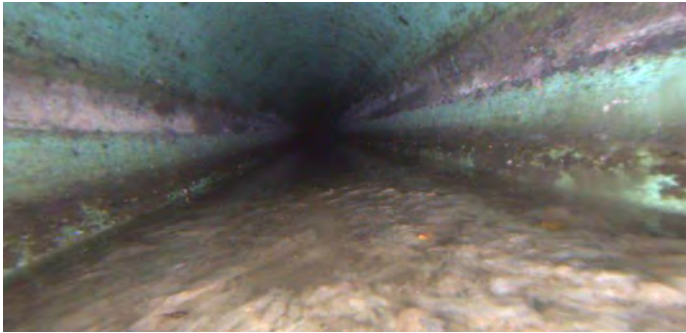
Code:	MWL
Description:	Water Level

Distance (ft):	.0
Structural Grade:	0
O&M Grade:	0
Clock Start/From:	
Clock To:	
1st Value:	
2nd Value:	
Value Percent:	30.000
Continuous Index:	
Within 8" of Joint:	NO
Remarks:

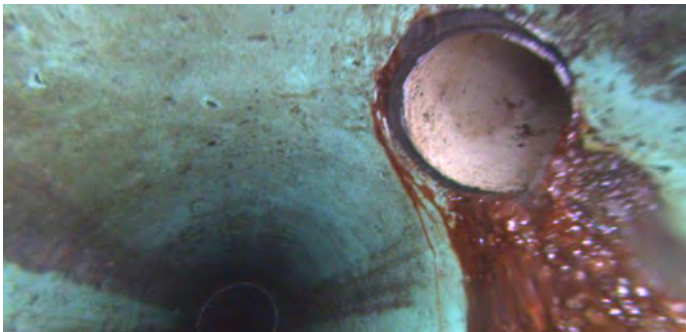
Code:	TSA
Description:	Tap Saddle Active

Distance (ft):	8.0
Structural Grade:	0
O&M Grade:	0
Clock Start/From:	2
Clock To:	
1st Value:	4.000
2nd Value:	
Value Percent:	
Continuous Index:	
Within 8" of Joint:	
Remarks:

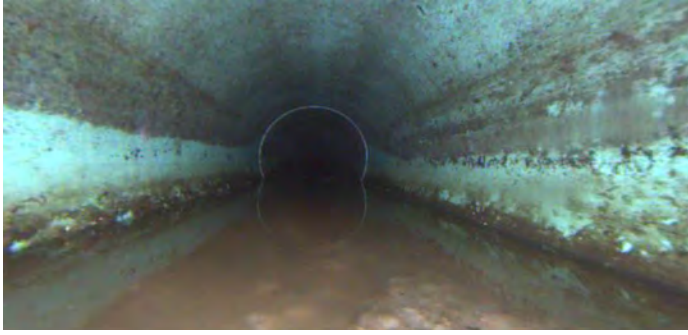
Code:	MSA
Description:	Abandoned Survey
Distance (ft):	9.8
Structural Grade:	0
O&M Grade:	0
Clock Start/From:	
Clock To:	
1st Value:	
2nd Value:	
Value Percent:	
Continuous Index:	
Within 8" of Joint:	NO
Remarks:	debris under water
