Profile/Photo Observation Report

Street:	FOXCROFT STREET	Flow Control:	Not Controlled
City:	Hobart, IN	Year Renewed:	
Location:	Parking Lot	Tape/Media #:	
Purpose:	Routine Assessment	Dia/Height:	10"
Use:	Sanitary	Material:	PVC
Drain Area:	NA	Lining:	
Category:	NA		
Comment:	F_S_P_C at 8 ft debris . Flow direction wrong		
Location Details:		Direction of Survey:	Downstream
US MH:	M-608-014	DS MH:	M-608-013
		Total Length Surveyed (ft):	9.8

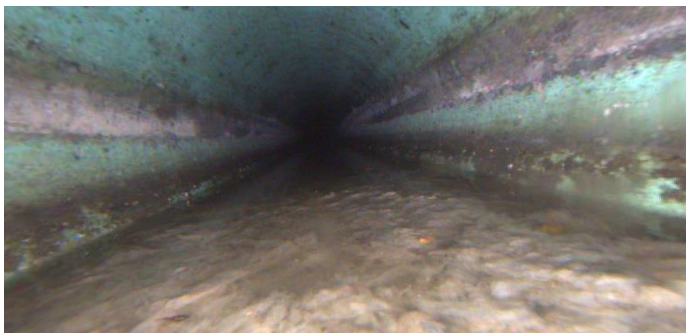
Code: **AMH**
Description: **Manhole**

Distance (ft): **.0**
Structural Grade: **0**
O&M Grade: **0**
Clock Start/From:
Clock To:
1st Value:
2nd Value:
Value Percent:
Continuous Index:
Within 8" of Joint: **NO**
Remarks: **M-608-014**

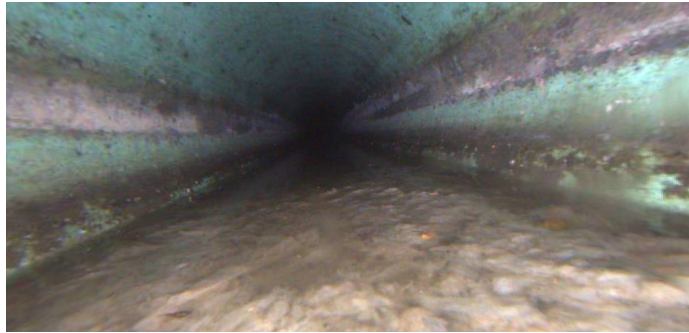
Code: **MWL**
Description: **Water Level**

Distance (ft): **.0**
Structural Grade: **0**
O&M Grade: **0**
Clock Start/From:
Clock To:
1st Value:
2nd Value:
Value Percent: **30.000**
Continuous Index:
Within 8" of Joint: **NO**
Remarks:

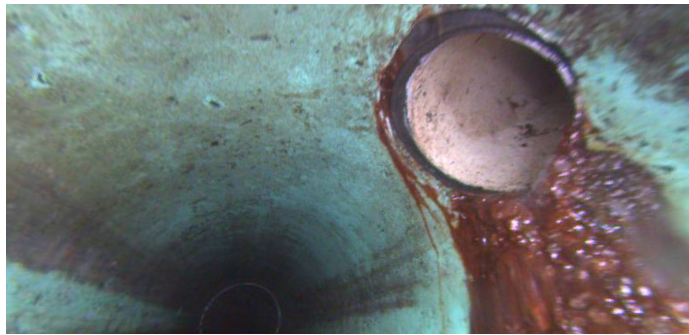
Code: **TSA**
Description: **Tap Saddle Active**

Distance (ft): **8.0**
Structural Grade: **0**
O&M Grade: **0**
Clock Start/From: **2**
Clock To:
1st Value: **4.000**
2nd Value:
Value Percent:
Continuous Index:
Within 8" of Joint:
Remarks:

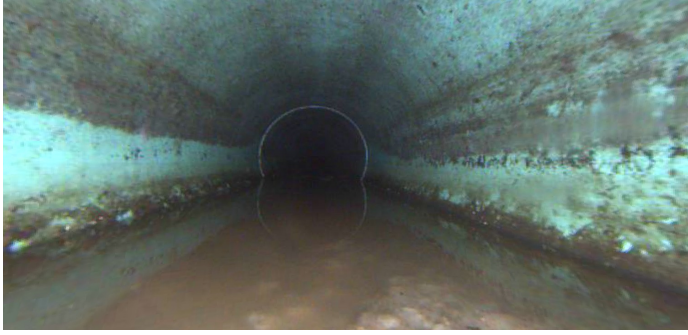
Code:	MSA
Description:	Abandoned Survey
Distance (ft):	9.8
Structural Grade:	0
O&M Grade:	0
Clock Start/From:	
Clock To:	
1st Value:	
2nd Value:	
Value Percent:	
Continuous Index:	
Within 8" of Joint:	NO
Remarks:	debris under water
