Profile/Photo Observation Report

Date:	10/11/2018	Weather:		Coding:	PACP 6.0
Pipe Length (ft):	170.3	Owner:	NA	Pre Clean:	Not Known
P.O.#:		Surveyor:	Selasie Honu	PSR:	P-608-013-014
Customer:		Clean Date:	01/01/1900	Shape:	C

Street:	OFF S ASH ST	Flow Control:	Not Controlled
City:	Hobart, IN	Year Renewed:	
Location:	Light Highway	Tape/Media #:	
Purpose:	Routine Assessment	Dia/Height:	10"
Use:	Sanitary	Material:	PVC
Drain Area:	NA	Lining:	
Category:	NA		
Comment:

Location Details:		Direction of Survey:	Downstream
US MH:	M-608-014	DS MH:	M-608-013
		Total Length Surveyed (ft):	170.8

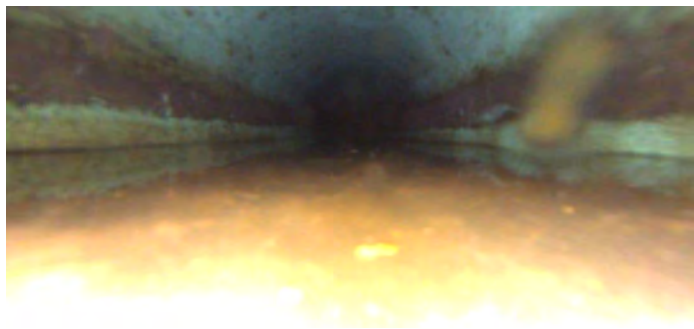
Code: **AMH**
Description: **Manhole**

Distance (ft): **.0**
Structural Grade: **0**
O&M Grade: **0**
Clock Start/From:
Clock To:
1st Value:
2nd Value:
Value Percent:
Continuous Index:
Within 8" of Joint: **NO**
Remarks: **M-608-014**

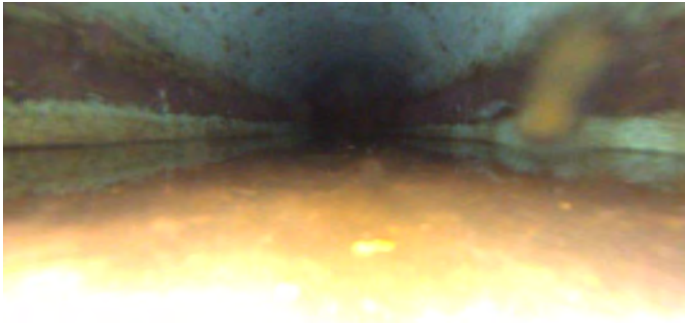
Code:	MWL
Description:	Water Level

Distance (ft):	.0
Structural Grade:	0
O&M Grade:	0
Clock Start/From:	
Clock To:	
1st Value:	
2nd Value:	
Value Percent:	5.000
Continuous Index:	
Within 8" of Joint:	NO
Remarks:

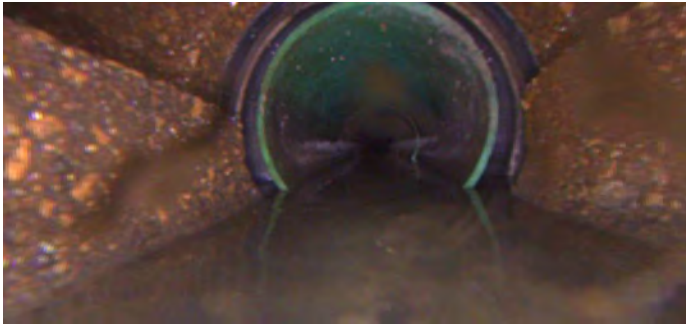
Code:	AMH
Description:	Manhole
Distance (ft):	170.8
Structural Grade:	0
O&M Grade:	0
Clock Start/From:	
Clock To:	
1st Value:	
2nd Value:	
Value Percent:	
Continuous Index:	
Within 8" of Joint:	NO
Remarks:	M-608-013
