Profile/Photo Observation Report

Street:	Washington St.	Flow Control:	Not Controlled
City:	Hobart, IN	Year Renewed:	
Location:	Light Highway	Tape/Media #:	
Purpose:	Routine Assessment	Dia/Height:	10"
Use:	Sanitary	Material:	PVC
Drain Area:	NA	Lining:	
Category:	NA		
Comment:

Location Details:		Direction of Survey:	Downstream
US MH:	M-608-014	DS MH:	M-608-013
		Total Length Surveyed (ft):	170.8

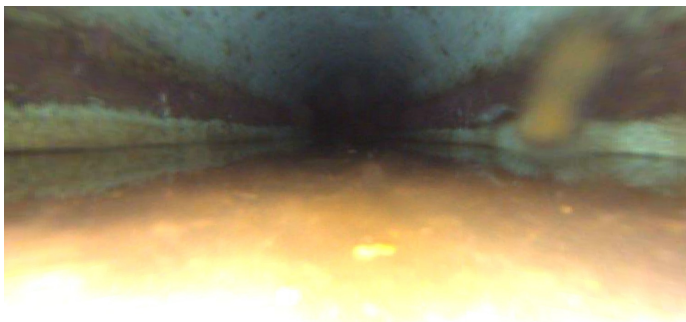
Code: **AMH**
Description: **Manhole**

Distance (ft): **.0**
Structural Grade: **0**
O&M Grade: **0**
Clock Start/From:
Clock To:
1st Value:
2nd Value:
Value Percent:
Continuous Index:
Within 8" of Joint: **NO**
Remarks: **M-608-014**

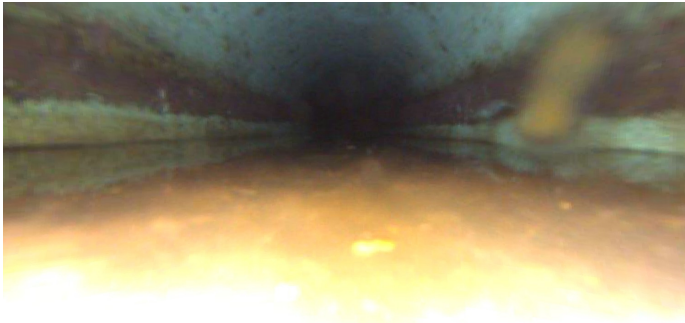
Code:	MWL
Description:	Water Level

Distance (ft):	.0
Structural Grade:	0
O&M Grade:	0
Clock Start/From:	
Clock To:	
1st Value:	
2nd Value:	
Value Percent:	5.000
Continuous Index:	
Within 8" of Joint:	NO
Remarks:

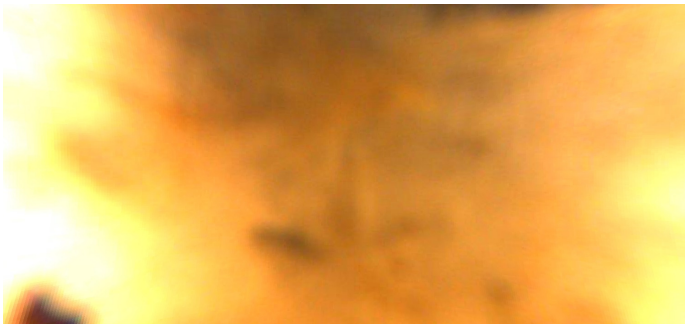
Code:	MWLS
Description:	Water Level Sag

Distance (ft):	4.6
Structural Grade:	2
O&M Grade:	3
Clock Start/From:	
Clock To:	
1st Value:	
2nd Value:	
Value Percent:	10.000
Continuous Index:	
Within 8" of Joint:	NO
Remarks:

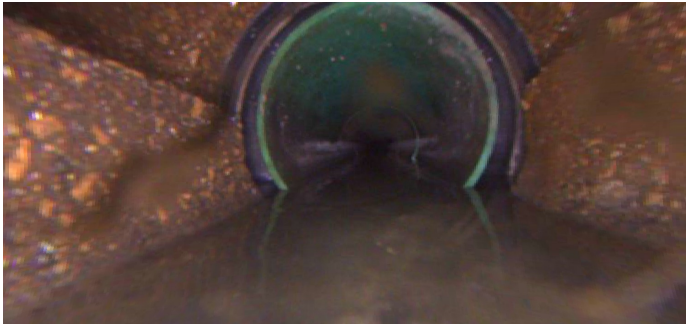
Code:	AMH
Description:	Manhole
Distance (ft):	170.8
Structural Grade:	0
O&M Grade:	0
Clock Start/From:	
Clock To:	
1st Value:	
2nd Value:	
Value Percent:	
Continuous Index:	
Within 8" of Joint:	NO
Remarks:	M-608-013
