## Profile/Photo Observation Report

Street:	<b>S ASH ST &amp; 15TH ST</b>	Flow Control:	<b>Not Controlled</b>
City:	<b>Hobart, IN</b>	Year Renewed:	
Location:	<b>Light Highway</b>	Tape/Media #:	
Purpose:	<b>Routine Assessment</b>	Dia/Height:	<b>10"</b>
Use:	<b>Sanitary</b>	Material:	<b>PVC</b>
Drain Area:	<b>NA</b>	Lining:	
Category:	<b>NA</b>		
Comment:

Location Details:		Direction of Survey:	<b>Upstream</b>
US MH:	<b>M-608-015</b>	DS MH:	<b>M-608-014</b>
		Total Length Surveyed (ft):	<b>255.9</b>

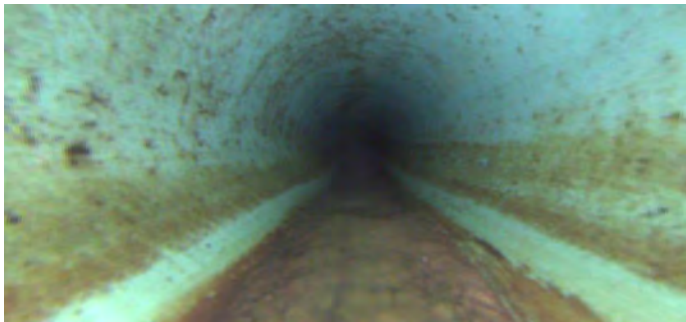
Code: **AMH**  
Description: **Manhole**

Distance (ft): **.0**  
Structural Grade: **0**  
O&M Grade: **0**  
Clock Start/From:  
Clock To:  
1st Value:  
2nd Value:  
Value Percent:  
Continuous Index:  
Within 8" of Joint: **NO**  
Remarks: **M-608-014**

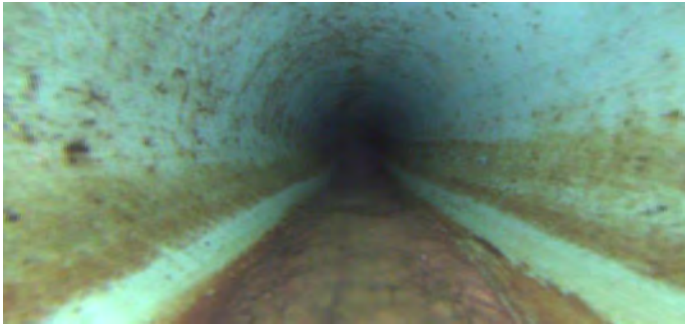
Code:	<b>MWL</b>
Description:	<b>Water Level</b>

Distance (ft):	<b>.0</b>
Structural Grade:	<b>0</b>
O&M Grade:	<b>0</b>
Clock Start/From:	
Clock To:	
1st Value:	
2nd Value:	
Value Percent:	<b>5.000</b>
Continuous Index:	
Within 8" of Joint:	<b>NO</b>
Remarks:

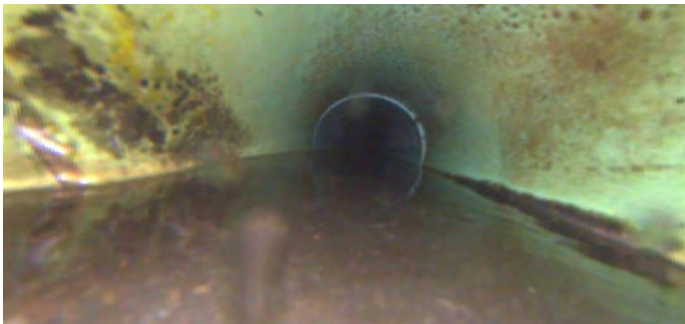
Code:	<b>AMH</b>
Description:	<b>Manhole</b>

Distance (ft):	<b>255.9</b>
Structural Grade:	<b>0</b>
O&M Grade:	<b>0</b>
Clock Start/From:	
Clock To:	
1st Value:	
2nd Value:	
Value Percent:	
Continuous Index:	
Within 8" of Joint:	<b>NO</b>
Remarks:	<b>M-608-015</b>
