Profile/Photo Observation Report

Street:	W 61ST AVE	Flow Control:	Not Controlled
City:	Hobart, IN	Year Renewed:	
Location:	Yard	Tape/Media #:	
Purpose:	Routine Assessment	Dia/Height:	8"
Use:	Sanitary	Material:	VCP
Drain Area:	NA	Lining:	
Category:	NA		
Comment:

Location Details:		Direction of Survey:	Downstream
US MH:	M-608-016	DS MH:	M-608-018
		Total Length Surveyed (ft):	133.9

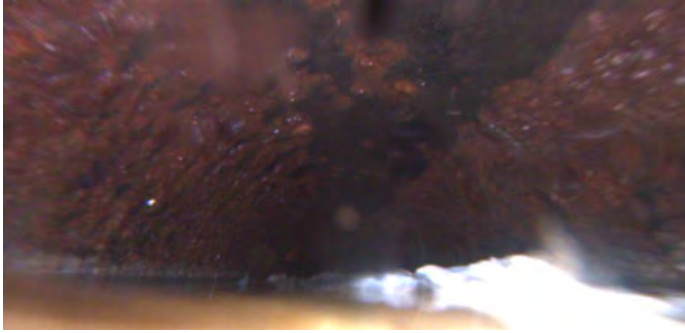
Code: **DAGS**
Description: **Deposits Attached Grease**

Distance (ft): **59.4**
Structural Grade: **0**
O&M Grade: **2**
Clock Start/From: **8**
Clock To: **4**
1st Value:
2nd Value:
Value Percent: **10.000**
Continuous Index: **S01**
Within 8" of Joint: **NO**
Remarks:
