## Profile/Photo Observation Report

Street:	<b>FOXCROFT STREET</b>	Flow Control:	<b>Not Controlled</b>
City:	<b>Hobart, IN</b>	Year Renewed:	
Location:	<b>Yard</b>	Tape/Media #:	
Purpose:	<b>Routine Assessment</b>	Dia/Height:	<b>8"</b>
Use:	<b>Sanitary</b>	Material:	<b>VCP</b>
Drain Area:	<b>NA</b>	Lining:	
Category:	<b>NA</b>		
Comment:

Location Details:		Direction of Survey:	<b>Downstream</b>
US MH:	<b>M-608-016</b>	DS MH:	<b>M-608-018</b>
		Total Length Surveyed (ft):	<b>133.9</b>

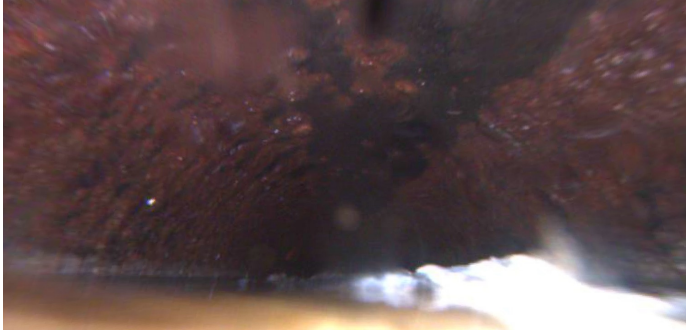
Code: **DAGS**  
Description: **Deposits Attached Grease**

Distance (ft): **59.4**  
Structural Grade: **0**  
O&M Grade: **2**  
Clock Start/From: **8**  
Clock To: **4**  
1st Value:  
2nd Value:  
Value Percent: **10.000**  
Continuous Index: **S01**  
Within 8" of Joint: **NO**  
Remarks:
