Profile/Photo Observation Report

Street:	OFF S ASH ST	Flow Control:	Not Controlled
City:	Hobart, IN	Year Renewed:	
Location:	Yard	Tape/Media #:	
Purpose:	Routine Assessment	Dia/Height:	8"
Use:	Sanitary	Material:	PVC
Drain Area:	NA	Lining:	
Category:	NA		
Comment:

Location Details:		Direction of Survey:	Upstream
US MH:	M-608-018	DS MH:	M-608-017
		Total Length Surveyed (ft):	5.0

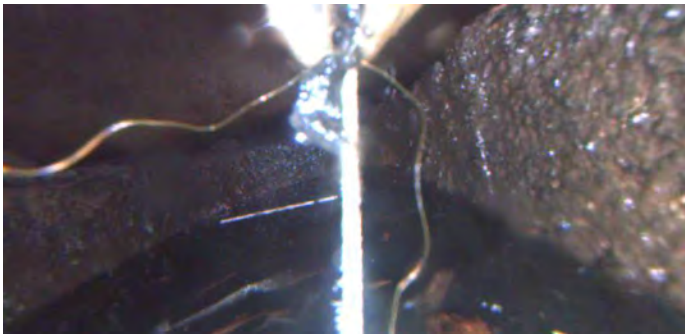
Code:	MGO
Description:	General Observation

Distance (ft):	.0
Structural Grade:	0
O&M Grade:	0
Clock Start/From:	
Clock To:	
1st Value:	
2nd Value:	
Value Percent:	
Continuous Index:	
Within 8" of Joint:	NO
Remarks:	rear camera
