Profile/Photo Observation Report

Date:	04/05/2018	Weather:		Coding:	PACP 6.0
Pipe Length (ft):	41.7	Owner:	NA	Pre Clean:	No Pre-Cleaning
P.O.#:		Surveyor:	Jen Costello	PSR:	P-608-017-018
Customer:		Clean Date:	01/01/1900	Shape:	C

Street:	FOXCROFT STREET	Flow Control:	Not Controlled
City:	Hobart, IN	Year Renewed:	
Location:	Yard	Tape/Media #:	
Purpose:	Routine Assessment	Dia/Height:	8"
Use:	Sanitary	Material:	PVC
Drain Area:	NA	Lining:	
Category:	NA		
Comment:

Location Details:		Direction of Survey:	Upstream
US MH:	M-608-018	DS MH:	M-608-017
		Total Length Surveyed (ft):	5.0

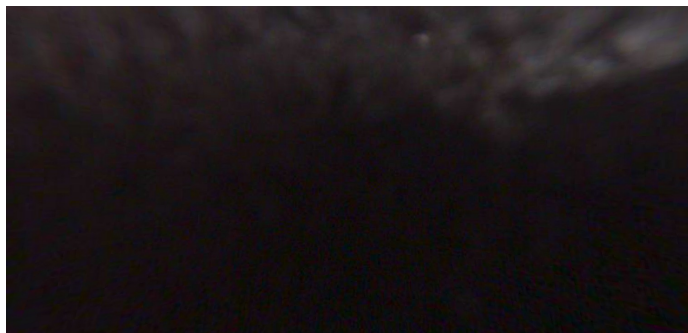
Code: **AMH**
Description: **Manhole**

Distance (ft): **.0**
Structural Grade: **0**
O&M Grade: **0**
Clock Start/From:
Clock To:
1st Value:
2nd Value:
Value Percent:
Continuous Index:
Within 8" of Joint: **NO**
Remarks: **M-608-017**

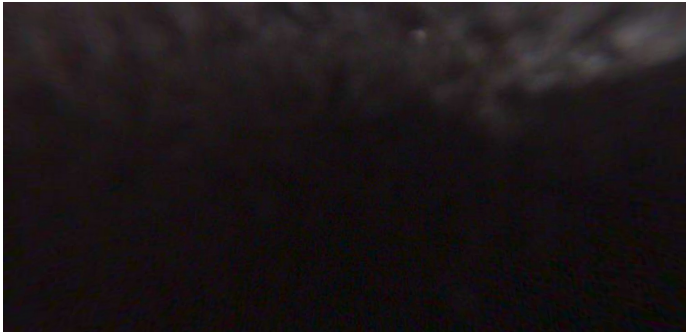
Code:	MWL
Description:	Water Level

Distance (ft):	.0
Structural Grade:	0
O&M Grade:	0
Clock Start/From:	
Clock To:	
1st Value:	
2nd Value:	
Value Percent:	100.000
Continuous Index:	
Within 8" of Joint:	NO
Remarks:

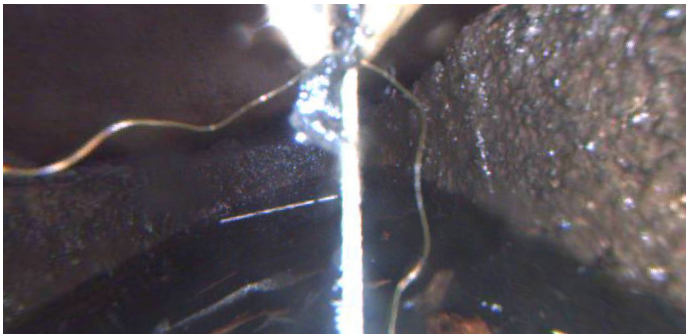
Code:	MGO
Description:	General Observation

Distance (ft):	.0
Structural Grade:	0
O&M Grade:	0
Clock Start/From:	
Clock To:	
1st Value:	
2nd Value:	
Value Percent:	
Continuous Index:	
Within 8" of Joint:	NO
Remarks:	rear camera
