## Profile/Photo Observation Report

Street:	<b>FOXCROFT STREET</b>	Flow Control:	<b>Not Controlled</b>
City:	<b>Hobart, IN</b>	Year Renewed:	
Location:	<b>Yard</b>	Tape/Media #:	
Purpose:	<b>Routine Assessment</b>	Dia/Height:	<b>8"</b>
Use:	<b>Sanitary</b>	Material:	<b>PVC</b>
Drain Area:	<b>NA</b>	Lining:	
Category:	<b>NA</b>		
Comment:

Location Details:		Direction of Survey:	<b>Upstream</b>
US MH:	<b>M-608-019</b>	DS MH:	<b>M-608-019A</b>
		Total Length Surveyed (ft):	<b>3.2</b>

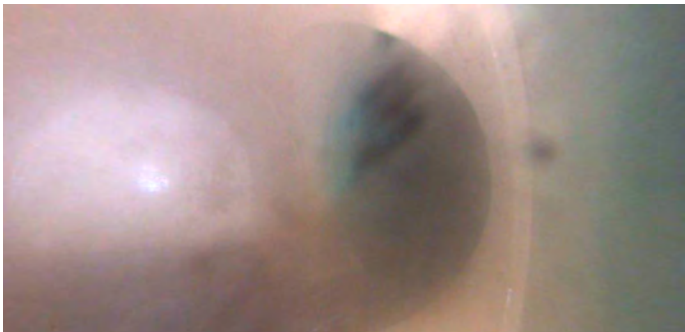
Code:	<b>TF</b>
Description:	<b>Tap Factory</b>

Distance (ft):	<b>2.5</b>
Structural Grade:	<b>0</b>
O&M Grade:	<b>0</b>
Clock Start/From:	<b>3</b>
Clock To:	
1st Value:	<b>4.000</b>
2nd Value:	
Value Percent:	
Continuous Index:	
Within 8" of Joint:	
Remarks:
