Profile/Photo Observation Report

Street:	OFF S ASH ST	Flow Control:	Not Controlled
City:	Hobart, IN	Year Renewed:	
Location:	Yard	Tape/Media #:	
Purpose:	Routine Assessment	Dia/Height:	8"
Use:	Sanitary	Material:	PVC
Drain Area:	NA	Lining:	
Category:	NA		
Comment:			
Location Details:		Direction of Survey:	Upstream
US MH:	M-608-019	DS MH:	M-608-018
		Total Length Surveyed (ft):	7.0

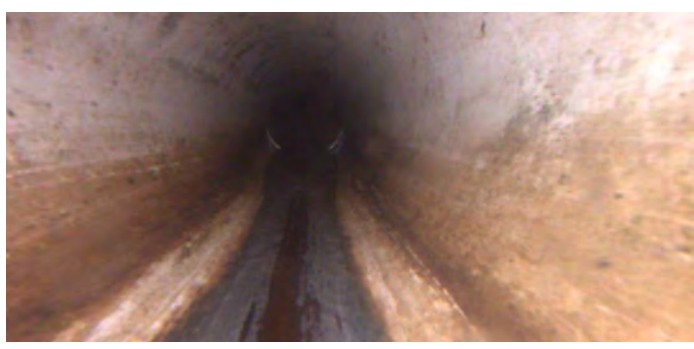
Code: **AMH**
Description: **Manhole**

Distance (ft): **.0**
Structural Grade: **0**
O&M Grade: **0**
Clock Start/From:
Clock To:
1st Value:
2nd Value:
Value Percent:
Continuous Index:
Within 8" of Joint: **NO**
Remarks: **M-608-018**

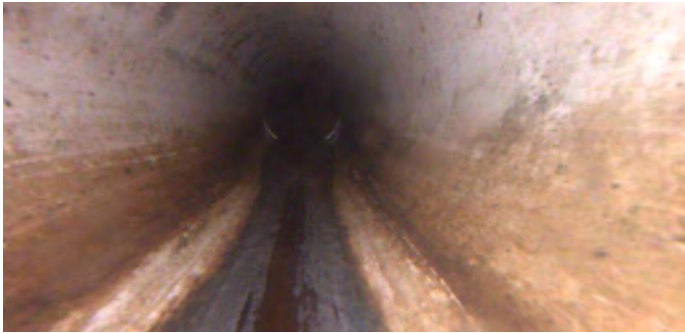
Code:	MWL
Description:	Water Level

Distance (ft):	.0
Structural Grade:	0
O&M Grade:	0
Clock Start/From:	
Clock To:	
1st Value:	
2nd Value:	
Value Percent:	5.000
Continuous Index:	
Within 8" of Joint:	NO
Remarks:

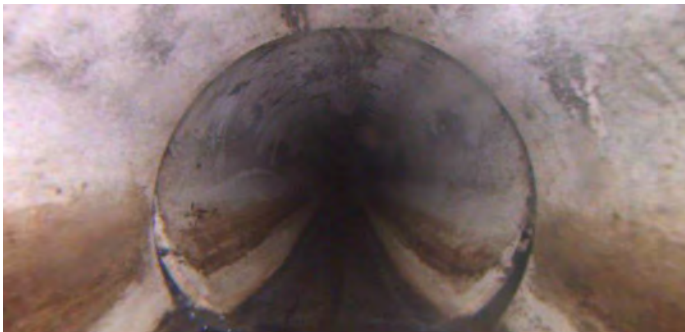
Code:	JOM
Description:	Joint Offset Medium

Distance (ft):	3.1
Structural Grade:	1
O&M Grade:	0
Clock Start/From:	
Clock To:	
1st Value:	
2nd Value:	
Value Percent:	
Continuous Index:	
Within 8" of Joint:	NO
Remarks:

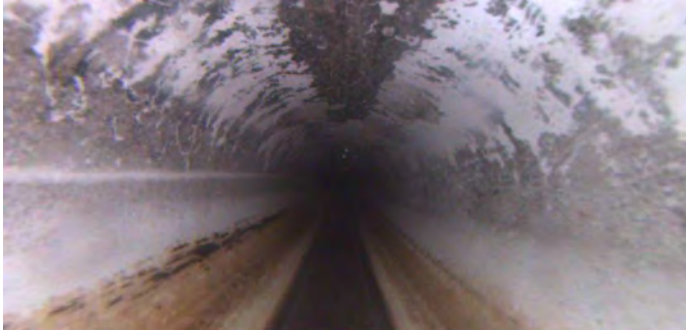
Code:	MSA
Description:	Abandoned Survey
Distance (ft):	7.0
Structural Grade:	0
O&M Grade:	0
Clock Start/From:	
Clock To:	
1st Value:	
2nd Value:	
Value Percent:	
Continuous Index:	
Within 8" of Joint:	NO
Remarks:	UNKNOWN
