## Profile/Photo Observation Report

Street:	<b>FOXCROFT STREET</b>	Flow Control:	<b>Not Controlled</b>
City:	<b>Hobart, IN</b>	Year Renewed:	
Location:	<b>Yard</b>	Tape/Media #:	
Purpose:	<b>Routine Assessment</b>	Dia/Height:	<b>8"</b>
Use:	<b>Sanitary</b>	Material:	<b>PVC</b>
Drain Area:	<b>NA</b>	Lining:	
Category:	<b>NA</b>		
Comment:

Location Details:		Direction of Survey:	<b>Upstream</b>
US MH:	<b>M-608-019</b>	DS MH:	<b>M-608-018</b>
		Total Length Surveyed (ft):	<b>7.0</b>

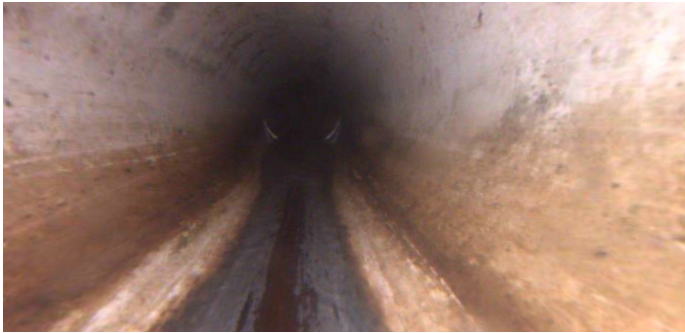
Code:	<b>MWL</b>
Description:	<b>Water Level</b>

Distance (ft):	<b>.0</b>
Structural Grade:	<b>0</b>
O&M Grade:	<b>0</b>
Clock Start/From:	
Clock To:	
1st Value:	
2nd Value:	
Value Percent:	<b>5.000</b>
Continuous Index:	
Within 8" of Joint:	<b>NO</b>
Remarks:

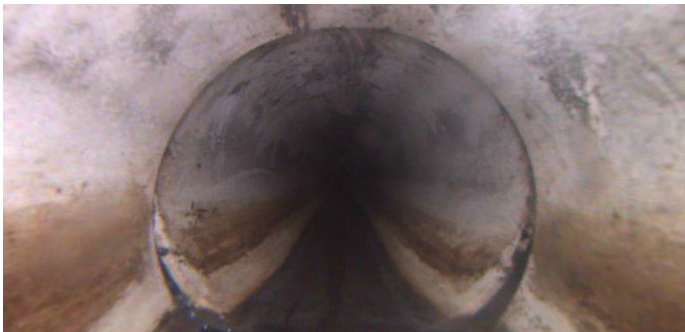
Code:	<b>JOM</b>
Description:	<b>Joint Offset Medium</b>

Distance (ft):	<b>3.1</b>
Structural Grade:	<b>1</b>
O&M Grade:	<b>0</b>
Clock Start/From:	
Clock To:	
1st Value:	
2nd Value:	
Value Percent:	
Continuous Index:	
Within 8" of Joint:	<b>NO</b>
Remarks:

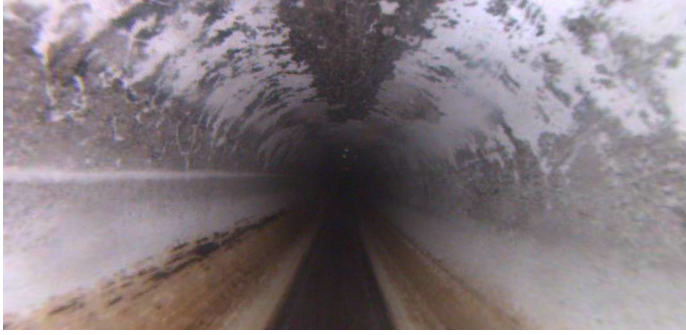
Code:	<b>MSA</b>
Description:	<b>Abandoned Survey</b>
Distance (ft):	<b>7.0</b>
Structural Grade:	<b>0</b>
O&M Grade:	<b>0</b>
Clock Start/From:	
Clock To:	
1st Value:	
2nd Value:	
Value Percent:	
Continuous Index:	
Within 8" of Joint:	<b>NO</b>
Remarks:	<b>UNKNOWN</b>
