## Profile/Photo Observation Report

Street:	<b>OFF S ASH ST</b>	Flow Control:	<b>Not Controlled</b>
City:	<b>Hobart, IN</b>	Year Renewed:	
Location:	<b>Yard</b>	Tape/Media #:	
Purpose:	<b>Routine Assessment</b>	Dia/Height:	<b>8"</b>
Use:	<b>Sanitary</b>	Material:	<b>PVC</b>
Drain Area:	<b>NA</b>	Lining:	
Category:	<b>NA</b>		
Comment:

Location Details:		Direction of Survey:	<b>Upstream</b>
US MH:	<b>M-608-021</b>	DS MH:	<b>M-608-020</b>
		Total Length Surveyed (ft):	<b>2.4</b>

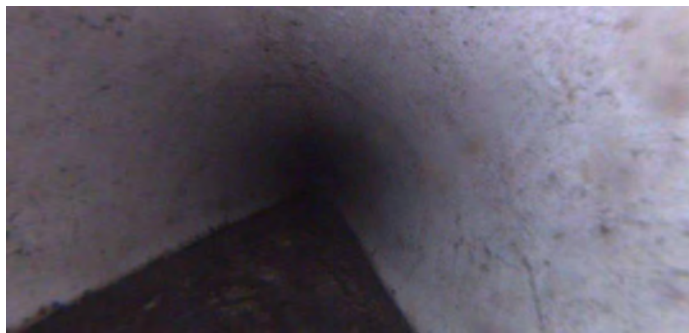
Code: **AMH**  
Description: **Manhole**

Distance (ft): **.0**  
Structural Grade: **0**  
O&M Grade: **0**  
Clock Start/From:  
Clock To:  
1st Value:  
2nd Value:  
Value Percent:  
Continuous Index:  
Within 8" of Joint: **NO**  
Remarks: **M-608-020**

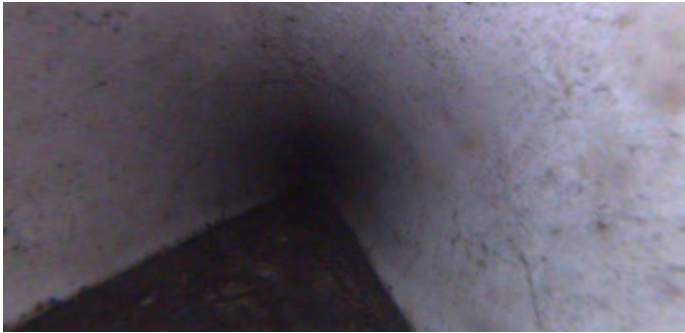
Code:	<b>MWL</b>
Description:	<b>Water Level</b>

Distance (ft):	<b>.0</b>
Structural Grade:	<b>0</b>
O&M Grade:	<b>0</b>
Clock Start/From:	
Clock To:	
1st Value:	
2nd Value:	
Value Percent:	<b>10.000</b>
Continuous Index:	
Within 8" of Joint:	<b>NO</b>
Remarks:

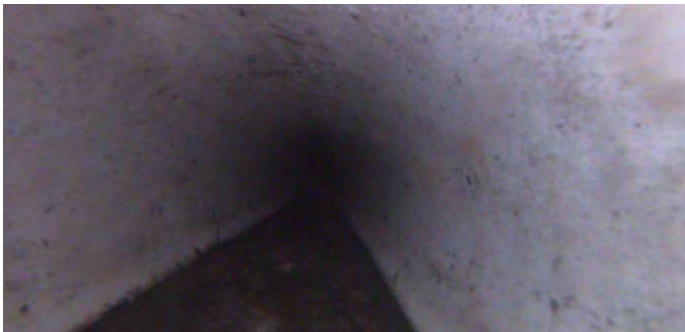
Code:	<b>MSA</b>
Description:	<b>Abandoned Survey</b>

Distance (ft):	<b>2.4</b>
Structural Grade:	<b>0</b>
O&M Grade:	<b>0</b>
Clock Start/From:	
Clock To:	
1st Value:	
2nd Value:	
Value Percent:	
Continuous Index:	
Within 8" of Joint:	<b>NO</b>
Remarks:	<b>UNKNOWN</b>
