## Profile/Photo Observation Report

Date:	<b>04/04/2018</b>	Weather:		Coding:	<b>PACP 6.0</b>
Pipe Length (ft):	<b>107.4</b>	Owner:	<b>NA</b>	Pre Clean:	<b>No Pre-Cleaning</b>
P.O.#:		Surveyor:	<b>Jen Costello</b>	PSR:	<b>P-608-020-021</b>
Customer:		Clean Date:	<b>01/01/1900</b>	Shape:	<b>C</b>

Street:	<b>FOXCROFT STREET</b>	Flow Control:	<b>Not Controlled</b>
City:	<b>Hobart, IN</b>	Year Renewed:	
Location:	<b>Yard</b>	Tape/Media #:	
Purpose:	<b>Routine Assessment</b>	Dia/Height:	<b>8"</b>
Use:	<b>Sanitary</b>	Material:	<b>PVC</b>
Drain Area:	<b>NA</b>	Lining:	
Category:	<b>NA</b>		
Comment:

Location Details:		Direction of Survey:	<b>Upstream</b>
US MH:	<b>M-608-021</b>	DS MH:	<b>M-608-020</b>
		Total Length Surveyed (ft):	<b>2.4</b>

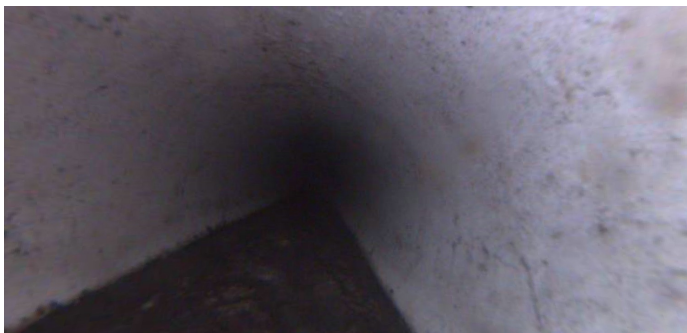
Code: **AMH**  
 Description: **Manhole**  
 Distance (ft): **.0**  
 Structural Grade: **0**  
 O&M Grade: **0**  
 Clock Start/From:  
 Clock To:  
 1st Value:  
 2nd Value:  
 Value Percent:  
 Continuous Index:  
 Within 8" of Joint: **NO**  
 Remarks: **M-608-020**

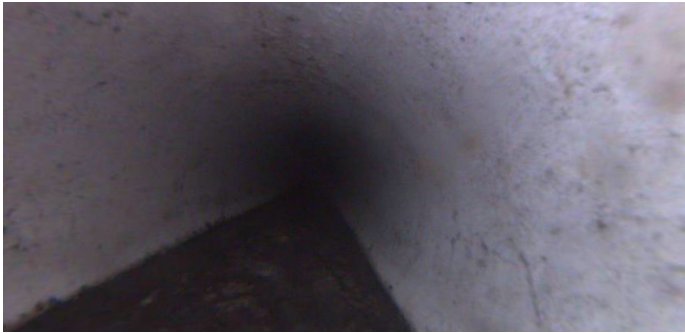
Code:	<b>MWL</b>
Description:	<b>Water Level</b>

Distance (ft):	<b>.0</b>
Structural Grade:	<b>0</b>
O&M Grade:	<b>0</b>
Clock Start/From:	
Clock To:	
1st Value:	
2nd Value:	
Value Percent:	<b>10.000</b>
Continuous Index:	
Within 8" of Joint:	<b>NO</b>
Remarks:

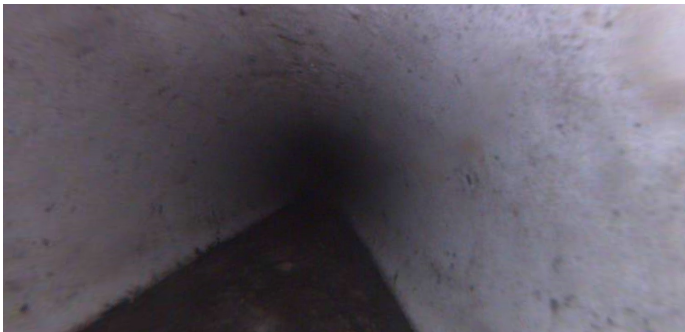
Code:	<b>MSA</b>
Description:	<b>Abandoned Survey</b>

Distance (ft):	<b>2.4</b>
Structural Grade:	<b>0</b>
O&M Grade:	<b>0</b>
Clock Start/From:	
Clock To:	
1st Value:	
2nd Value:	
Value Percent:	
Continuous Index:	
Within 8" of Joint:	<b>NO</b>
Remarks:	<b>UNKNOWN</b>
