## Profile/Photo Observation Report

Street:	<b>St. Mary's Hospital</b>	Flow Control:	<b>Not Controlled</b>
City:	<b>Hobart, IN</b>	Year Renewed:	
Location:	<b>Light Highway</b>	Tape/Media #:	
Purpose:	<b>Routine Assessment</b>	Dia/Height:	<b>8"</b>
Use:	<b>Sanitary</b>	Material:	<b>VCP</b>
Drain Area:	<b>NA</b>	Lining:	
Category:	<b>NA</b>		
Comment:

Location Details:		Direction of Survey:	<b>Upstream</b>
US MH:	<b>M-608-021</b>	DS MH:	<b>M-608-020</b>
		Total Length Surveyed (ft):	<b>108.0</b>

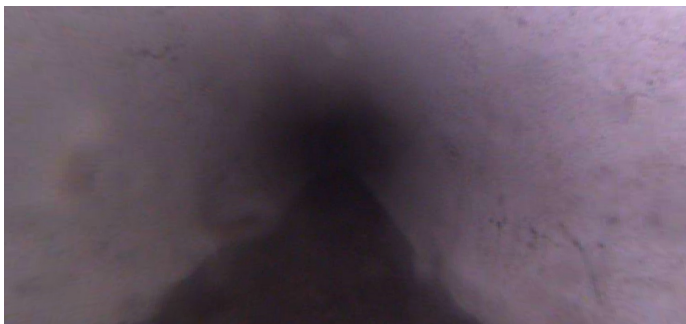
Code: **AMH**  
Description: **Manhole**

Distance (ft): **.0**  
Structural Grade: **0**  
O&M Grade: **0**  
Clock Start/From:  
Clock To:  
1st Value:  
2nd Value:  
Value Percent:  
Continuous Index:  
Within 8" of Joint: **NO**  
Remarks: **M-608-020**

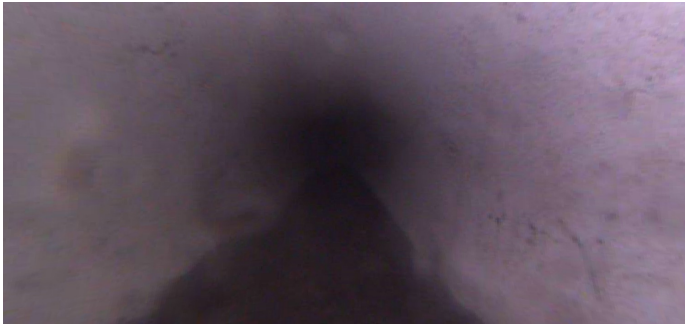
Code:	<b>MWL</b>
Description:	<b>Water Level</b>

Distance (ft):	<b>.0</b>
Structural Grade:	<b>0</b>
O&M Grade:	<b>0</b>
Clock Start/From:	
Clock To:	
1st Value:	
2nd Value:	
Value Percent:	<b>5.000</b>
Continuous Index:	
Within 8" of Joint:	<b>NO</b>
Remarks:

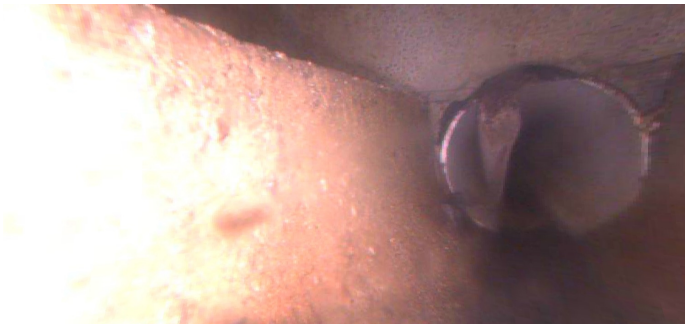
Code:	<b>AMH</b>
Description:	<b>Manhole</b>

Distance (ft):	<b>108.0</b>
Structural Grade:	<b>0</b>
O&M Grade:	<b>0</b>
Clock Start/From:	
Clock To:	
1st Value:	
2nd Value:	
Value Percent:	
Continuous Index:	
Within 8" of Joint:	<b>NO</b>
Remarks:	<b>M-608-021</b>
