Profile/Photo Observation Report

Street:	OFF W 14TH ST	Flow Control:	Not Controlled
City:	Hobart, IN	Year Renewed:	
Location:	Yard	Tape/Media #:	
Purpose:	Routine Assessment	Dia/Height:	8"
Use:	Sanitary	Material:	PVC
Drain Area:	NA	Lining:	
Category:	NA		
Comment:

Location Details:		Direction of Survey:	Downstream
US MH:	M-608-022	DS MH:	M-608-021
		Total Length Surveyed (ft):	299.4

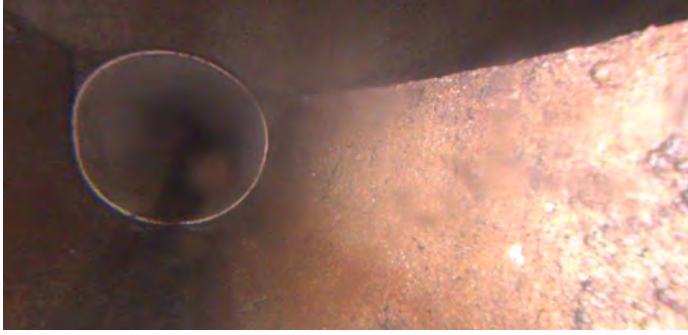
Code:	AMH
Description:	Manhole
Distance (ft):	299.4
Structural Grade:	0
O&M Grade:	0
Clock Start/From:	
Clock To:	
1st Value:	
2nd Value:	
Value Percent:	
Continuous Index:	
Within 8" of Joint:	NO
Remarks:	M-608-021
