Profile/Photo Observation Report

| Street: | FOXCROFT STREET | Flow Control: | Not Controlled |
| Purpose: | Routine Assessment | Dia/Height: | 8" |

| US MH: | M-608-022 | DS MH: | M-608-021 |

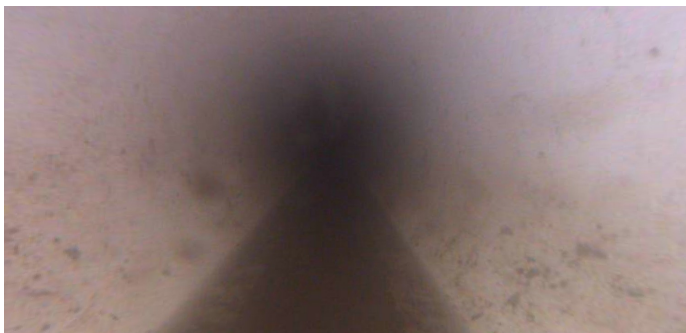
Code: **AMH**
Description: **Manhole**

Distance (ft): **.0**
Structural Grade: **0**
O&M Grade: **0**
Clock Start/From:
Clock To:
1st Value:
2nd Value:
Value Percent:
Continuous Index:
Within 8" of Joint: **NO**
Remarks: **M-608-022**

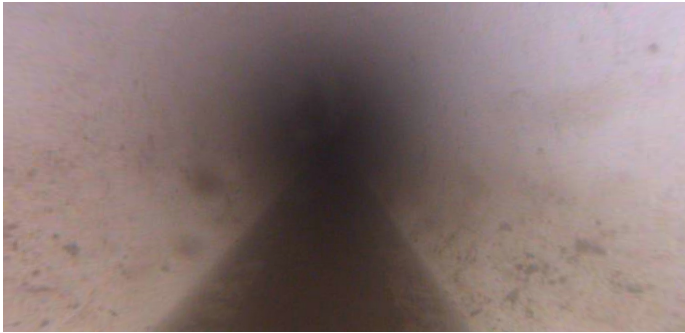
| Code: | MWL |
| Description: | Water Level |

| Distance (ft): | .0 |
| Value Percent: | 5.000 |

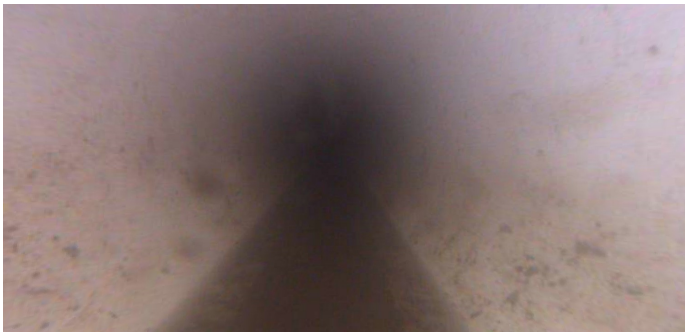
| Code: | MWL |
| Description: | Water Level |

| Distance (ft): | .0 |
| Value Percent: | 5.000 |

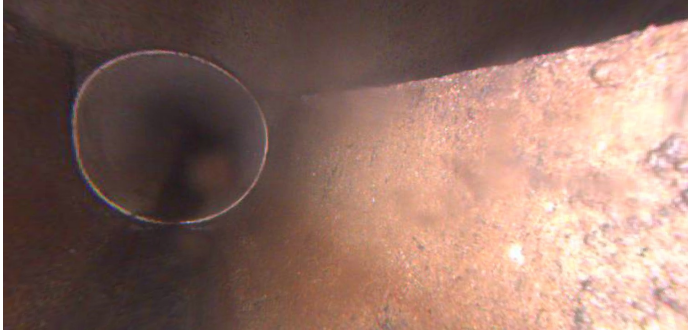
| Code: | AMH |
| Description: | Manhole |
| Distance (ft): | 299.4 |
| Remarks: | M-608-021 |
