Profile/Photo Observation Report

Date:	10/23/2021	Weather:		Coding:	PACP 6.0
Pipe Length (ft):		Owner:	Hobart, IN	Pre Clean:	Not Known
P.O.#:	979_1	Surveyor:	M. Pielacha	PSR:	P-608-023-024
Customer:	Hobart, IN	Clean Date:		Shape:	C

Street:	Hospital Lot	Flow Control:	
City:	Hobart, IN	Year Renewed:	
Location:	Parking Lot	Tape/Media #:	979
Purpose:	Routine Assessment	Dia/Height:	12"
Use:	Sanitary	Material:	PVC
Drain Area:		Lining:	
Category:	NA		
Comment:

Location Details:		Direction of Survey:	Upstream
US MH:	M-608-24	DS MH:	M-608-23
		Total Length Surveyed (ft):	1.0

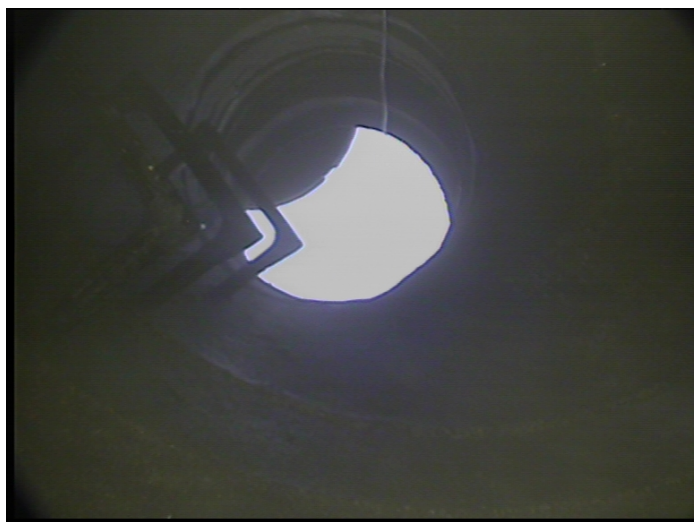
Code: **AMH**
Description: **Manhole**

Distance (ft): **.0**
Structural Grade: **0**
O&M Grade: **0**
Clock Start/From:
Clock To:
1st Value:
2nd Value:
Value Percent:
Continuous Index:
Within 8" of Joint: **NO**
Remarks: **M-608-23**

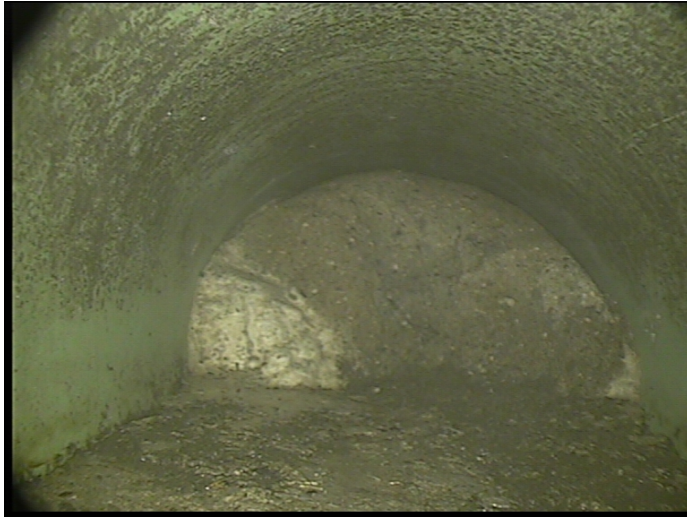
Code: **MWL**
Description: **Water Level**

Distance (ft): **.0**
Structural Grade: **0**
O&M Grade: **0**
Clock Start/From:
Clock To:
1st Value:
2nd Value:
Value Percent: **5.000**
Continuous Index:
Within 8" of Joint: **NO**
Remarks:

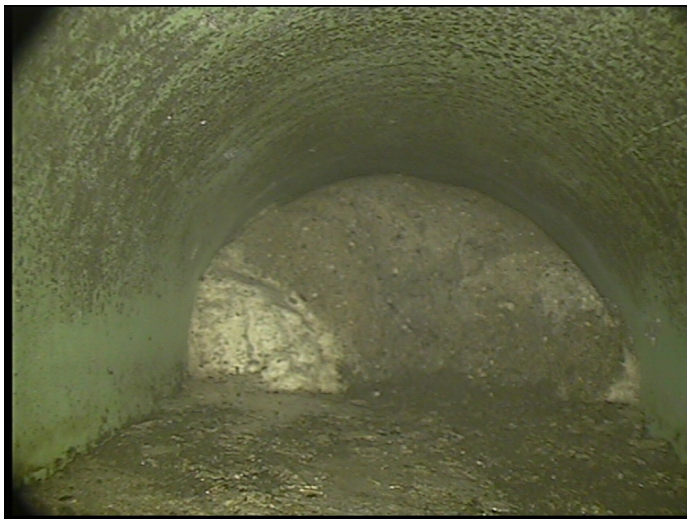
Code: **MSA**
Description: **Abandoned Survey**

Distance (ft): **1.0**
Structural Grade: **0**
O&M Grade: **0**
Clock Start/From:
Clock To:
1st Value:
2nd Value:
Value Percent:
Continuous Index:
Within 8" of Joint: **NO**
Remarks: **Line is capped**
