Profile/Ph	oto Observation	Report			RedZone
Date:	04/04/2018	Weather:		Coding:	PACP 6.0
Pipe Length (ft): 157.0	Owner:	NA	Pre Clean:	No Pre-Cleaning
P.O.#:		Surveyor:	Jen Costello	PSR:	P-608-024-025
Customer:		Clean Date:	01/01/1900	Shape:	С
Street:	OFF S ASH ST		Flow Control:	Not Controlle	ł
City:	Hobart, IN		Year Renewed:		
Location:	Yard		Tape/Media #:		
Purpose:	Routine Assessmen	it	Dia/Height:	12"	
Use:	Sanitary		Material:	PVC	
Drain Area:	NA		Lining:		
Category:	NA				
Comment:					
Location Detail	ls:		Direction of Sur	rvey: Upstream	
US MH:	M-608-025	DS MH:	M-608-024	Total Length Surveyed (fi): 151.9
0&M Index:	0.00	O&M Quick:	00	00 O&M Rating:	0.00
tructural Index:	0.00	Structural Qu	uick: 00	00 Structural Rating	0.00
Overall Index:	0.00	Overall Quick	<: 00	00 Overall Rating:	0.00

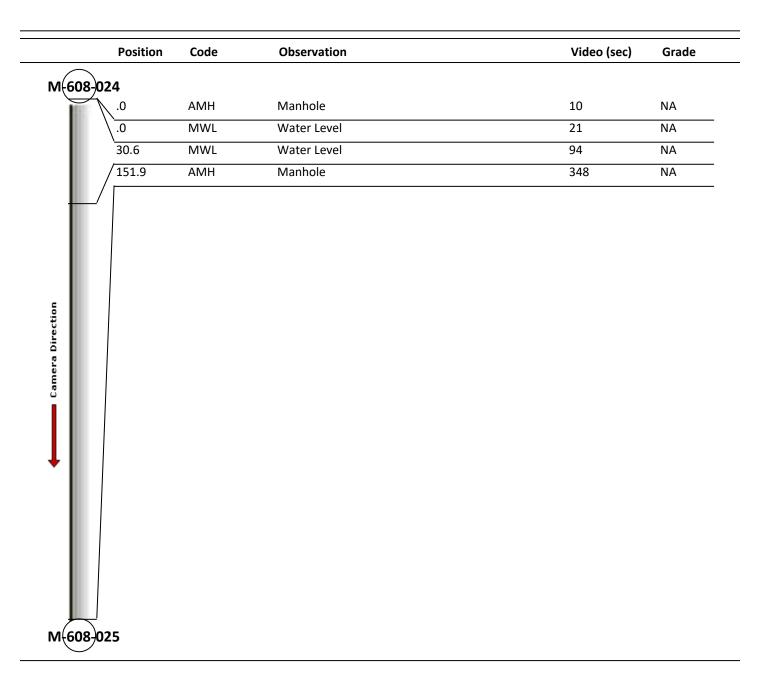
Code: Description:	AMH Manhole	
	_	
Distance (ft):	.0	
Structural Grade:	0	
O&M Grade:	0	
Clock Start/From:		
Clock To:		
1st Value:		
2nd Value:		
Value Percent:		
Continuous Index:		
Within 8" of Joint:	NO	
Remarks:	M-608-024
