## Profile/Photo Observation Report

Street:	<b>OFF W 14TH ST</b>	Flow Control:	<b>Not Controlled</b>
City:	<b>Hobart, IN</b>	Year Renewed:	
Location:	<b>Yard</b>	Tape/Media #:	
Purpose:	<b>Routine Assessment</b>	Dia/Height:	<b>12"</b>
Use:	<b>Sanitary</b>	Material:	<b>PVC</b>
Drain Area:	<b>NA</b>	Lining:	
Category:	<b>NA</b>		
Comment:

Location Details:		Direction of Survey:	<b>Upstream</b>
US MH:	<b>M-608-026</b>	DS MH:	<b>M-608-025</b>
		Total Length Surveyed (ft):	<b>239.3</b>

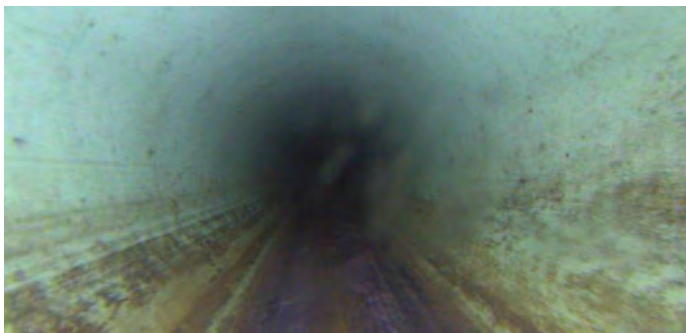
Code: **AMH**  
Description: **Manhole**

Distance (ft): **.0**  
Structural Grade: **0**  
O&M Grade: **0**  
Clock Start/From:  
Clock To:  
1st Value:  
2nd Value:  
Value Percent:  
Continuous Index:  
Within 8" of Joint: **NO**  
Remarks: **M-608-025**

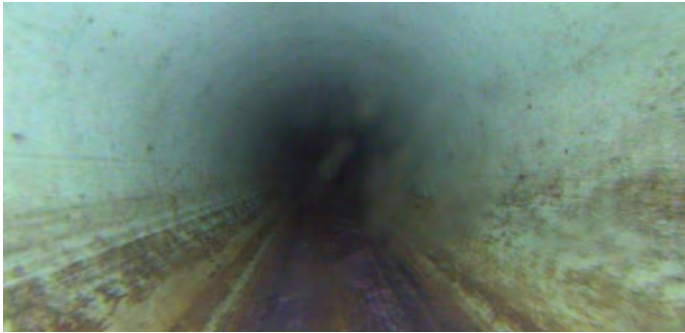
Code:	<b>MWL</b>
Description:	<b>Water Level</b>

Distance (ft):	<b>.0</b>
Structural Grade:	<b>0</b>
O&M Grade:	<b>0</b>
Clock Start/From:	
Clock To:	
1st Value:	
2nd Value:	
Value Percent:	<b>5.000</b>
Continuous Index:	
Within 8" of Joint:	<b>NO</b>
Remarks:

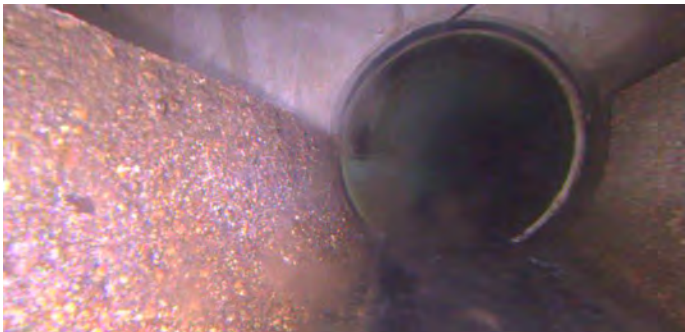
Code:	<b>AMH</b>
Description:	<b>Manhole</b>

Distance (ft):	<b>239.3</b>
Structural Grade:	<b>0</b>
O&M Grade:	<b>0</b>
Clock Start/From:	
Clock To:	
1st Value:	
2nd Value:	
Value Percent:	
Continuous Index:	
Within 8" of Joint:	<b>NO</b>
Remarks:	<b>M-608-026</b>
