## Profile/Photo Observation Report

Street:	<b>FOXCROFT STREET</b>	Flow Control:	<b>Not Controlled</b>
City:	<b>Hobart, IN</b>	Year Renewed:	
Location:	<b>Yard</b>	Tape/Media #:	
Purpose:	<b>Routine Assessment</b>	Dia/Height:	<b>12"</b>
Use:	<b>Sanitary</b>	Material:	<b>PVC</b>
Drain Area:	<b>NA</b>	Lining:	
Category:	<b>NA</b>		
Comment:	<b>Flow direction marked wrong.</b>

Location Details:		Direction of Survey:	<b>Downstream</b>
US MH:	<b>M-608-027</b>	DS MH:	<b>M-608-026</b>
		Total Length Surveyed (ft):	<b>63.0</b>

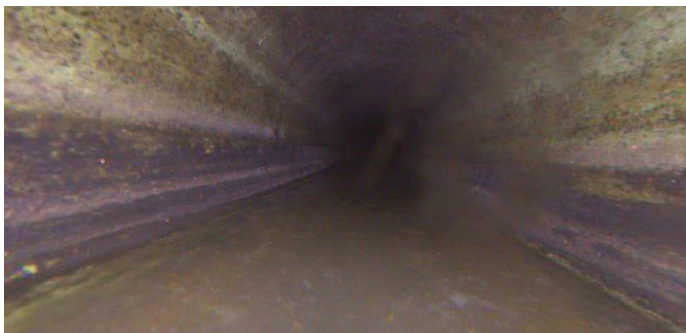
Code: **AMH**  
Description: **Manhole**

Distance (ft): **.0**  
Structural Grade: **0**  
O&M Grade: **0**  
Clock Start/From:  
Clock To:  
1st Value:  
2nd Value:  
Value Percent:  
Continuous Index:  
Within 8" of Joint: **NO**  
Remarks: **M-608-027**

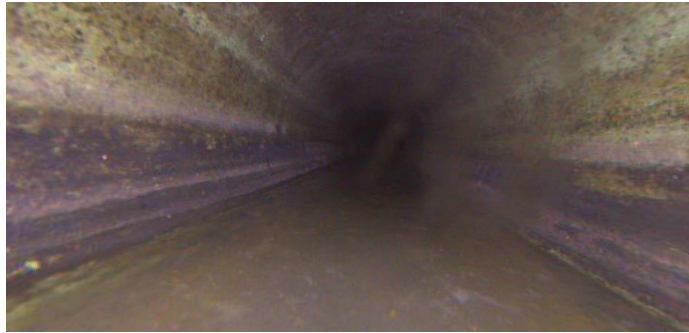
Code:	<b>MWL</b>
Description:	<b>Water Level</b>
Distance (ft):	<b>.0</b>
Structural Grade:	<b>0</b>
O&M Grade:	<b>0</b>
Clock Start/From:	
Clock To:	
1st Value:	
2nd Value:	
Value Percent:	<b>30.000</b>
Continuous Index:	
Within 8" of Joint:	<b>NO</b>
Remarks:

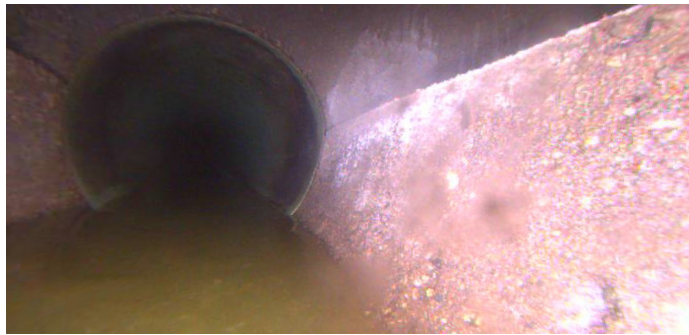
Code:	<b>AMH</b>
Description:	<b>Manhole</b>
Distance (ft):	<b>63.0</b>
Structural Grade:	<b>0</b>
O&M Grade:	<b>0</b>
Clock Start/From:	
Clock To:	
1st Value:	
2nd Value:	
Value Percent:	
Continuous Index:	
Within 8" of Joint:	<b>NO</b>
Remarks:	<b>M-608-026</b>
