Profile/Photo Observation Report

Street:	OFF S LAKE PARK AVE	Flow Control:	Not Controlled
City:	Hobart, IN	Year Renewed:	
Location:	Yard	Tape/Media #:	
Purpose:	Routine Assessment	Dia/Height:	10"
Use:	Sanitary	Material:	VCP
Drain Area:	NA	Lining:	
Category:	NA		
Comment:

Location Details:		Direction of Survey:	Downstream
US MH:	M-608-028	DS MH:	M-608-029
		Total Length Surveyed (ft):	6.7

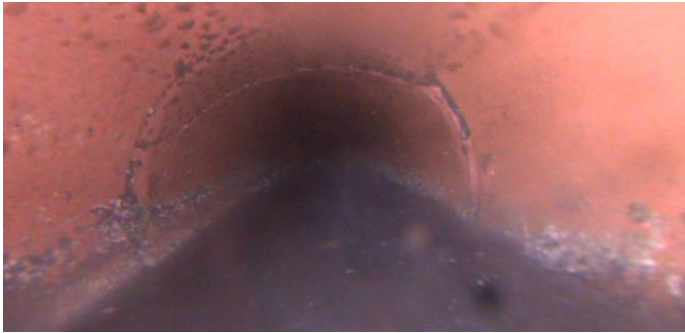
Code:	MWL
Description:	Water Level

Distance (ft):	.0
Structural Grade:	0
O&M Grade:	0
Clock Start/From:	
Clock To:	
1st Value:	
2nd Value:	
Value Percent:	30.000
Continuous Index:	
Within 8" of Joint:	NO
Remarks:

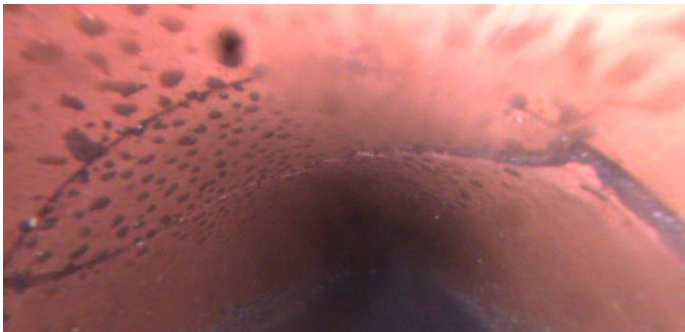
Code:	FC
Description:	Fracture Circumferential

Distance (ft):	1.1
Structural Grade:	2
O&M Grade:	0
Clock Start/From:	9
Clock To:	1
1st Value:	
2nd Value:	
Value Percent:	
Continuous Index:	
Within 8" of Joint:	YES
Remarks:

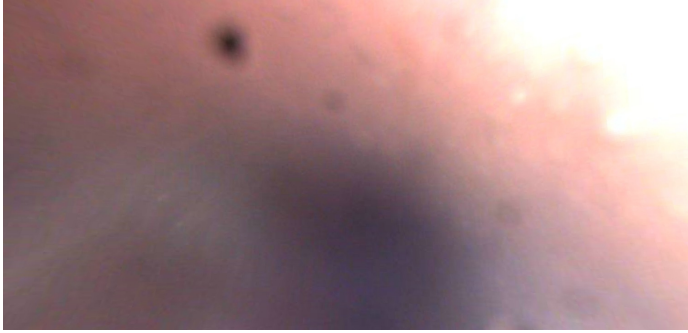
Code:	MSA
Description:	Abandoned Survey
Distance (ft):	6.7
Structural Grade:	0
O&M Grade:	0
Clock Start/From:	
Clock To:	
1st Value:	
2nd Value:	
Value Percent:	
Continuous Index:	
Within 8" of Joint:	NO
Remarks:	DEBRIS UNDER WATER
