Profile/Photo Observation Report

Street:	FOXCROFT STREET	Flow Control:	Not Controlled
City:	Hobart, IN	Year Renewed:	
Location:	Yard	Tape/Media #:	
Purpose:	Routine Assessment	Dia/Height:	10"
Use:	Sanitary	Material:	VCP
Drain Area:	NA	Lining:	
Category:	NA		
Comment:

Location Details:		Direction of Survey:	Downstream
US MH:	M-608-028	DS MH:	M-608-029
		Total Length Surveyed (ft):	6.7

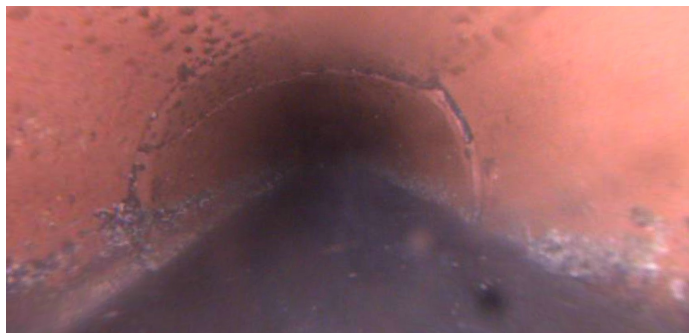
Code: **AMH**
Description: **Manhole**

Distance (ft): **.0**
Structural Grade: **0**
O&M Grade: **0**
Clock Start/From:
Clock To:
1st Value:
2nd Value:
Value Percent:
Continuous Index:
Within 8" of Joint: **NO**
Remarks: **M-608-028**

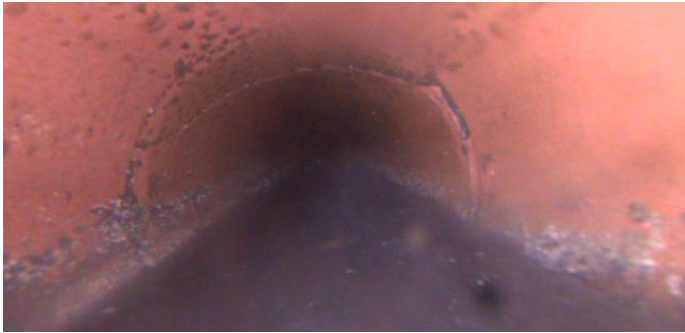
Code:	MWL
Description:	Water Level

Distance (ft):	.0
Structural Grade:	0
O&M Grade:	0
Clock Start/From:	
Clock To:	
1st Value:	
2nd Value:	
Value Percent:	30.000
Continuous Index:	
Within 8" of Joint:	NO
Remarks:

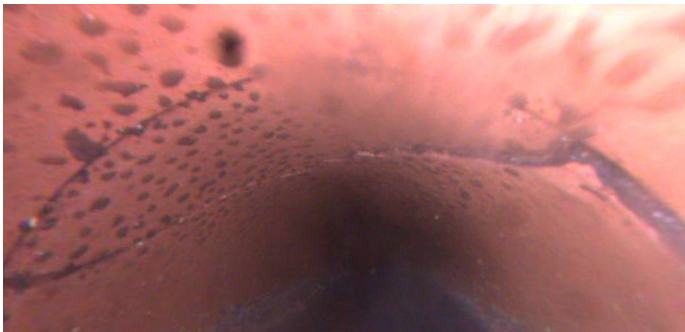
Code:	FC
Description:	Fracture Circumferential

Distance (ft):	1.1
Structural Grade:	2
O&M Grade:	0
Clock Start/From:	9
Clock To:	1
1st Value:	
2nd Value:	
Value Percent:	
Continuous Index:	
Within 8" of Joint:	YES
Remarks:

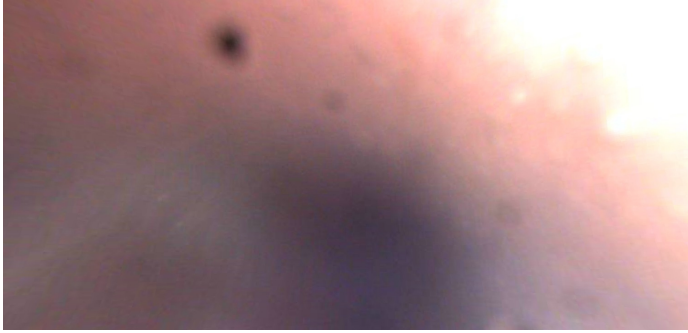
Code:	MSA
Description:	Abandoned Survey
Distance (ft):	6.7
Structural Grade:	0
O&M Grade:	0
Clock Start/From:	
Clock To:	
1st Value:	
2nd Value:	
Value Percent:	
Continuous Index:	
Within 8" of Joint:	NO
Remarks:	DEBRIS UNDER WATER
