Profile/Photo Observation Report

Street:	OFF S LAKE PARK AVE	Flow Control:	Not Controlled
City:	Hobart, IN	Year Renewed:	
Location:	Yard	Tape/Media #:	
Purpose:	Routine Assessment	Dia/Height:	10"
Use:	Sanitary	Material:	VCP
Drain Area:	NA	Lining:	
Category:	NA		
Comment:	P_C debris 24lf, flow direction is marked wrong.		
Location Details:		Direction of Survey:	Downstream
US MH:	M-608-028	DS MH:	M-608-042
		Total Length Surveyed (ft):	25.5

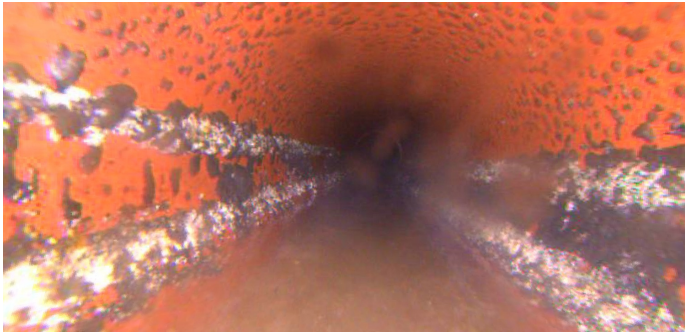
Code:	MWL
Description:	Water Level

Distance (ft):	.0
Structural Grade:	0
O&M Grade:	0
Clock Start/From:	
Clock To:	
1st Value:	
2nd Value:	
Value Percent:	10.000
Continuous Index:	
Within 8" of Joint:	NO
Remarks:

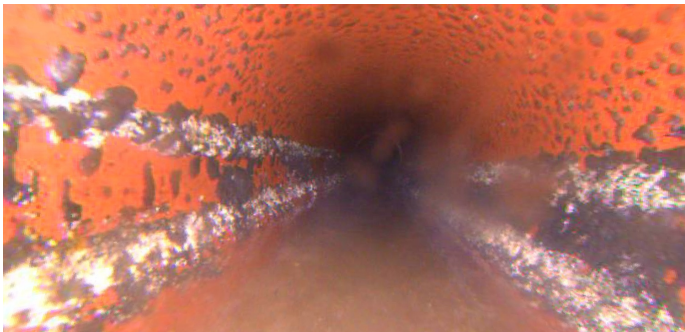
Code:	DAGS
Description:	Deposits Attached Grease

Distance (ft):	.0
Structural Grade:	0
O&M Grade:	2
Clock Start/From:	8
Clock To:	4
1st Value:	
2nd Value:	
Value Percent:	5.000
Continuous Index:	S01
Within 8" of Joint:	NO
Remarks:

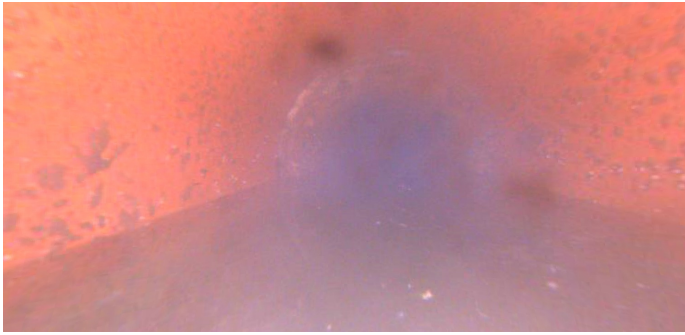
Code: **MWL**
Description: **Water Level**

Distance (ft): **17.7**
Structural Grade: **0**
O&M Grade: **0**
Clock Start/From:
Clock To:
1st Value:
2nd Value:
Value Percent: **40.000**
Continuous Index:
Within 8" of Joint: **NO**
Remarks:

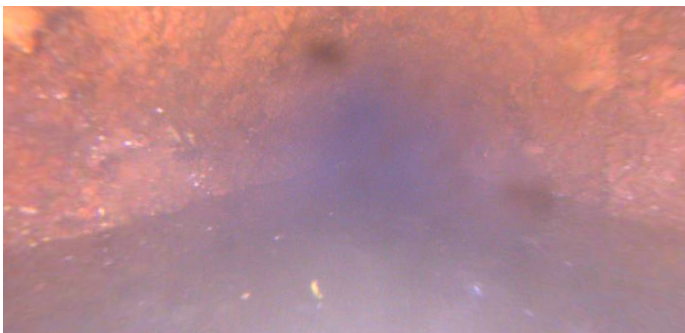
Code: **DAGS**
Description: **Deposits Attached Grease**

Distance (ft): **18.5**
Structural Grade: **0**
O&M Grade: **2**
Clock Start/From: **8**
Clock To: **4**
1st Value:
2nd Value:
Value Percent: **5.000**
Continuous Index: **F01**
Within 8" of Joint: **NO**
Remarks:

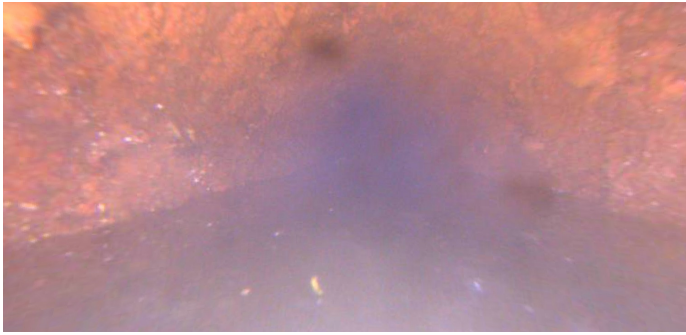
Code: **DAE**
Description: **Deposits Attached Encrustation**

Distance (ft): **18.5**
Structural Grade: **0**
O&M Grade: **3**
Clock Start/From: **8**
Clock To: **4**
1st Value:
2nd Value:
Value Percent: **20.000**
Continuous Index: **S02**
Within 8" of Joint: **NO**
Remarks:
