## Profile/Photo Observation Report

Street:	<b>FOXCROFT STREET</b>	Flow Control:	<b>Not Controlled</b>
City:	<b>Hobart, IN</b>	Year Renewed:	
Location:	<b>Yard</b>	Tape/Media #:	
Purpose:	<b>Routine Assessment</b>	Dia/Height:	<b>10"</b>
Use:	<b>Sanitary</b>	Material:	<b>VCP</b>
Drain Area:	<b>NA</b>	Lining:	
Category:	<b>NA</b>		
Comment:	<b>P_C debris 24lf, flow direction is marked wrong.</b>		
Location Details:		Direction of Survey:	<b>Downstream</b>
US MH:	<b>M-608-028</b>	DS MH:	<b>M-608-042</b>
		Total Length Surveyed (ft):	<b>25.5</b>

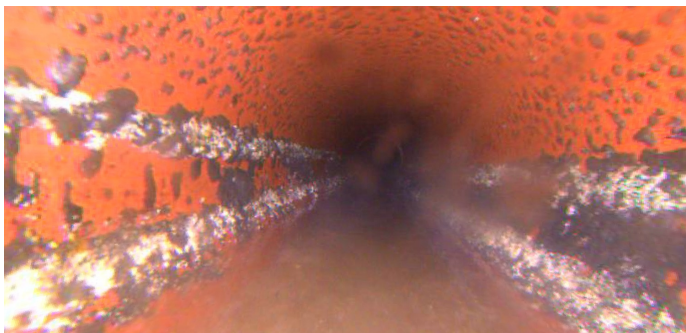
Code: **AMH**  
Description: **Manhole**

Distance (ft): **.0**  
Structural Grade: **0**  
O&M Grade: **0**  
Clock Start/From:  
Clock To:  
1st Value:  
2nd Value:  
Value Percent:  
Continuous Index:  
Within 8" of Joint: **NO**  
Remarks: **M-608-028**

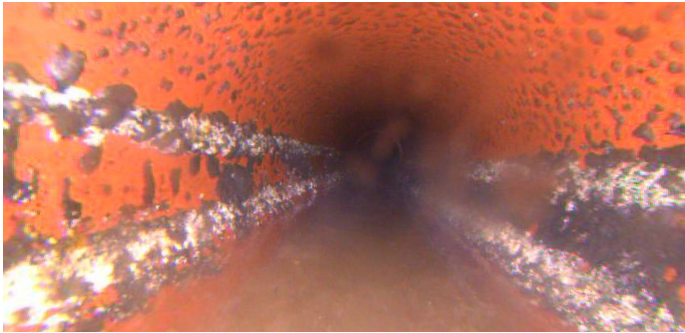
Code:	<b>MWL</b>
Description:	<b>Water Level</b>

Distance (ft):	<b>.0</b>
Structural Grade:	<b>0</b>
O&M Grade:	<b>0</b>
Clock Start/From:	
Clock To:	
1st Value:	
2nd Value:	
Value Percent:	<b>10.000</b>
Continuous Index:	
Within 8" of Joint:	<b>NO</b>
Remarks:

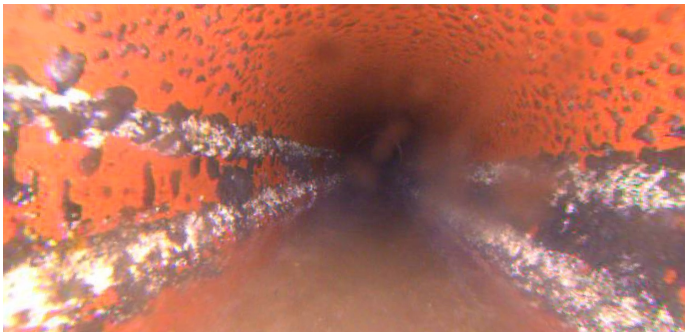
Code:	<b>DAGS</b>
Description:	<b>Deposits Attached Grease</b>

Distance (ft):	<b>.0</b>
Structural Grade:	<b>0</b>
O&M Grade:	<b>2</b>
Clock Start/From:	<b>8</b>
Clock To:	<b>4</b>
1st Value:	
2nd Value:	
Value Percent:	<b>5.000</b>
Continuous Index:	<b>S01</b>
Within 8" of Joint:	<b>NO</b>
Remarks:

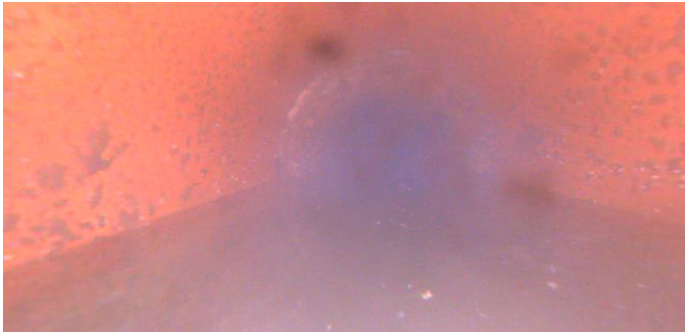
Code: **MWL**  
Description: **Water Level**

Distance (ft): **17.7**  
Structural Grade: **0**  
O&M Grade: **0**  
Clock Start/From:  
Clock To:  
1st Value:  
2nd Value:  
Value Percent: **40.000**  
Continuous Index:  
Within 8" of Joint: **NO**  
Remarks:

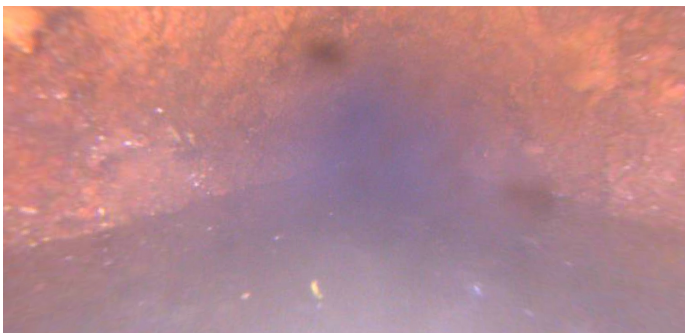
Code: **DAGS**  
Description: **Deposits Attached Grease**

Distance (ft): **18.5**  
Structural Grade: **0**  
O&M Grade: **2**  
Clock Start/From: **8**  
Clock To: **4**  
1st Value:  
2nd Value:  
Value Percent: **5.000**  
Continuous Index: **F01**  
Within 8" of Joint: **NO**  
Remarks:

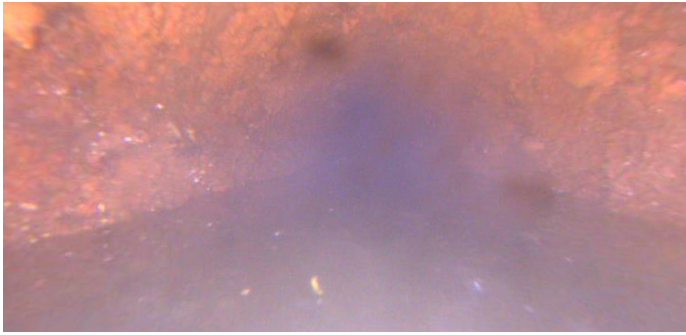
Code: **DAE**  
Description: **Deposits Attached Encrustation**

Distance (ft): **18.5**  
Structural Grade: **0**  
O&M Grade: **3**  
Clock Start/From: **8**  
Clock To: **4**  
1st Value:  
2nd Value:  
Value Percent: **20.000**  
Continuous Index: **S02**  
Within 8" of Joint: **NO**  
Remarks:
