## Profile/Photo Observation Report

Date:	<b>10/23/2021</b>	Weather:		Coding:	<b>PACP 6.0</b>
Pipe Length (ft):		Owner:	<b>Hobart, IN</b>	Pre Clean:	<b>Not Known</b>
P.O.#:	<b>981_1</b>	Surveyor:	<b>M. Pielacha</b>	PSR:	<b>P-608-042-029</b>
Customer:	<b>Hobart, IN</b>	Clean Date:		Shape:	<b>C</b>

Location Details:		Direction of Survey:	<b>Upstream</b>
US MH:	<b>M-608-29</b>	DS MH:	<b>M-608-42</b>
		Total Length Surveyed (ft):	<b>69.6</b>

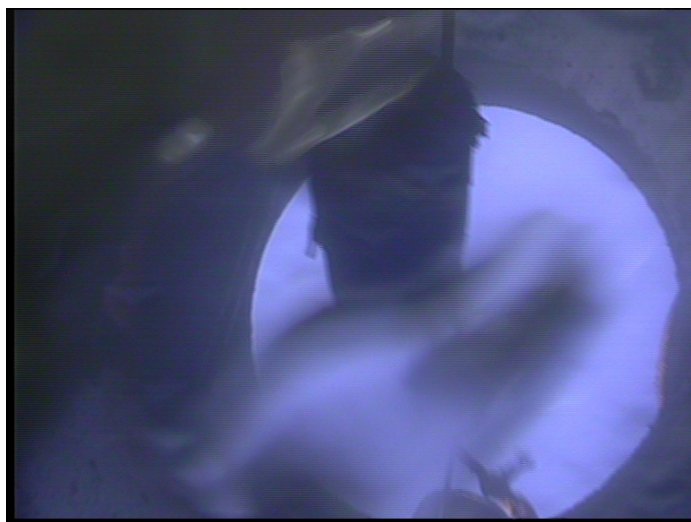
Code: **AMH**  
Description: **Manhole**

Distance (ft): **.0**  
Structural Grade: **0**  
O&M Grade: **0**  
Clock Start/From:  
Clock To:  
1st Value:  
2nd Value:  
Value Percent:  
Continuous Index:  
Within 8" of Joint: **NO**  
Remarks: **M-608-42**

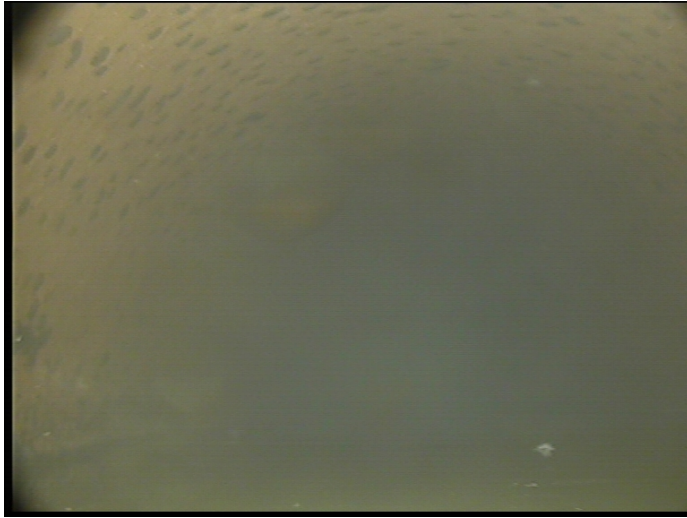
Code: **MWL**  
Description: **Water Level**

Distance (ft): **.0**  
Structural Grade: **0**  
O&M Grade: **0**  
Clock Start/From:  
Clock To:  
1st Value:  
2nd Value:  
Value Percent: **20.000**  
Continuous Index:  
Within 8" of Joint: **NO**  
Remarks:

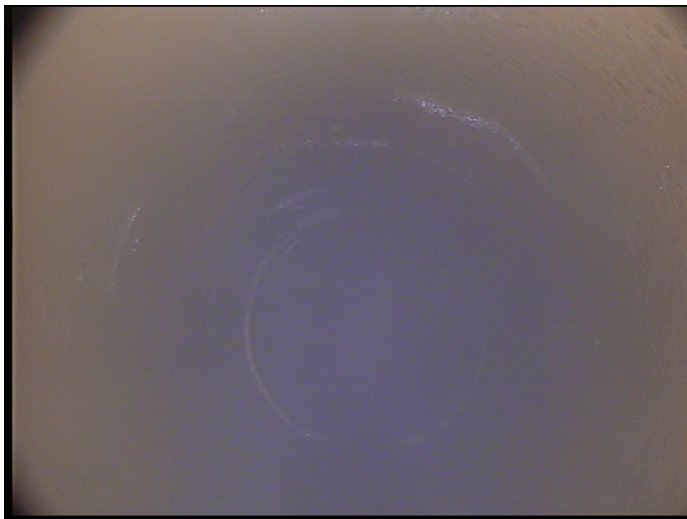
Code: **MGO**  
Description: **General Observation**

Distance (ft): **13.8**  
Structural Grade: **0**  
O&M Grade: **0**  
Clock Start/From:  
Clock To:  
1st Value:  
2nd Value:  
Value Percent:  
Continuous Index:  
Within 8" of Joint: **NO**  
Remarks: **Fog in the line; D/s manhole is covered.**

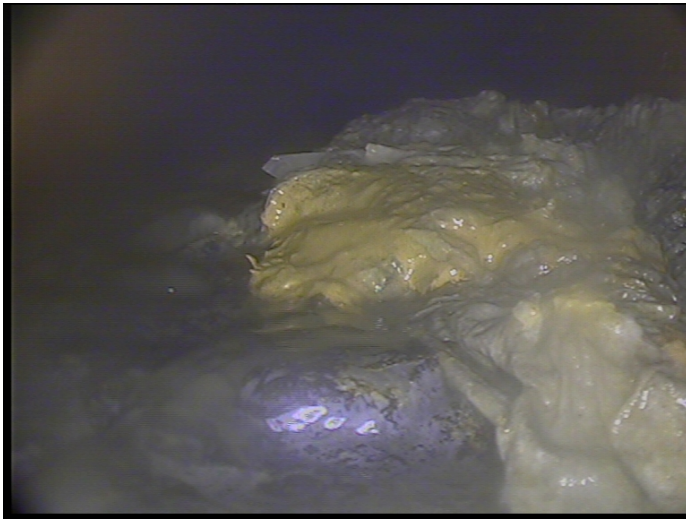
Code: **OBZ**  
Description: **Obstacle Other**

Distance (ft): **65.4**  
Structural Grade: **0**  
O&M Grade: **3**  
Clock Start/From: **4**  
Clock To: **8**  
1st Value:  
2nd Value:  
Value Percent: **20.000**  
Continuous Index:  
Within 8" of Joint: **NO**  
Remarks: **Debris**

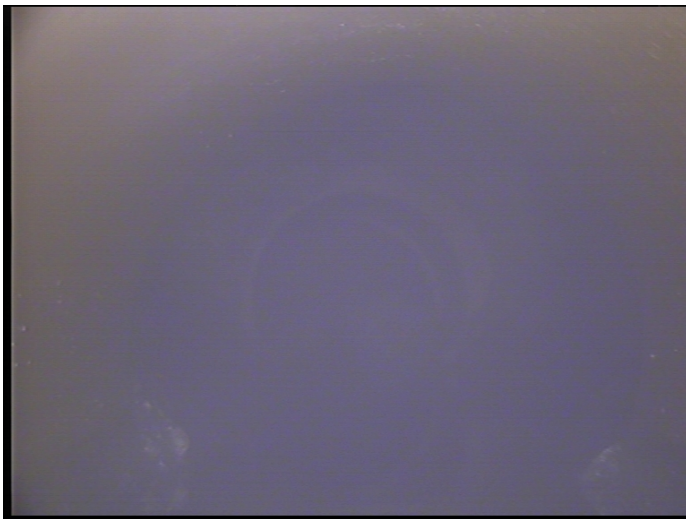
Code: **MSA**  
Description: **Abandoned Survey**

Distance (ft): **69.6**  
Structural Grade: **0**  
O&M Grade: **0**  
Clock Start/From:  
Clock To:  
1st Value:  
2nd Value:  
Value Percent:  
Continuous Index:  
Within 8" of Joint: **NO**  
Remarks: **20% OBZ Manhole 1-2' ahead.**
