Profile/Photo Observation Report

Date:	10/23/2021	Weather:		Coding:	PACP 6.0
Pipe Length (ft):		Owner:	Hobart, IN	Pre Clean:	Not Known
P.O.#:	980_1	Surveyor:	M. Pielacha	PSR:	P-608-0SL-030
Customer:	Hobart, IN	Clean Date:		Shape:	C

Street:	Hospital Lot	Flow Control:	
City:	Hobart, IN	Year Renewed:	
Location:	Parking Lot	Tape/Media #:	980
Purpose:	Routine Assessment	Dia/Height:	8"
Use:	Sanitary	Material:	VCP
Drain Area:		Lining:	
Category:	NA		
Comment:

Location Details:		Direction of Survey:	Upstream
US MH:	M-608-30	DS MH:	M-608-30
		Total Length Surveyed (ft):	212.0

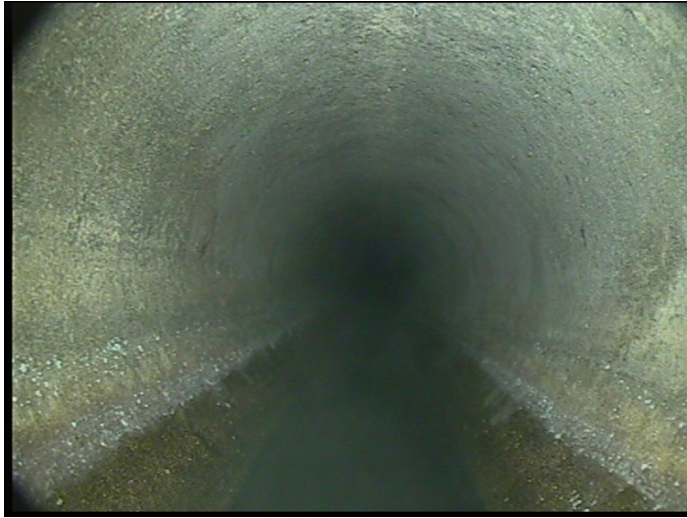
Code: **MWL**
Description: **Water Level**

Distance (ft): **.0**
Structural Grade: **0**
O&M Grade: **0**
Clock Start/From:
Clock To:
1st Value:
2nd Value:
Value Percent: **5.000**
Continuous Index:
Within 8" of Joint: **NO**
Remarks:

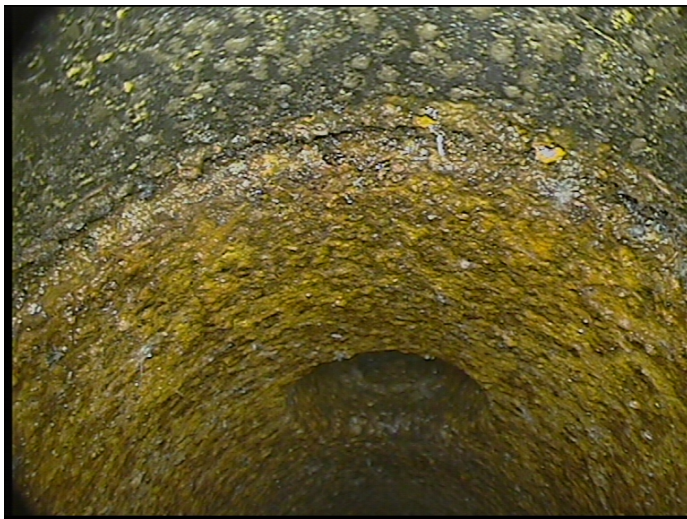
Code: **MMC**
Description: **Material Change**

Distance (ft): **107.2**
Structural Grade: **0**
O&M Grade: **0**
Clock Start/From:
Clock To:
1st Value:
2nd Value:
Value Percent:
Continuous Index:
Within 8" of Joint: **NO**
Remarks: **Steel**

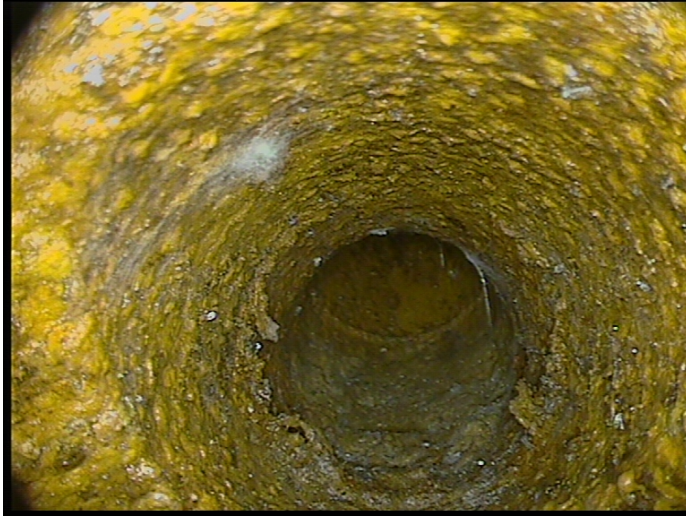
Code: **TF**
Description: **Tap Factory**

Distance (ft): **108.3**
Structural Grade: **0**
O&M Grade: **0**
Clock Start/From: **12**
Clock To:
1st Value: **4.000**
2nd Value:
Value Percent:
Continuous Index:
Within 8" of Joint: **NO**
Remarks:

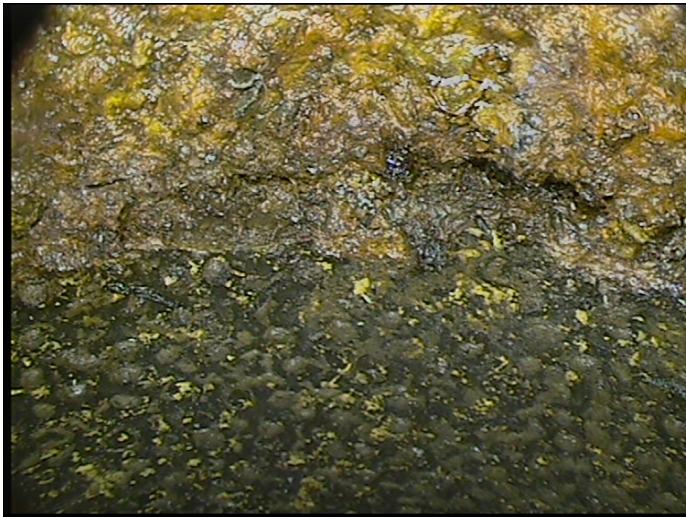
Code: **MMC**
Description: **Material Change**

Distance (ft): **109.7**
Structural Grade: **0**
O&M Grade: **0**
Clock Start/From:
Clock To:
1st Value:
2nd Value:
Value Percent:
Continuous Index:
Within 8" of Joint: **NO**
Remarks: **vcp**

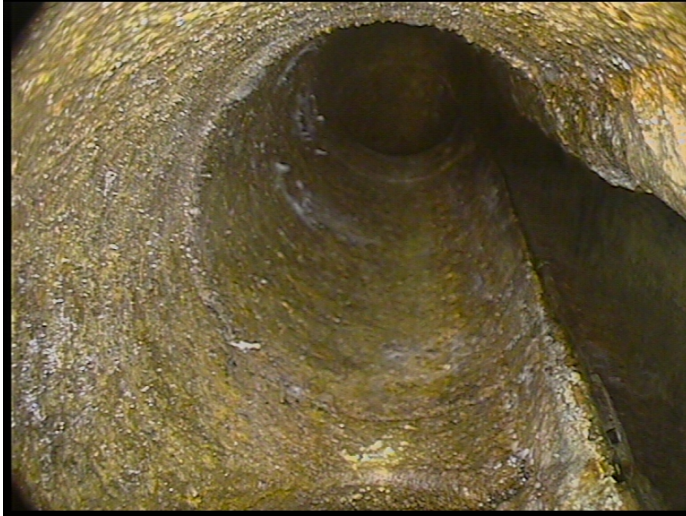
Code: **TF**
Description: **Tap Factory**

Distance (ft): **211.7**
Structural Grade: **0**
O&M Grade: **0**
Clock Start/From: **3**
Clock To:
1st Value: **6.000**
2nd Value:
Value Percent:
Continuous Index:
Within 8" of Joint: **NO**
Remarks:

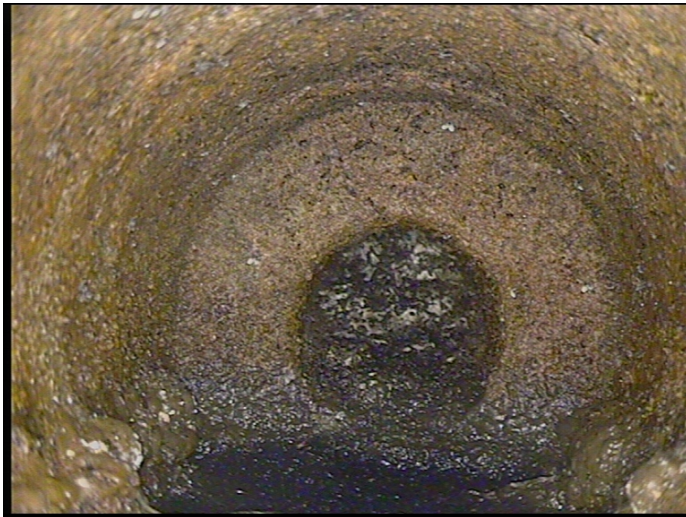
Code: **MGO**
Description: **General Observation**

Distance (ft): **212.0**
Structural Grade: **0**
O&M Grade: **0**
Clock Start/From:
Clock To:
1st Value:
2nd Value:
Value Percent:
Continuous Index:
Within 8" of Joint: **NO**
Remarks: **end of line**

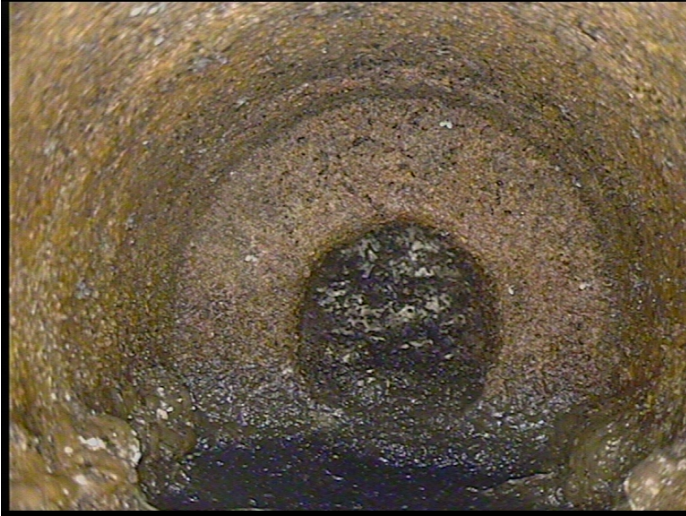
Code:	MSA
Description:	Abandoned Survey
Distance (ft):	212.0
Structural Grade:	0
O&M Grade:	0
Clock Start/From:	
Clock To:	
1st Value:	
2nd Value:	
Value Percent:	
Continuous Index:	
Within 8" of Joint:	NO
Remarks:	End of line
