Profile/Photo Observation Report

Date:	04/05/2018	Weather:		Coding:	PACP 6.0
Pipe Length (ft):	194.0	Owner:	NA	Pre Clean:	No Pre-Cleaning
P.O.#:		Surveyor:	Jen Costello	PSR:	P-608-029-032
Customer:		Clean Date:	01/01/1900	Shape:	C

Street:	OFF S LAKE PARK AVE	Flow Control:	Not Controlled
City:	Hobart, IN	Year Renewed:	
Location:	Yard	Tape/Media #:	
Purpose:	Routine Assessment	Dia/Height:	12"
Use:	Sanitary	Material:	VCP
Drain Area:	NA	Lining:	
Category:	NA		
Comment:	Flow direction is marked wrong.

Location Details:		Direction of Survey:	Downstream
US MH:	M-608-032	DS MH:	M-608-029
		Total Length Surveyed (ft):	187.9

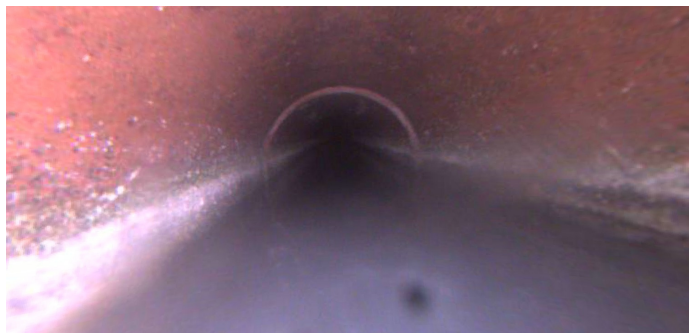
Code: **AMH**
Description: **Manhole**

Distance (ft): **.0**
Structural Grade: **0**
O&M Grade: **0**
Clock Start/From:
Clock To:
1st Value:
2nd Value:
Value Percent:
Continuous Index:
Within 8" of Joint: **NO**
Remarks: **M-608-032**

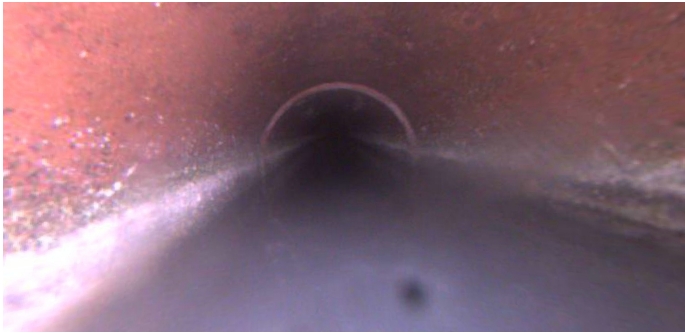
Code:	MWL
Description:	Water Level

Distance (ft):	.0
Structural Grade:	0
O&M Grade:	0
Clock Start/From:	
Clock To:	
1st Value:	
2nd Value:	
Value Percent:	30.000
Continuous Index:	
Within 8" of Joint:	NO
Remarks:

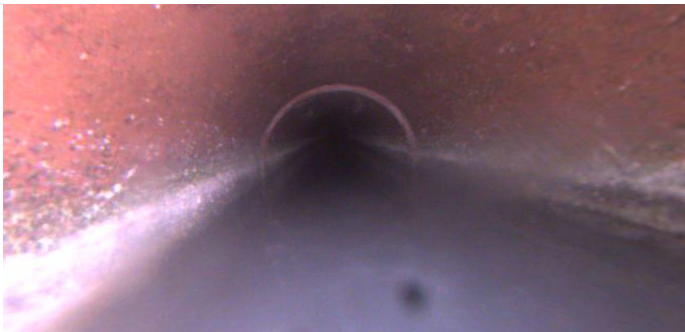
Code:	DAGS
Description:	Deposits Attached Grease

Distance (ft):	.0
Structural Grade:	0
O&M Grade:	2
Clock Start/From:	8
Clock To:	4
1st Value:	
2nd Value:	
Value Percent:	5.000
Continuous Index:	S01
Within 8" of Joint:	NO
Remarks:

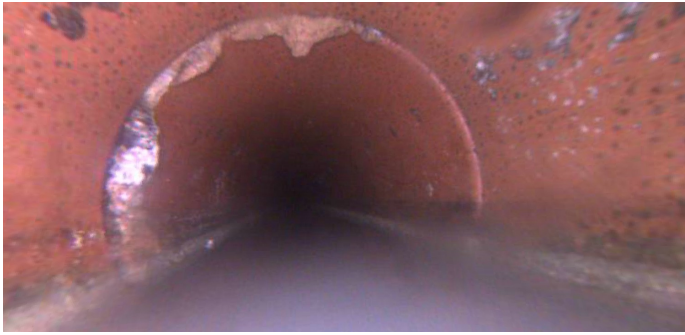
Code: **DAE**
Description: **Deposits Attached Encrustation**

Distance (ft): **32.4**
Structural Grade: **0**
O&M Grade: **2**
Clock Start/From: **8**
Clock To: **12**
1st Value:
2nd Value:
Value Percent: **5.000**
Continuous Index:
Within 8" of Joint: **YES**
Remarks:

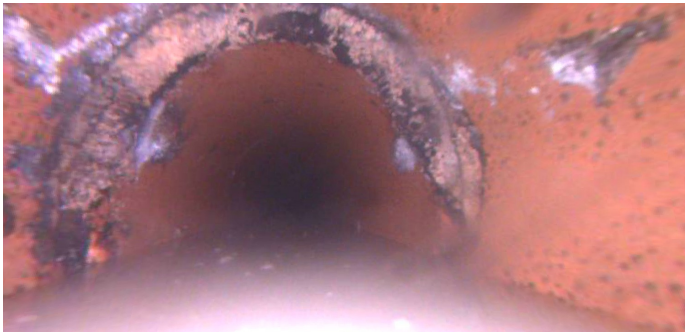
Code: **DAE**
Description: **Deposits Attached Encrustation**

Distance (ft): **68.7**
Structural Grade: **0**
O&M Grade: **2**
Clock Start/From: **8**
Clock To: **4**
1st Value:
2nd Value:
Value Percent: **10.000**
Continuous Index:
Within 8" of Joint: **YES**
Remarks:

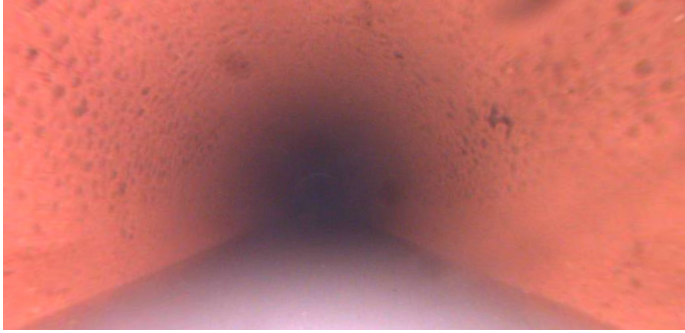
Code: **DAGS**
Description: **Deposits Attached Grease**

Distance (ft): **136.6**
Structural Grade: **0**
O&M Grade: **2**
Clock Start/From: **8**
Clock To: **4**
1st Value:
2nd Value:
Value Percent: **5.000**
Continuous Index: **F01**
Within 8" of Joint: **NO**
Remarks:

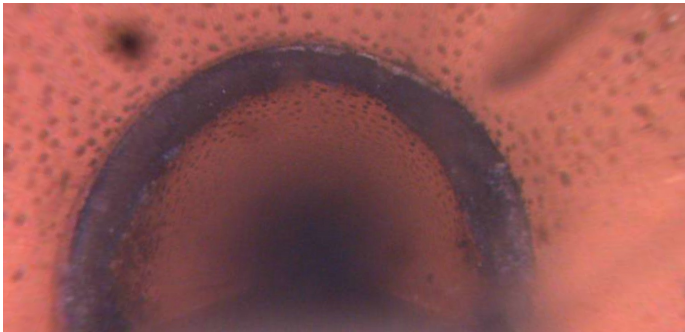
Code: **IS**
Description: **Infil Stain**

Distance (ft): **153.4**
Structural Grade: **0**
O&M Grade: **0**
Clock Start/From: **8**
Clock To: **4**
1st Value:
2nd Value:
Value Percent:
Continuous Index:
Within 8" of Joint: **YES**
Remarks:

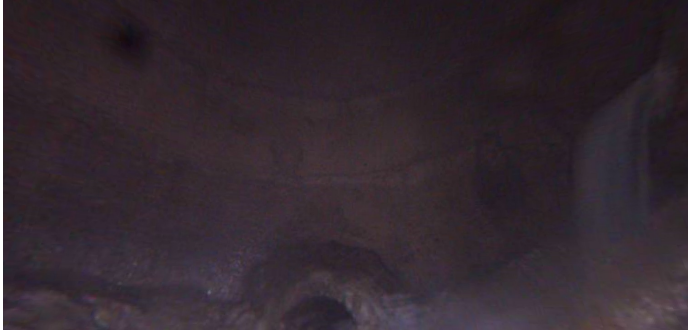
Code:	AMH
Description:	Manhole
Distance (ft):	187.9
Structural Grade:	0
O&M Grade:	0
Clock Start/From:	
Clock To:	
1st Value:	
2nd Value:	
Value Percent:	
Continuous Index:	
Within 8" of Joint:	NO
Remarks:	M-608-029
