## Profile/Photo Observation Report

Date:	<b>04/05/2018</b>	Weather:		Coding:	<b>PACP 6.0</b>
Pipe Length (ft):	<b>194.0</b>	Owner:	<b>NA</b>	Pre Clean:	<b>No Pre-Cleaning</b>
P.O.#:		Surveyor:	<b>Jen Costello</b>	PSR:	<b>P-608-029-032</b>
Customer:		Clean Date:	<b>01/01/1900</b>	Shape:	<b>C</b>

Street:	<b>FOXCROFT STREET</b>	Flow Control:	<b>Not Controlled</b>
City:	<b>Hobart, IN</b>	Year Renewed:	
Location:	<b>Yard</b>	Tape/Media #:	
Purpose:	<b>Routine Assessment</b>	Dia/Height:	<b>12"</b>
Use:	<b>Sanitary</b>	Material:	<b>VCP</b>
Drain Area:	<b>NA</b>	Lining:	
Category:	<b>NA</b>		
Comment:	<b>Flow direction is marked wrong.</b>

Location Details:		Direction of Survey:	<b>Downstream</b>
US MH:	<b>M-608-032</b>	DS MH:	<b>M-608-029</b>
		Total Length Surveyed (ft):	<b>187.9</b>

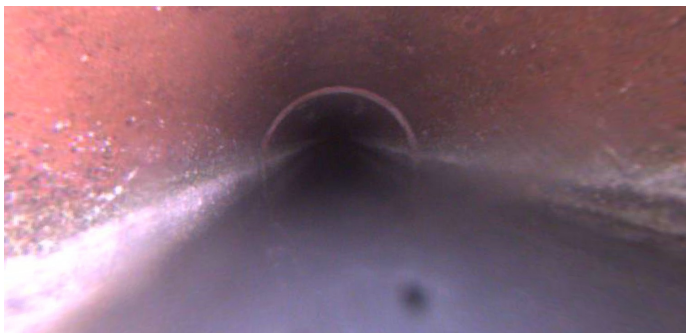
Code: **AMH**  
Description: **Manhole**

Distance (ft): **.0**  
Structural Grade: **0**  
O&M Grade: **0**  
Clock Start/From:  
Clock To:  
1st Value:  
2nd Value:  
Value Percent:  
Continuous Index:  
Within 8" of Joint: **NO**  
Remarks: **M-608-032**

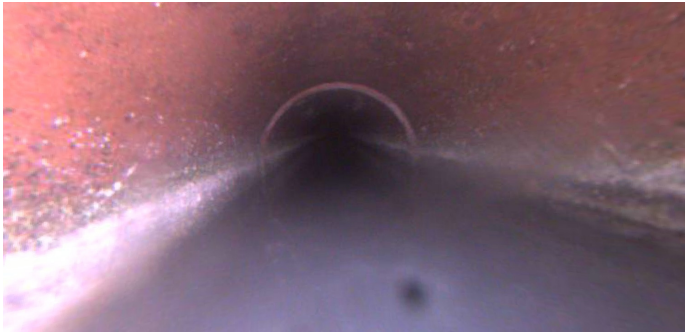
Code:	<b>MWL</b>
Description:	<b>Water Level</b>

Distance (ft):	<b>.0</b>
Structural Grade:	<b>0</b>
O&M Grade:	<b>0</b>
Clock Start/From:	
Clock To:	
1st Value:	
2nd Value:	
Value Percent:	<b>30.000</b>
Continuous Index:	
Within 8" of Joint:	<b>NO</b>
Remarks:

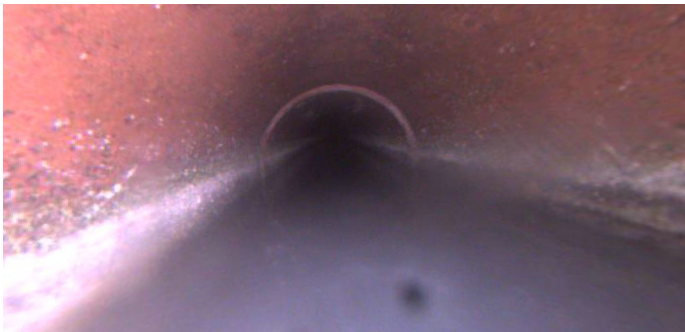
Code:	<b>DAGS</b>
Description:	<b>Deposits Attached Grease</b>

Distance (ft):	<b>.0</b>
Structural Grade:	<b>0</b>
O&M Grade:	<b>2</b>
Clock Start/From:	<b>8</b>
Clock To:	<b>4</b>
1st Value:	
2nd Value:	
Value Percent:	<b>5.000</b>
Continuous Index:	<b>S01</b>
Within 8" of Joint:	<b>NO</b>
Remarks:

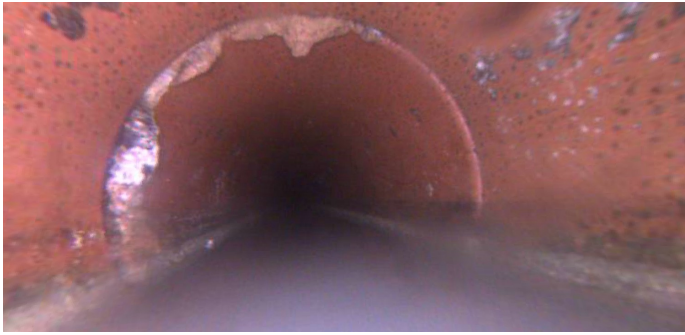
Code: **DAE**  
Description: **Deposits Attached Encrustation**

Distance (ft): **32.4**  
Structural Grade: **0**  
O&M Grade: **2**  
Clock Start/From: **8**  
Clock To: **12**  
1st Value:  
2nd Value:  
Value Percent: **5.000**  
Continuous Index:  
Within 8" of Joint: **YES**  
Remarks:

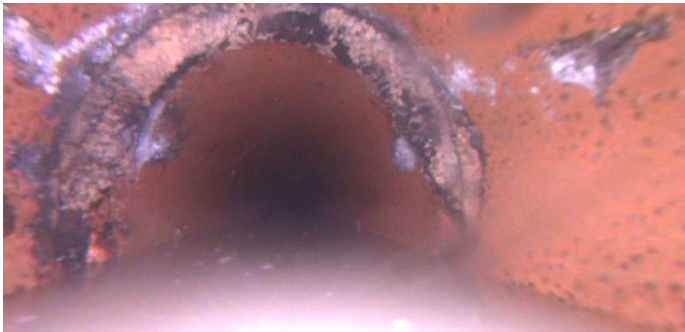
Code: **DAE**  
Description: **Deposits Attached Encrustation**

Distance (ft): **68.7**  
Structural Grade: **0**  
O&M Grade: **2**  
Clock Start/From: **8**  
Clock To: **4**  
1st Value:  
2nd Value:  
Value Percent: **10.000**  
Continuous Index:  
Within 8" of Joint: **YES**  
Remarks:

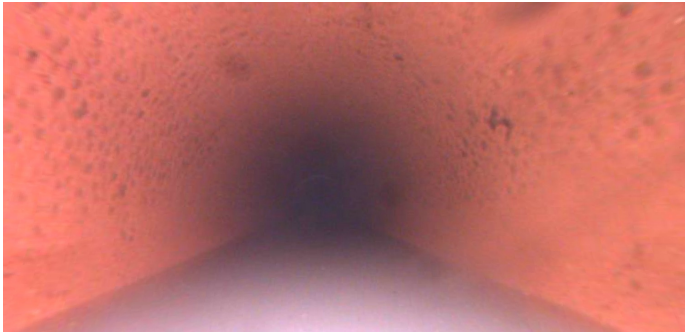
Code: **DAGS**  
Description: **Deposits Attached Grease**

Distance (ft): **136.6**  
Structural Grade: **0**  
O&M Grade: **2**  
Clock Start/From: **8**  
Clock To: **4**  
1st Value:  
2nd Value:  
Value Percent: **5.000**  
Continuous Index: **F01**  
Within 8" of Joint: **NO**  
Remarks:

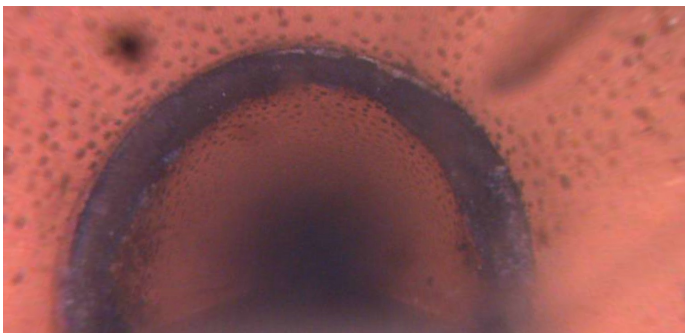
Code: **IS**  
Description: **Infil Stain**

Distance (ft): **153.4**  
Structural Grade: **0**  
O&M Grade: **0**  
Clock Start/From: **8**  
Clock To: **4**  
1st Value:  
2nd Value:  
Value Percent:  
Continuous Index:  
Within 8" of Joint: **YES**  
Remarks:

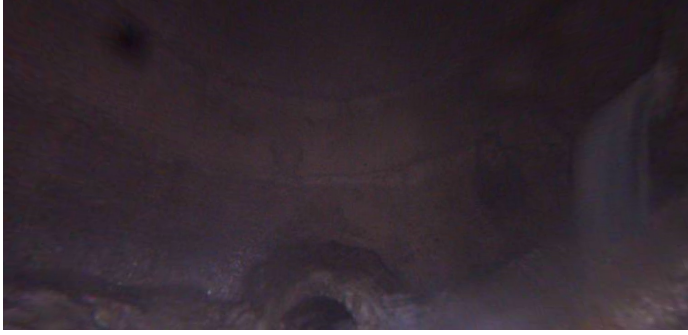
Code:	<b>AMH</b>
Description:	<b>Manhole</b>
Distance (ft):	<b>187.9</b>
Structural Grade:	<b>0</b>
O&M Grade:	<b>0</b>
Clock Start/From:	
Clock To:	
1st Value:	
2nd Value:	
Value Percent:	
Continuous Index:	
Within 8" of Joint:	<b>NO</b>
Remarks:	<b>M-608-029</b>
