## Profile/Photo Observation Report

Date:	<b>04/05/2018</b>	Weather:		Coding:	<b>PACP 6.0</b>
Pipe Length (ft):	<b>377.8</b>	Owner:	<b>NA</b>	Pre Clean:	<b>No Pre-Cleaning</b>
P.O.#:		Surveyor:	<b>Jen Costello</b>	PSR:	<b>P-608-030-032</b>
Customer:		Clean Date:	<b>01/01/1900</b>	Shape:	<b>C</b>

Street:	<b>OFF W 14TH ST</b>	Flow Control:	<b>Not Controlled</b>
City:	<b>Hobart, IN</b>	Year Renewed:	
Location:	<b>Yard</b>	Tape/Media #:	
Purpose:	<b>Routine Assessment</b>	Dia/Height:	<b>8"</b>
Use:	<b>Sanitary</b>	Material:	<b>VCP</b>
Drain Area:	<b>NA</b>	Lining:	
Category:	<b>NA</b>		
Comment:	<b>Flow direction is wrong.</b>		
Location Details:		Direction of Survey:	<b>Upstream</b>
US MH:	<b>M-608-032</b>	DS MH:	<b>M-608-030</b>
		Total Length Surveyed (ft):	<b>367.8</b>

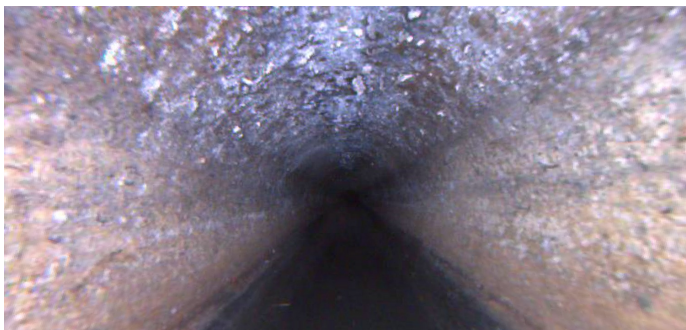
Code: **AMH**  
Description: **Manhole**

Distance (ft): **.0**  
Structural Grade: **0**  
O&M Grade: **0**  
Clock Start/From:  
Clock To:  
1st Value:  
2nd Value:  
Value Percent:  
Continuous Index:  
Within 8" of Joint: **NO**  
Remarks: **M-608-030**

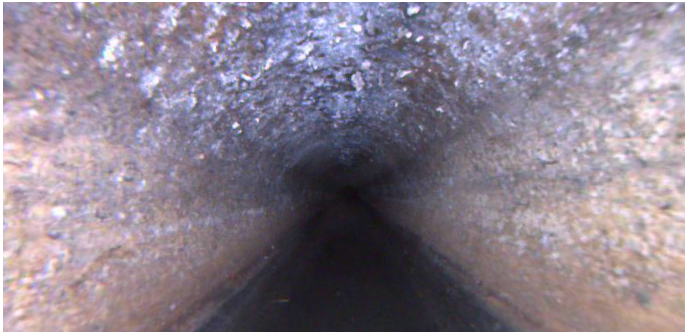
Code:	<b>MWL</b>
Description:	<b>Water Level</b>

Distance (ft):	<b>.0</b>
Structural Grade:	<b>0</b>
O&M Grade:	<b>0</b>
Clock Start/From:	
Clock To:	
1st Value:	
2nd Value:	
Value Percent:	<b>5.000</b>
Continuous Index:	
Within 8" of Joint:	<b>NO</b>
Remarks:

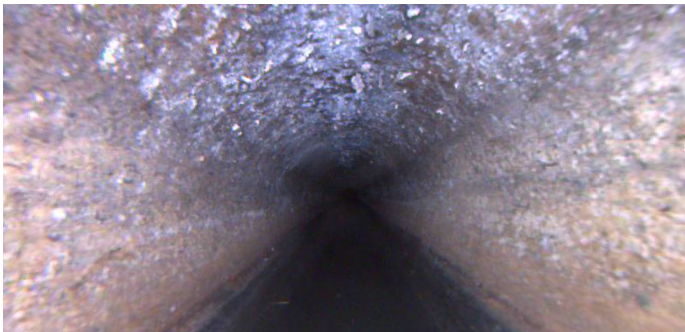
Code:	<b>DAGS</b>
Description:	<b>Deposits Attached Grease</b>

Distance (ft):	<b>.0</b>
Structural Grade:	<b>0</b>
O&M Grade:	<b>2</b>
Clock Start/From:	<b>8</b>
Clock To:	<b>4</b>
1st Value:	
2nd Value:	
Value Percent:	<b>5.000</b>
Continuous Index:	<b>S01</b>
Within 8" of Joint:	<b>NO</b>
Remarks:

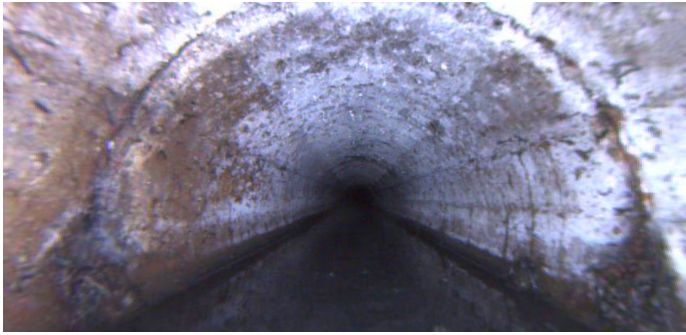
Code: **RFJ**  
Description: **Roots Fine Joint**

Distance (ft): **7.6**  
Structural Grade: **0**  
O&M Grade: **1**  
Clock Start/From: **8**  
Clock To: **4**  
1st Value:  
2nd Value:  
Value Percent:  
Continuous Index:  
Within 8" of Joint: **YES**  
Remarks:

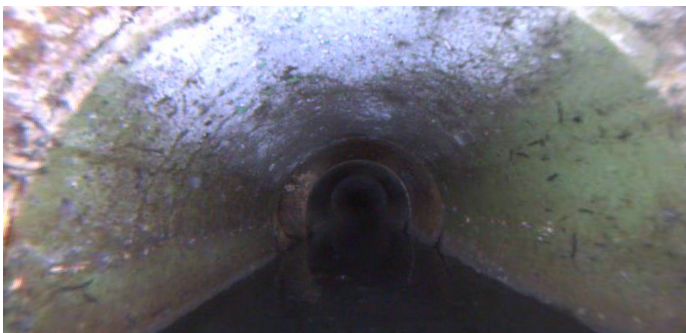
Code: **MMC**  
Description: **Material Change**

Distance (ft): **13.0**  
Structural Grade: **0**  
O&M Grade: **0**  
Clock Start/From:  
Clock To:  
1st Value:  
2nd Value:  
Value Percent:  
Continuous Index:  
Within 8" of Joint: **NO**  
Remarks: **PVC**

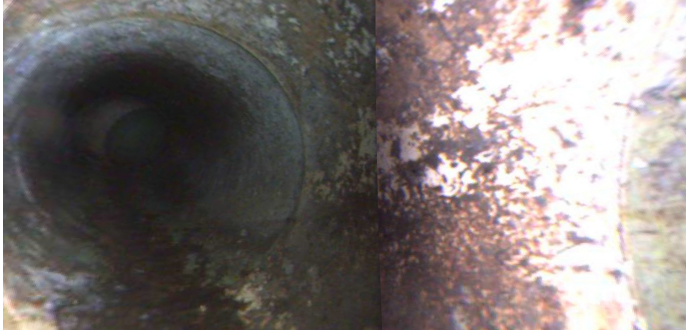
Code: **TF**  
Description: **Tap Factory**

Distance (ft): **14.6**  
Structural Grade: **0**  
O&M Grade: **0**  
Clock Start/From: **9**  
Clock To:  
1st Value: **4.000**  
2nd Value:  
Value Percent:  
Continuous Index:  
Within 8" of Joint:  
Remarks:

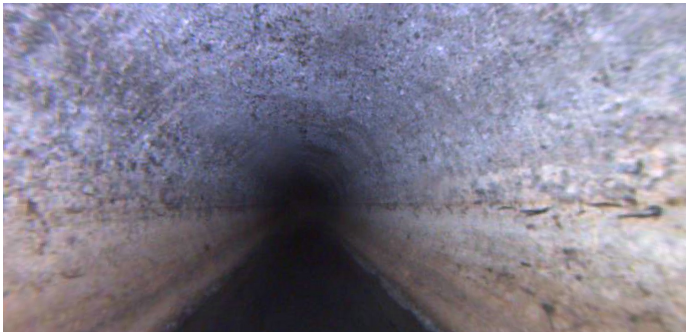
Code: **MMC**  
Description: **Material Change**

Distance (ft): **16.5**  
Structural Grade: **0**  
O&M Grade: **0**  
Clock Start/From:  
Clock To:  
1st Value:  
2nd Value:  
Value Percent:  
Continuous Index:  
Within 8" of Joint: **NO**  
Remarks: **VCP**

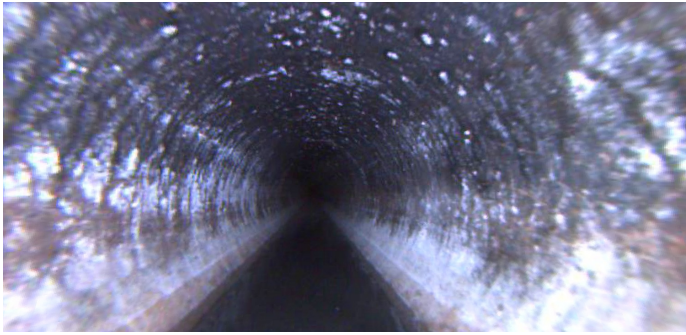
Code: **CM**  
Description: **Crack Multiple**

Distance (ft): **49.5**  
Structural Grade: **3**  
O&M Grade: **0**  
Clock Start/From: **8**  
Clock To: **4**  
1st Value:  
2nd Value:  
Value Percent:  
Continuous Index: **S03**  
Within 8" of Joint:  
Remarks:

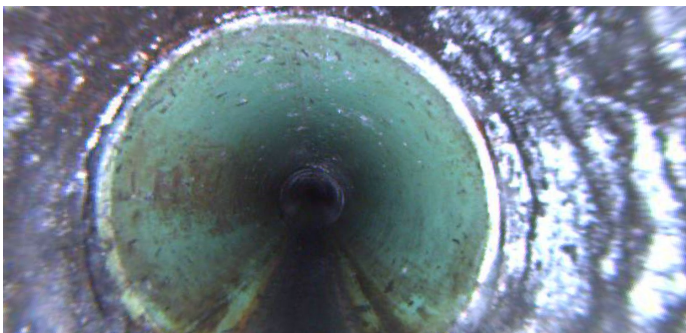
Code: **CM**  
Description: **Crack Multiple**

Distance (ft): **87.8**  
Structural Grade: **3**  
O&M Grade: **0**  
Clock Start/From: **8**  
Clock To: **4**  
1st Value:  
2nd Value:  
Value Percent:  
Continuous Index: **F03**  
Within 8" of Joint:  
Remarks:

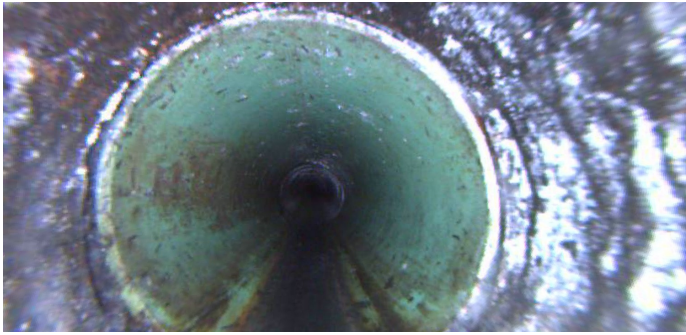
Code: **MMC**  
Description: **Material Change**

Distance (ft): **87.8**  
Structural Grade: **0**  
O&M Grade: **0**  
Clock Start/From:  
Clock To:  
1st Value:  
2nd Value:  
Value Percent:  
Continuous Index:  
Within 8" of Joint: **NO**  
Remarks: **pvc**

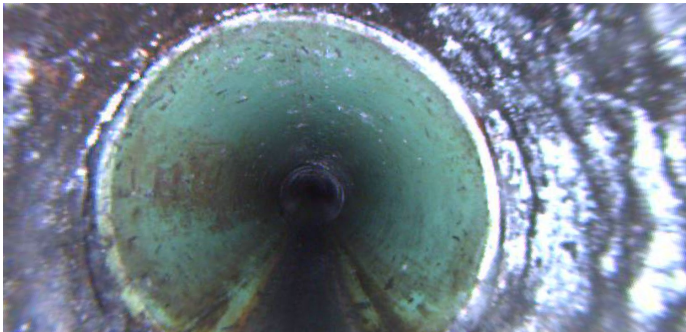
Code: **DAGS**  
Description: **Deposits Attached Grease**

Distance (ft): **87.8**  
Structural Grade: **0**  
O&M Grade: **2**  
Clock Start/From: **8**  
Clock To: **4**  
1st Value:  
2nd Value:  
Value Percent: **5.000**  
Continuous Index: **F01**  
Within 8" of Joint: **NO**  
Remarks:

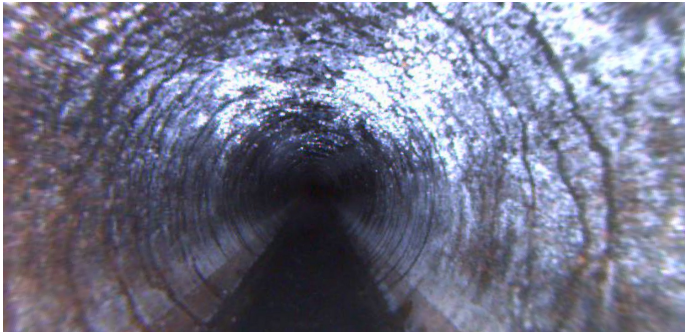
Code: **MMC**  
Description: **Material Change**

Distance (ft): **90.8**  
Structural Grade: **0**  
O&M Grade: **0**  
Clock Start/From:  
Clock To:  
1st Value:  
2nd Value:  
Value Percent:  
Continuous Index:  
Within 8" of Joint: **NO**  
Remarks: **VCP**

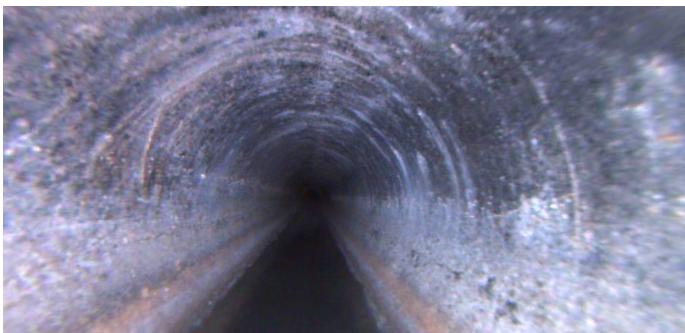
Code: **CM**  
Description: **Crack Multiple**

Distance (ft): **125.8**  
Structural Grade: **3**  
O&M Grade: **0**  
Clock Start/From: **8**  
Clock To: **4**  
1st Value:  
2nd Value:  
Value Percent:  
Continuous Index: **S04**  
Within 8" of Joint:  
Remarks:

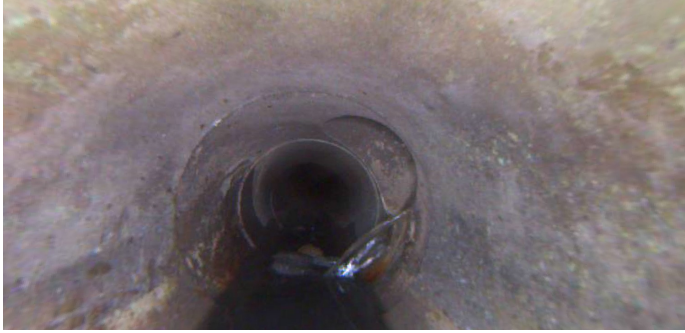
Code: **MMC**  
Description: **Material Change**

Distance (ft): **134.8**  
Structural Grade: **0**  
O&M Grade: **0**  
Clock Start/From:  
Clock To:  
1st Value:  
2nd Value:  
Value Percent:  
Continuous Index:  
Within 8" of Joint: **NO**  
Remarks: **pvc**

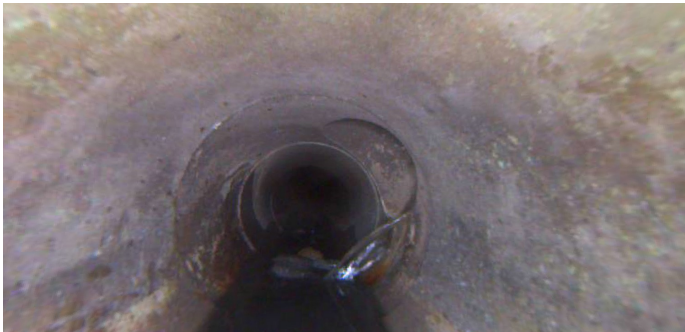
Code: **CM**  
Description: **Crack Multiple**

Distance (ft): **134.8**  
Structural Grade: **3**  
O&M Grade: **0**  
Clock Start/From: **8**  
Clock To: **4**  
1st Value:  
2nd Value:  
Value Percent:  
Continuous Index: **F04**  
Within 8" of Joint:  
Remarks:

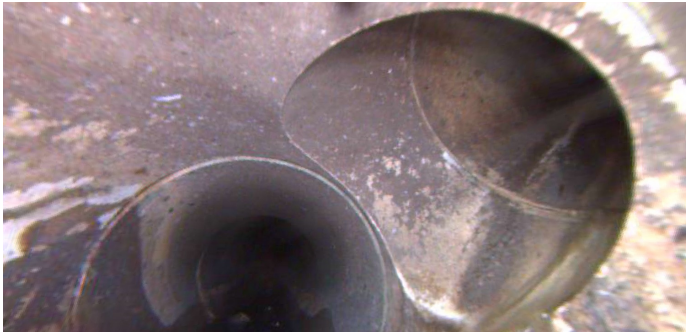
Code: **TFA**  
Description: **Tap Factory Active**

Distance (ft): **135.4**  
Structural Grade: **0**  
O&M Grade: **0**  
Clock Start/From: **2**  
Clock To:  
1st Value: **4.000**  
2nd Value:  
Value Percent:  
Continuous Index:  
Within 8" of Joint:  
Remarks:

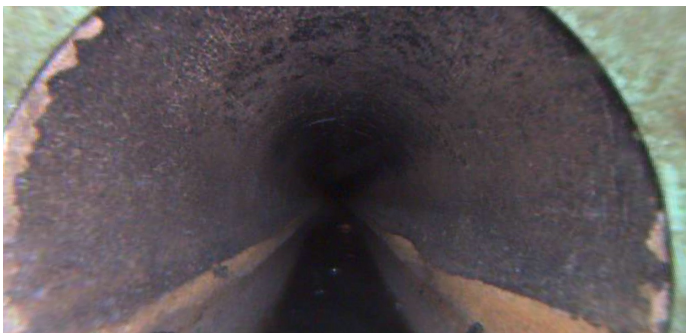
Code: **MMC**  
Description: **Material Change**

Distance (ft): **137.0**  
Structural Grade: **0**  
O&M Grade: **0**  
Clock Start/From:  
Clock To:  
1st Value:  
2nd Value:  
Value Percent:  
Continuous Index:  
Within 8" of Joint: **NO**  
Remarks: **DIP**

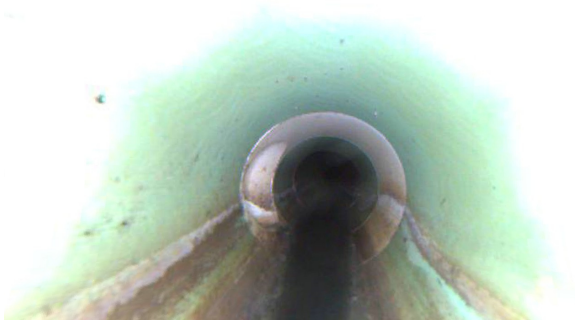
Code: **MMC**  
Description: **Material Change**

Distance (ft): **200.0**  
Structural Grade: **0**  
O&M Grade: **0**  
Clock Start/From:  
Clock To:  
1st Value:  
2nd Value:  
Value Percent:  
Continuous Index:  
Within 8" of Joint: **NO**  
Remarks: **pvc**

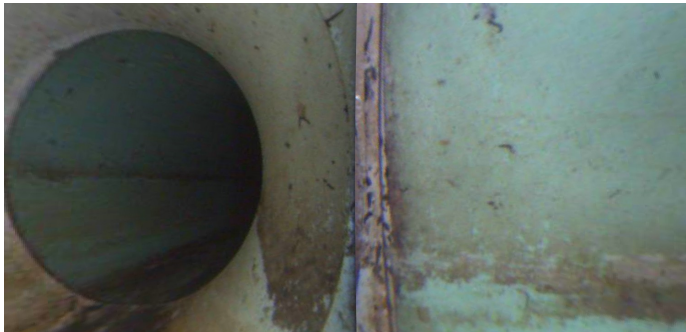
Code: **TFA**  
Description: **Tap Factory Active**

Distance (ft): **201.7**  
Structural Grade: **0**  
O&M Grade: **0**  
Clock Start/From: **9**  
Clock To:  
1st Value: **4.000**  
2nd Value:  
Value Percent:  
Continuous Index:  
Within 8" of Joint:  
Remarks:

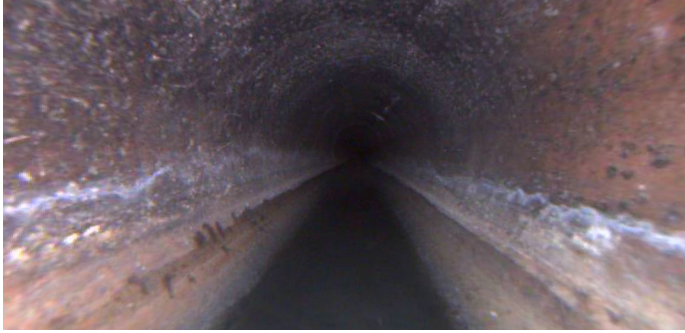
Code: **MMC**  
Description: **Material Change**

Distance (ft): **202.8**  
Structural Grade: **0**  
O&M Grade: **0**  
Clock Start/From:  
Clock To:  
1st Value:  
2nd Value:  
Value Percent:  
Continuous Index:  
Within 8" of Joint: **NO**  
Remarks: **dip**

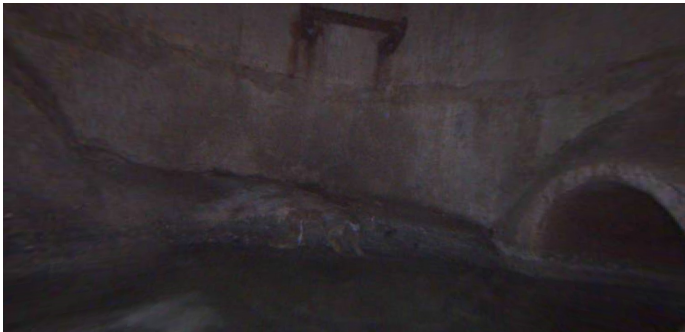
Code: **AMH**  
Description: **Manhole**

Distance (ft): **367.8**  
Structural Grade: **0**  
O&M Grade: **0**  
Clock Start/From:  
Clock To:  
1st Value:  
2nd Value:  
Value Percent:  
Continuous Index:  
Within 8" of Joint: **NO**  
Remarks: **M-608-032**
