Profile/Photo Observation Report

Date:	04/05/2018	Weather:		Coding:	PACP 6.0
Pipe Length (ft):	377.8	Owner:	NA	Pre Clean:	No Pre-Cleaning
P.O.#:		Surveyor:	Jen Costello	PSR:	P-608-030-032
Customer:		Clean Date:	01/01/1900	Shape:	C

Street:	FOXCROFT STREET	Flow Control:	Not Controlled
City:	Hobart, IN	Year Renewed:	
Location:	Yard	Tape/Media #:	
Purpose:	Routine Assessment	Dia/Height:	8"
Use:	Sanitary	Material:	VCP
Drain Area:	NA	Lining:	
Category:	NA		
Comment:	Flow direction is wrong.		
Location Details:		Direction of Survey:	Upstream
US MH:	M-608-032	DS MH:	M-608-030
		Total Length Surveyed (ft):	367.8

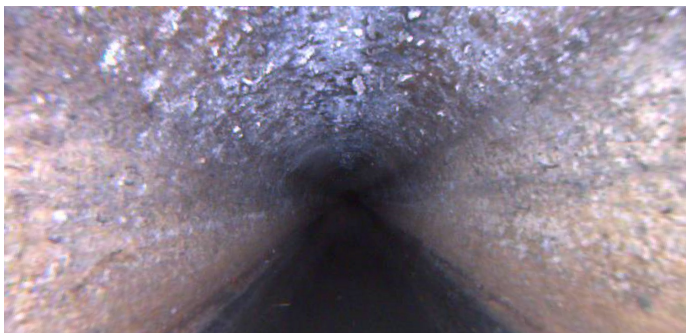
Code: **AMH**
Description: **Manhole**

Distance (ft): **.0**
Structural Grade: **0**
O&M Grade: **0**
Clock Start/From:
Clock To:
1st Value:
2nd Value:
Value Percent:
Continuous Index:
Within 8" of Joint: **NO**
Remarks: **M-608-030**

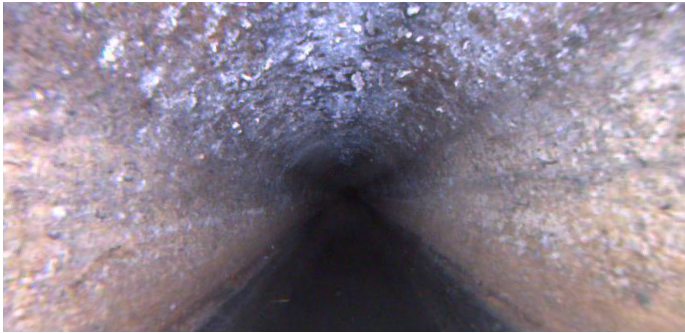
Code:	MWL
Description:	Water Level

Distance (ft):	.0
Structural Grade:	0
O&M Grade:	0
Clock Start/From:	
Clock To:	
1st Value:	
2nd Value:	
Value Percent:	5.000
Continuous Index:	
Within 8" of Joint:	NO
Remarks:

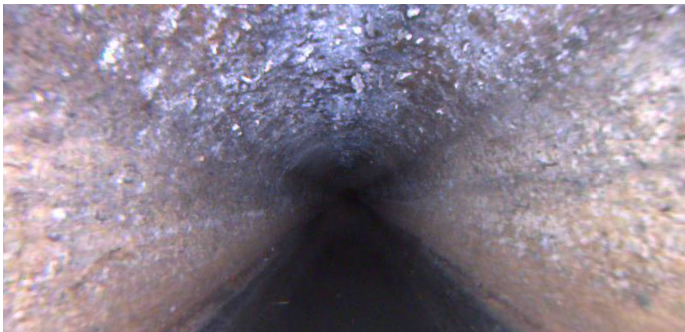
Code:	DAGS
Description:	Deposits Attached Grease

Distance (ft):	.0
Structural Grade:	0
O&M Grade:	2
Clock Start/From:	8
Clock To:	4
1st Value:	
2nd Value:	
Value Percent:	5.000
Continuous Index:	S01
Within 8" of Joint:	NO
Remarks:

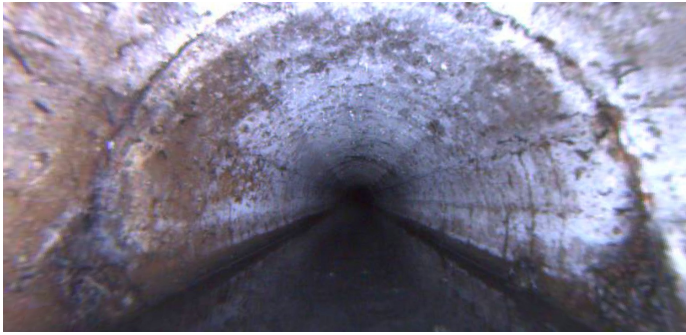
Code: **RFJ**
Description: **Roots Fine Joint**

Distance (ft): **7.6**
Structural Grade: **0**
O&M Grade: **1**
Clock Start/From: **8**
Clock To: **4**
1st Value:
2nd Value:
Value Percent:
Continuous Index:
Within 8" of Joint: **YES**
Remarks:

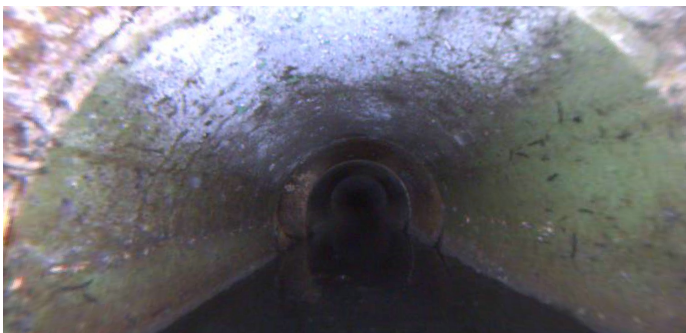
Code: **MMC**
Description: **Material Change**

Distance (ft): **13.0**
Structural Grade: **0**
O&M Grade: **0**
Clock Start/From:
Clock To:
1st Value:
2nd Value:
Value Percent:
Continuous Index:
Within 8" of Joint: **NO**
Remarks: **PVC**

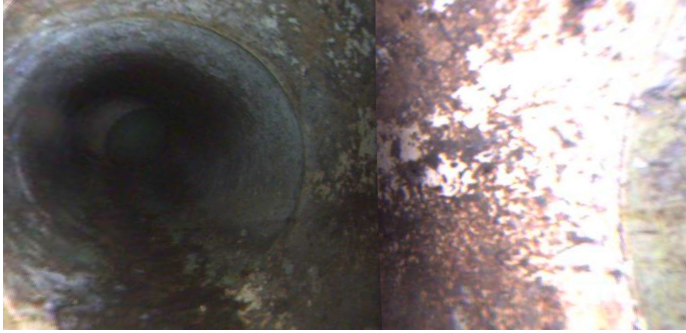
Code: **TF**
Description: **Tap Factory**

Distance (ft): **14.6**
Structural Grade: **0**
O&M Grade: **0**
Clock Start/From: **9**
Clock To:
1st Value: **4.000**
2nd Value:
Value Percent:
Continuous Index:
Within 8" of Joint:
Remarks:

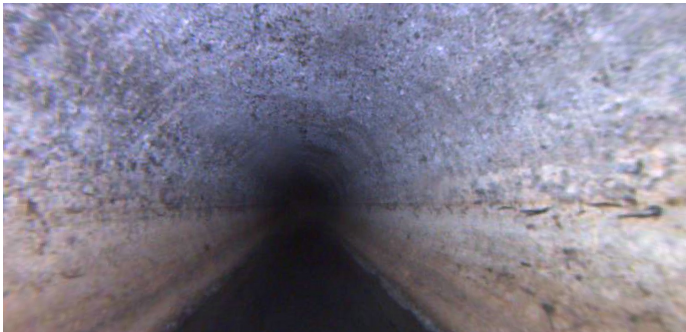
Code: **MMC**
Description: **Material Change**

Distance (ft): **16.5**
Structural Grade: **0**
O&M Grade: **0**
Clock Start/From:
Clock To:
1st Value:
2nd Value:
Value Percent:
Continuous Index:
Within 8" of Joint: **NO**
Remarks: **VCP**

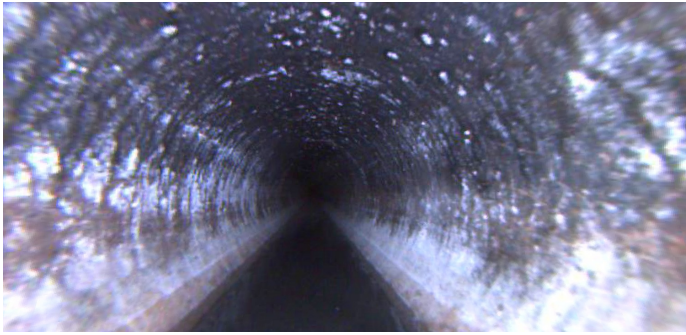
Code: **CM**
Description: **Crack Multiple**

Distance (ft): **49.5**
Structural Grade: **3**
O&M Grade: **0**
Clock Start/From: **8**
Clock To: **4**
1st Value:
2nd Value:
Value Percent:
Continuous Index: **S03**
Within 8" of Joint:
Remarks:

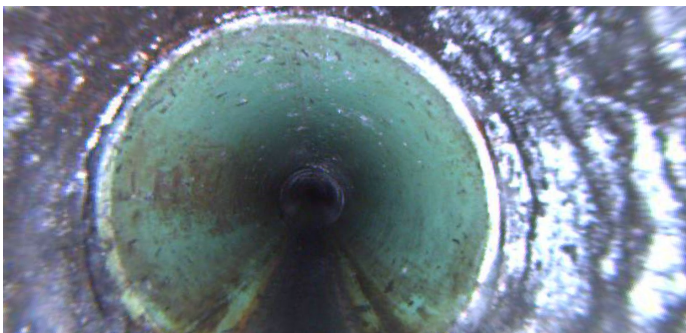
Code: **CM**
Description: **Crack Multiple**

Distance (ft): **87.8**
Structural Grade: **3**
O&M Grade: **0**
Clock Start/From: **8**
Clock To: **4**
1st Value:
2nd Value:
Value Percent:
Continuous Index: **F03**
Within 8" of Joint:
Remarks:

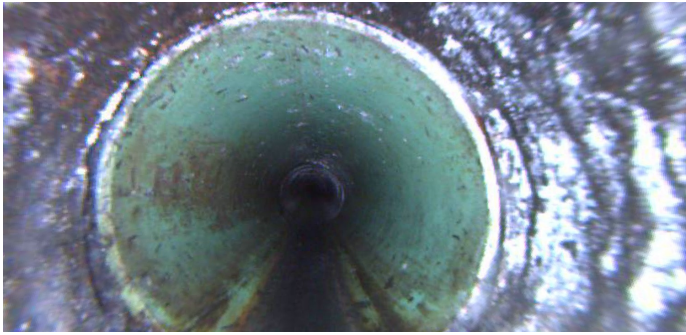
Code: **MMC**
Description: **Material Change**

Distance (ft): **87.8**
Structural Grade: **0**
O&M Grade: **0**
Clock Start/From:
Clock To:
1st Value:
2nd Value:
Value Percent:
Continuous Index:
Within 8" of Joint: **NO**
Remarks: **pvc**

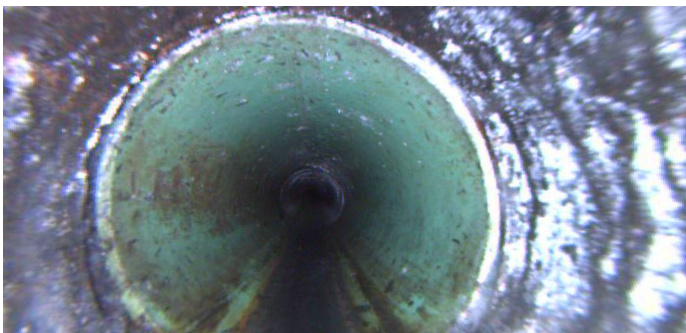
Code: **DAGS**
Description: **Deposits Attached Grease**

Distance (ft): **87.8**
Structural Grade: **0**
O&M Grade: **2**
Clock Start/From: **8**
Clock To: **4**
1st Value:
2nd Value:
Value Percent: **5.000**
Continuous Index: **F01**
Within 8" of Joint: **NO**
Remarks:

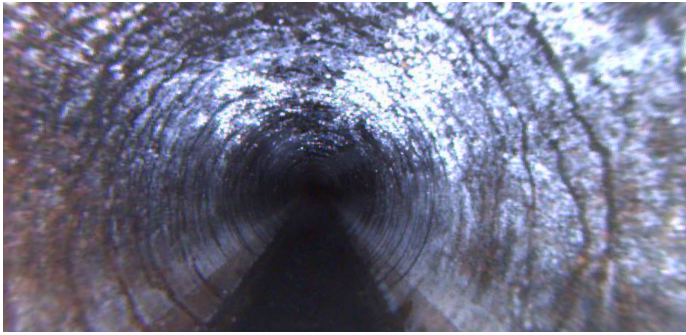
Code: **MMC**
Description: **Material Change**

Distance (ft): **90.8**
Structural Grade: **0**
O&M Grade: **0**
Clock Start/From:
Clock To:
1st Value:
2nd Value:
Value Percent:
Continuous Index:
Within 8" of Joint: **NO**
Remarks: **VCP**

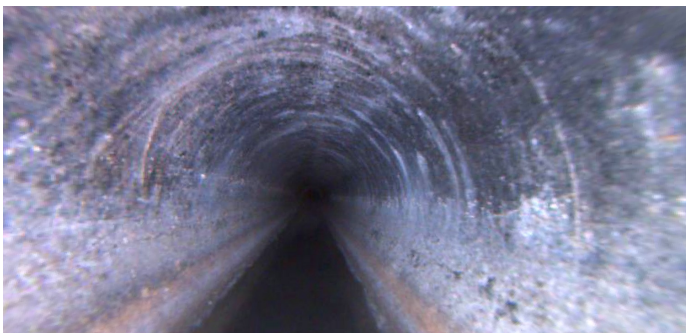
Code: **CM**
Description: **Crack Multiple**

Distance (ft): **125.8**
Structural Grade: **3**
O&M Grade: **0**
Clock Start/From: **8**
Clock To: **4**
1st Value:
2nd Value:
Value Percent:
Continuous Index: **S04**
Within 8" of Joint:
Remarks:

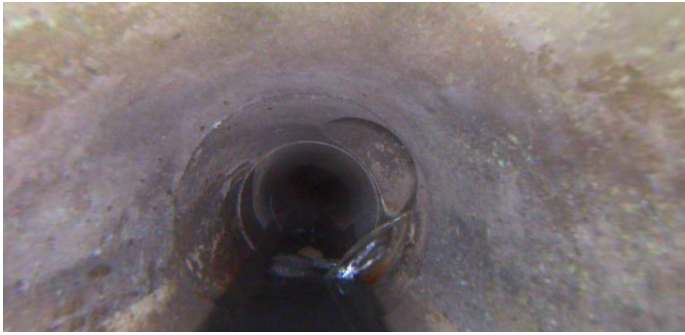
Code: **MMC**
Description: **Material Change**

Distance (ft): **134.8**
Structural Grade: **0**
O&M Grade: **0**
Clock Start/From:
Clock To:
1st Value:
2nd Value:
Value Percent:
Continuous Index:
Within 8" of Joint: **NO**
Remarks: **pvc**

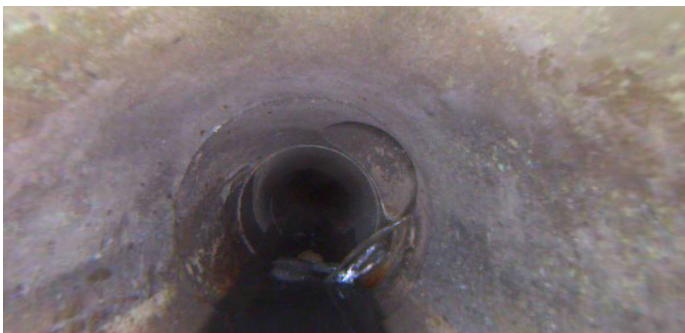
Code: **CM**
Description: **Crack Multiple**

Distance (ft): **134.8**
Structural Grade: **3**
O&M Grade: **0**
Clock Start/From: **8**
Clock To: **4**
1st Value:
2nd Value:
Value Percent:
Continuous Index: **F04**
Within 8" of Joint:
Remarks:

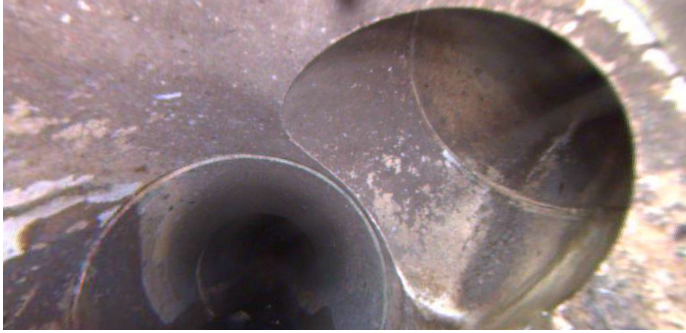
Code: **TFA**
Description: **Tap Factory Active**

Distance (ft): **135.4**
Structural Grade: **0**
O&M Grade: **0**
Clock Start/From: **2**
Clock To:
1st Value: **4.000**
2nd Value:
Value Percent:
Continuous Index:
Within 8" of Joint:
Remarks:

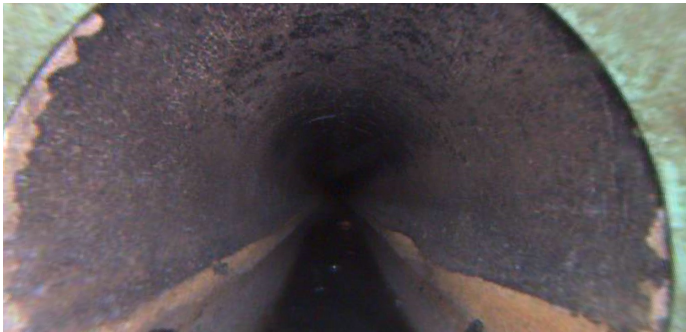
Code: **MMC**
Description: **Material Change**

Distance (ft): **137.0**
Structural Grade: **0**
O&M Grade: **0**
Clock Start/From:
Clock To:
1st Value:
2nd Value:
Value Percent:
Continuous Index:
Within 8" of Joint: **NO**
Remarks: **DIP**

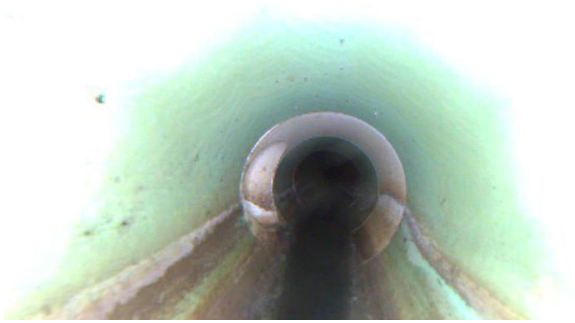
Code: **MMC**
Description: **Material Change**

Distance (ft): **200.0**
Structural Grade: **0**
O&M Grade: **0**
Clock Start/From:
Clock To:
1st Value:
2nd Value:
Value Percent:
Continuous Index:
Within 8" of Joint: **NO**
Remarks: **pvc**

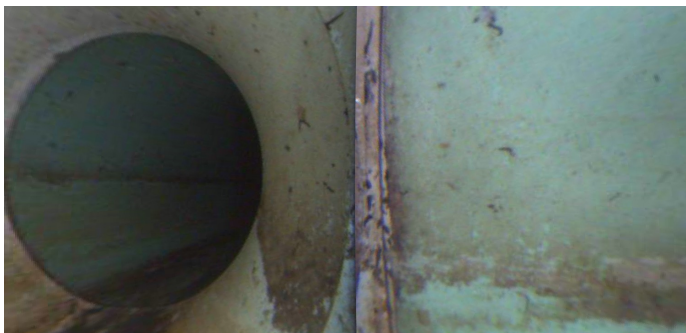
Code: **TFA**
Description: **Tap Factory Active**

Distance (ft): **201.7**
Structural Grade: **0**
O&M Grade: **0**
Clock Start/From: **9**
Clock To:
1st Value: **4.000**
2nd Value:
Value Percent:
Continuous Index:
Within 8" of Joint:
Remarks:

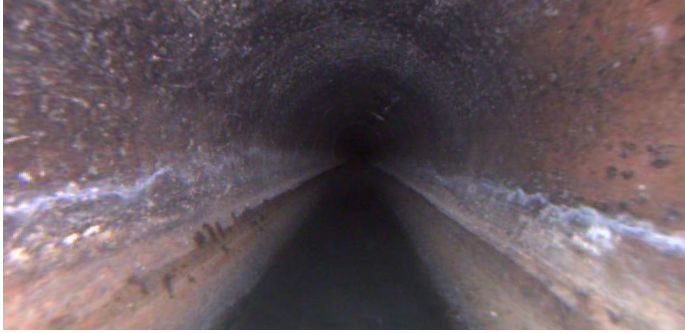
Code: **MMC**
Description: **Material Change**

Distance (ft): **202.8**
Structural Grade: **0**
O&M Grade: **0**
Clock Start/From:
Clock To:
1st Value:
2nd Value:
Value Percent:
Continuous Index:
Within 8" of Joint: **NO**
Remarks: **dip**

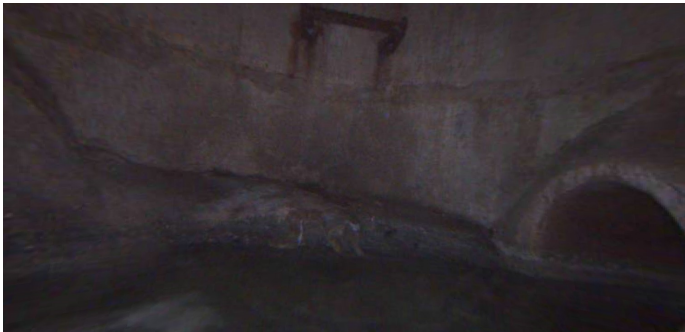
Code: **AMH**
Description: **Manhole**

Distance (ft): **367.8**
Structural Grade: **0**
O&M Grade: **0**
Clock Start/From:
Clock To:
1st Value:
2nd Value:
Value Percent:
Continuous Index:
Within 8" of Joint: **NO**
Remarks: **M-608-032**
