## Profile/Photo Observation Report

Street:	<b>FOXCROFT STREET</b>	Flow Control:	<b>Not Controlled</b>
City:	<b>Hobart, IN</b>	Year Renewed:	
Location:	<b>Yard</b>	Tape/Media #:	
Purpose:	<b>Routine Assessment</b>	Dia/Height:	<b>12"</b>
Use:	<b>Sanitary</b>	Material:	<b>PVC</b>
Drain Area:	<b>NA</b>	Lining:	
Category:	<b>NA</b>		
Comment:	<b>Flow direction is marked wrong.</b>

Location Details:		Direction of Survey:	<b>Upstream</b>
US MH:	<b>M-608-033</b>	DS MH:	<b>M-608-032</b>
		Total Length Surveyed (ft):	<b>6.7</b>

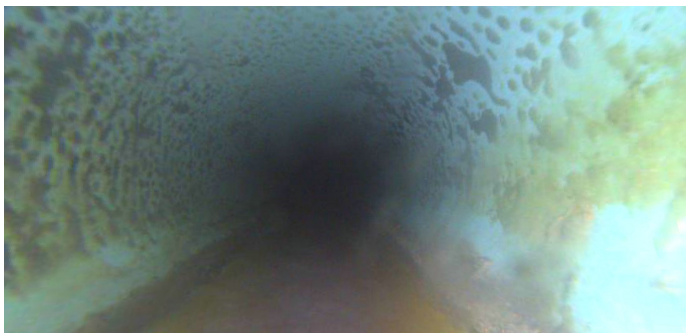
Code: **AMH**  
Description: **Manhole**

Distance (ft): **.0**  
Structural Grade: **0**  
O&M Grade: **0**  
Clock Start/From:  
Clock To:  
1st Value:  
2nd Value:  
Value Percent:  
Continuous Index:  
Within 8" of Joint: **NO**  
Remarks: **M-608-032**

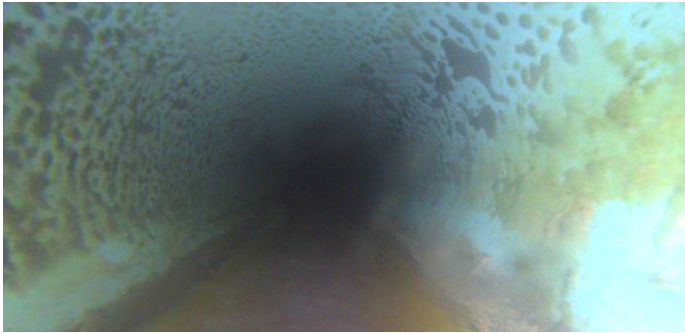
Code:	<b>MWL</b>
Description:	<b>Water Level</b>

Distance (ft):	<b>.0</b>
Structural Grade:	<b>0</b>
O&M Grade:	<b>0</b>
Clock Start/From:	
Clock To:	
1st Value:	
2nd Value:	
Value Percent:	<b>10.000</b>
Continuous Index:	
Within 8" of Joint:	<b>NO</b>
Remarks:

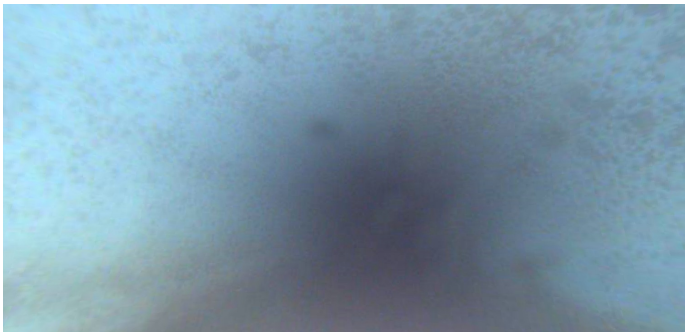
Code:	<b>MSA</b>
Description:	<b>Abandoned Survey</b>

Distance (ft):	<b>6.7</b>
Structural Grade:	<b>0</b>
O&M Grade:	<b>0</b>
Clock Start/From:	
Clock To:	
1st Value:	
2nd Value:	
Value Percent:	
Continuous Index:	
Within 8" of Joint:	<b>NO</b>
Remarks:	<b>unknown</b>
