Profile/Photo Observation Report

Street:	OFF W 14TH ST	Flow Control:	Not Controlled
City:	Hobart, IN	Year Renewed:	
Location:	Yard	Tape/Media #:	
Purpose:	Routine Assessment	Dia/Height:	12"
Use:	Sanitary	Material:	PVC
Drain Area:	NA	Lining:	
Category:	NA		
Comment:	Flow direction is marked wrong.

Location Details:		Direction of Survey:	Downstream
US MH:	M-608-033	DS MH:	M-608-032
		Total Length Surveyed (ft):	130.5

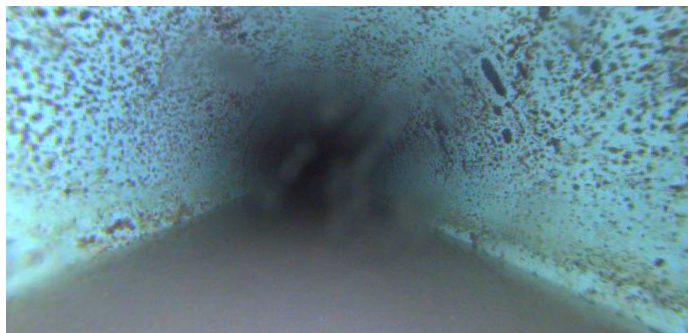
Code: **AMH**
 Description: **Manhole**

Distance (ft): **.0**
 Structural Grade: **0**
 O&M Grade: **0**
 Clock Start/From:
 Clock To:
 1st Value:
 2nd Value:
 Value Percent:
 Continuous Index:
 Within 8" of Joint: **NO**
 Remarks: **M-608-033**

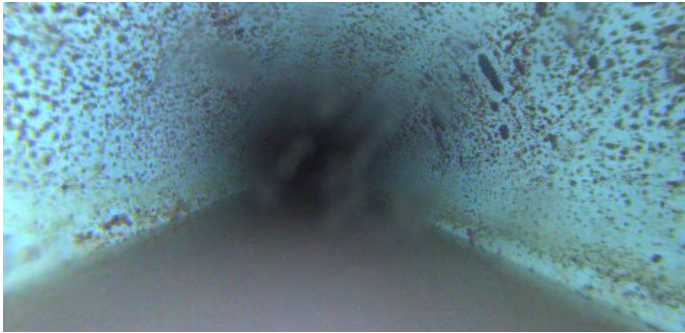
Code:	MWL
Description:	Water Level

Distance (ft):	.0
Structural Grade:	0
O&M Grade:	0
Clock Start/From:	
Clock To:	
1st Value:	
2nd Value:	
Value Percent:	20.000
Continuous Index:	
Within 8" of Joint:	NO
Remarks:

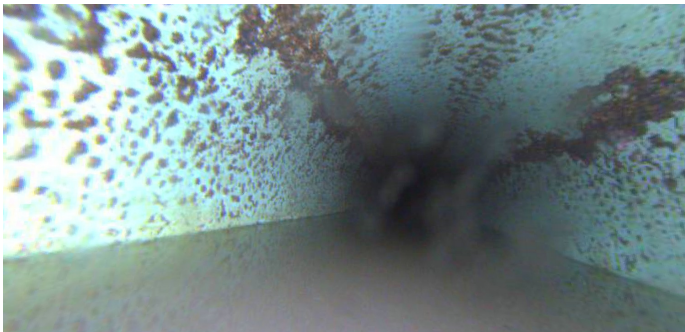
Code:	DAZ
Description:	Deposits Attached Other

Distance (ft):	42.7
Structural Grade:	0
O&M Grade:	2
Clock Start/From:	8
Clock To:	4
1st Value:	
2nd Value:	
Value Percent:	5.000
Continuous Index:	S01
Within 8" of Joint:	NO
Remarks:

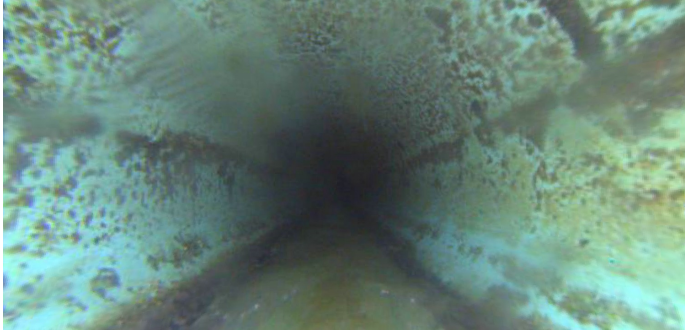
Code: **MGO**
Description: **General Observation**

Distance (ft): **70.6**
Structural Grade: **0**
O&M Grade: **0**
Clock Start/From:
Clock To:
1st Value:
2nd Value:
Value Percent:
Continuous Index:
Within 8" of Joint: **NO**
Remarks: **REAR CAMERA**

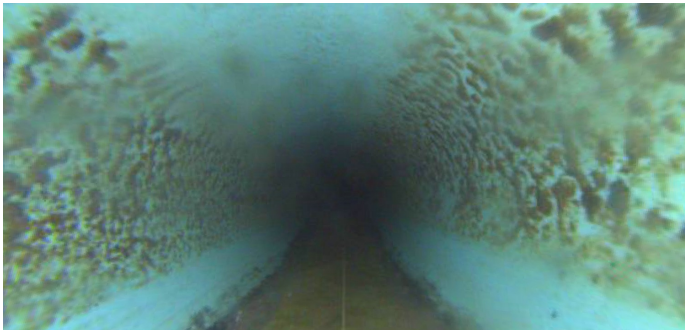
Code: **DAZ**
Description: **Deposits Attached Other**

Distance (ft): **82.9**
Structural Grade: **0**
O&M Grade: **2**
Clock Start/From: **8**
Clock To: **4**
1st Value:
2nd Value:
Value Percent: **5.000**
Continuous Index: **F01**
Within 8" of Joint: **NO**
Remarks:

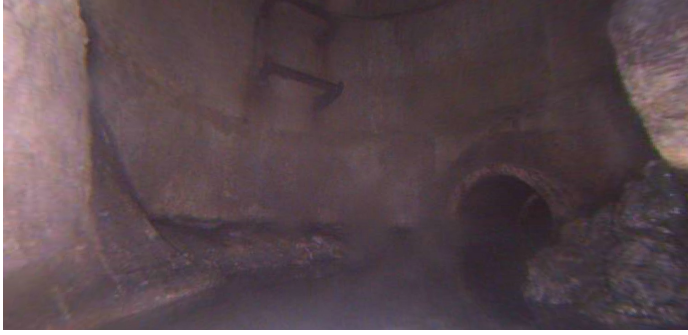
Code:	AMH
Description:	Manhole
Distance (ft):	130.2
Structural Grade:	0
O&M Grade:	0
Clock Start/From:	
Clock To:	
1st Value:	
2nd Value:	
Value Percent:	
Continuous Index:	
Within 8" of Joint:	NO
Remarks:	M-608-032
